# Application Notes

## Diagnosis of Vibration Problems in Holland

### Case Studies from the Groenpol Vibration Consultancy

Matt o'Sullivan  
Mechanical Engineer  
Brüel and Kjær, Denmark

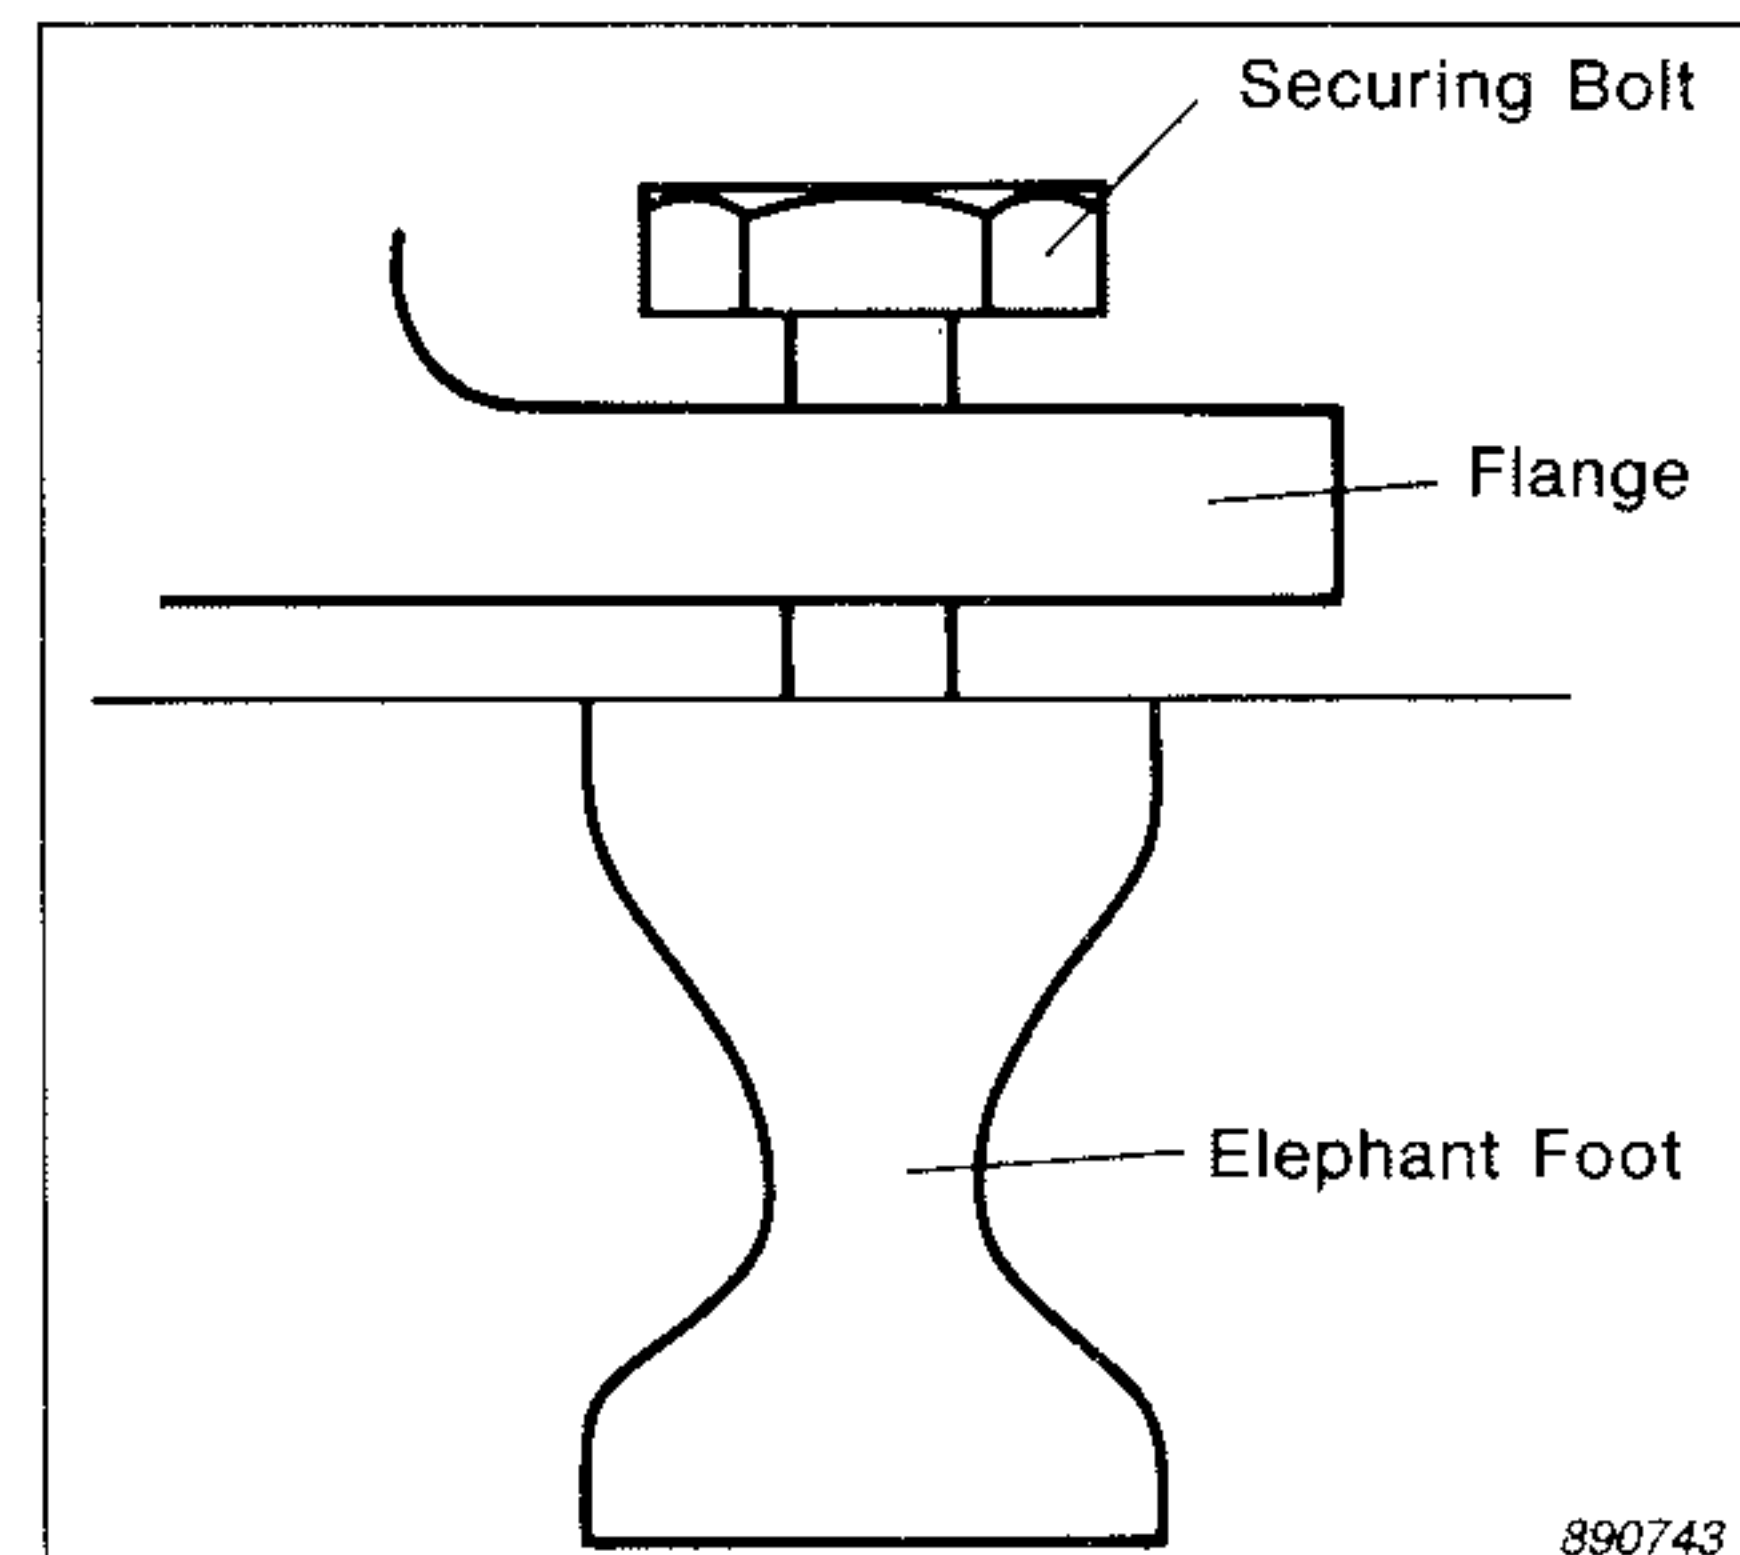
Fig. 2. A loose bolt, in its elephant foot, at the base of the non-driven end of the compressor. The casing is excited at the shaft rotation speed, causing a harmonic family of the shaft speed in the spectrum

They found two loose, worn bolts on the elephant feet at the non-driven end of the compressor, see Fig. 2. The company decided to wait until the next scheduled stop before replacing the bolts. After that, the machines would be ready for systematic monitoring.

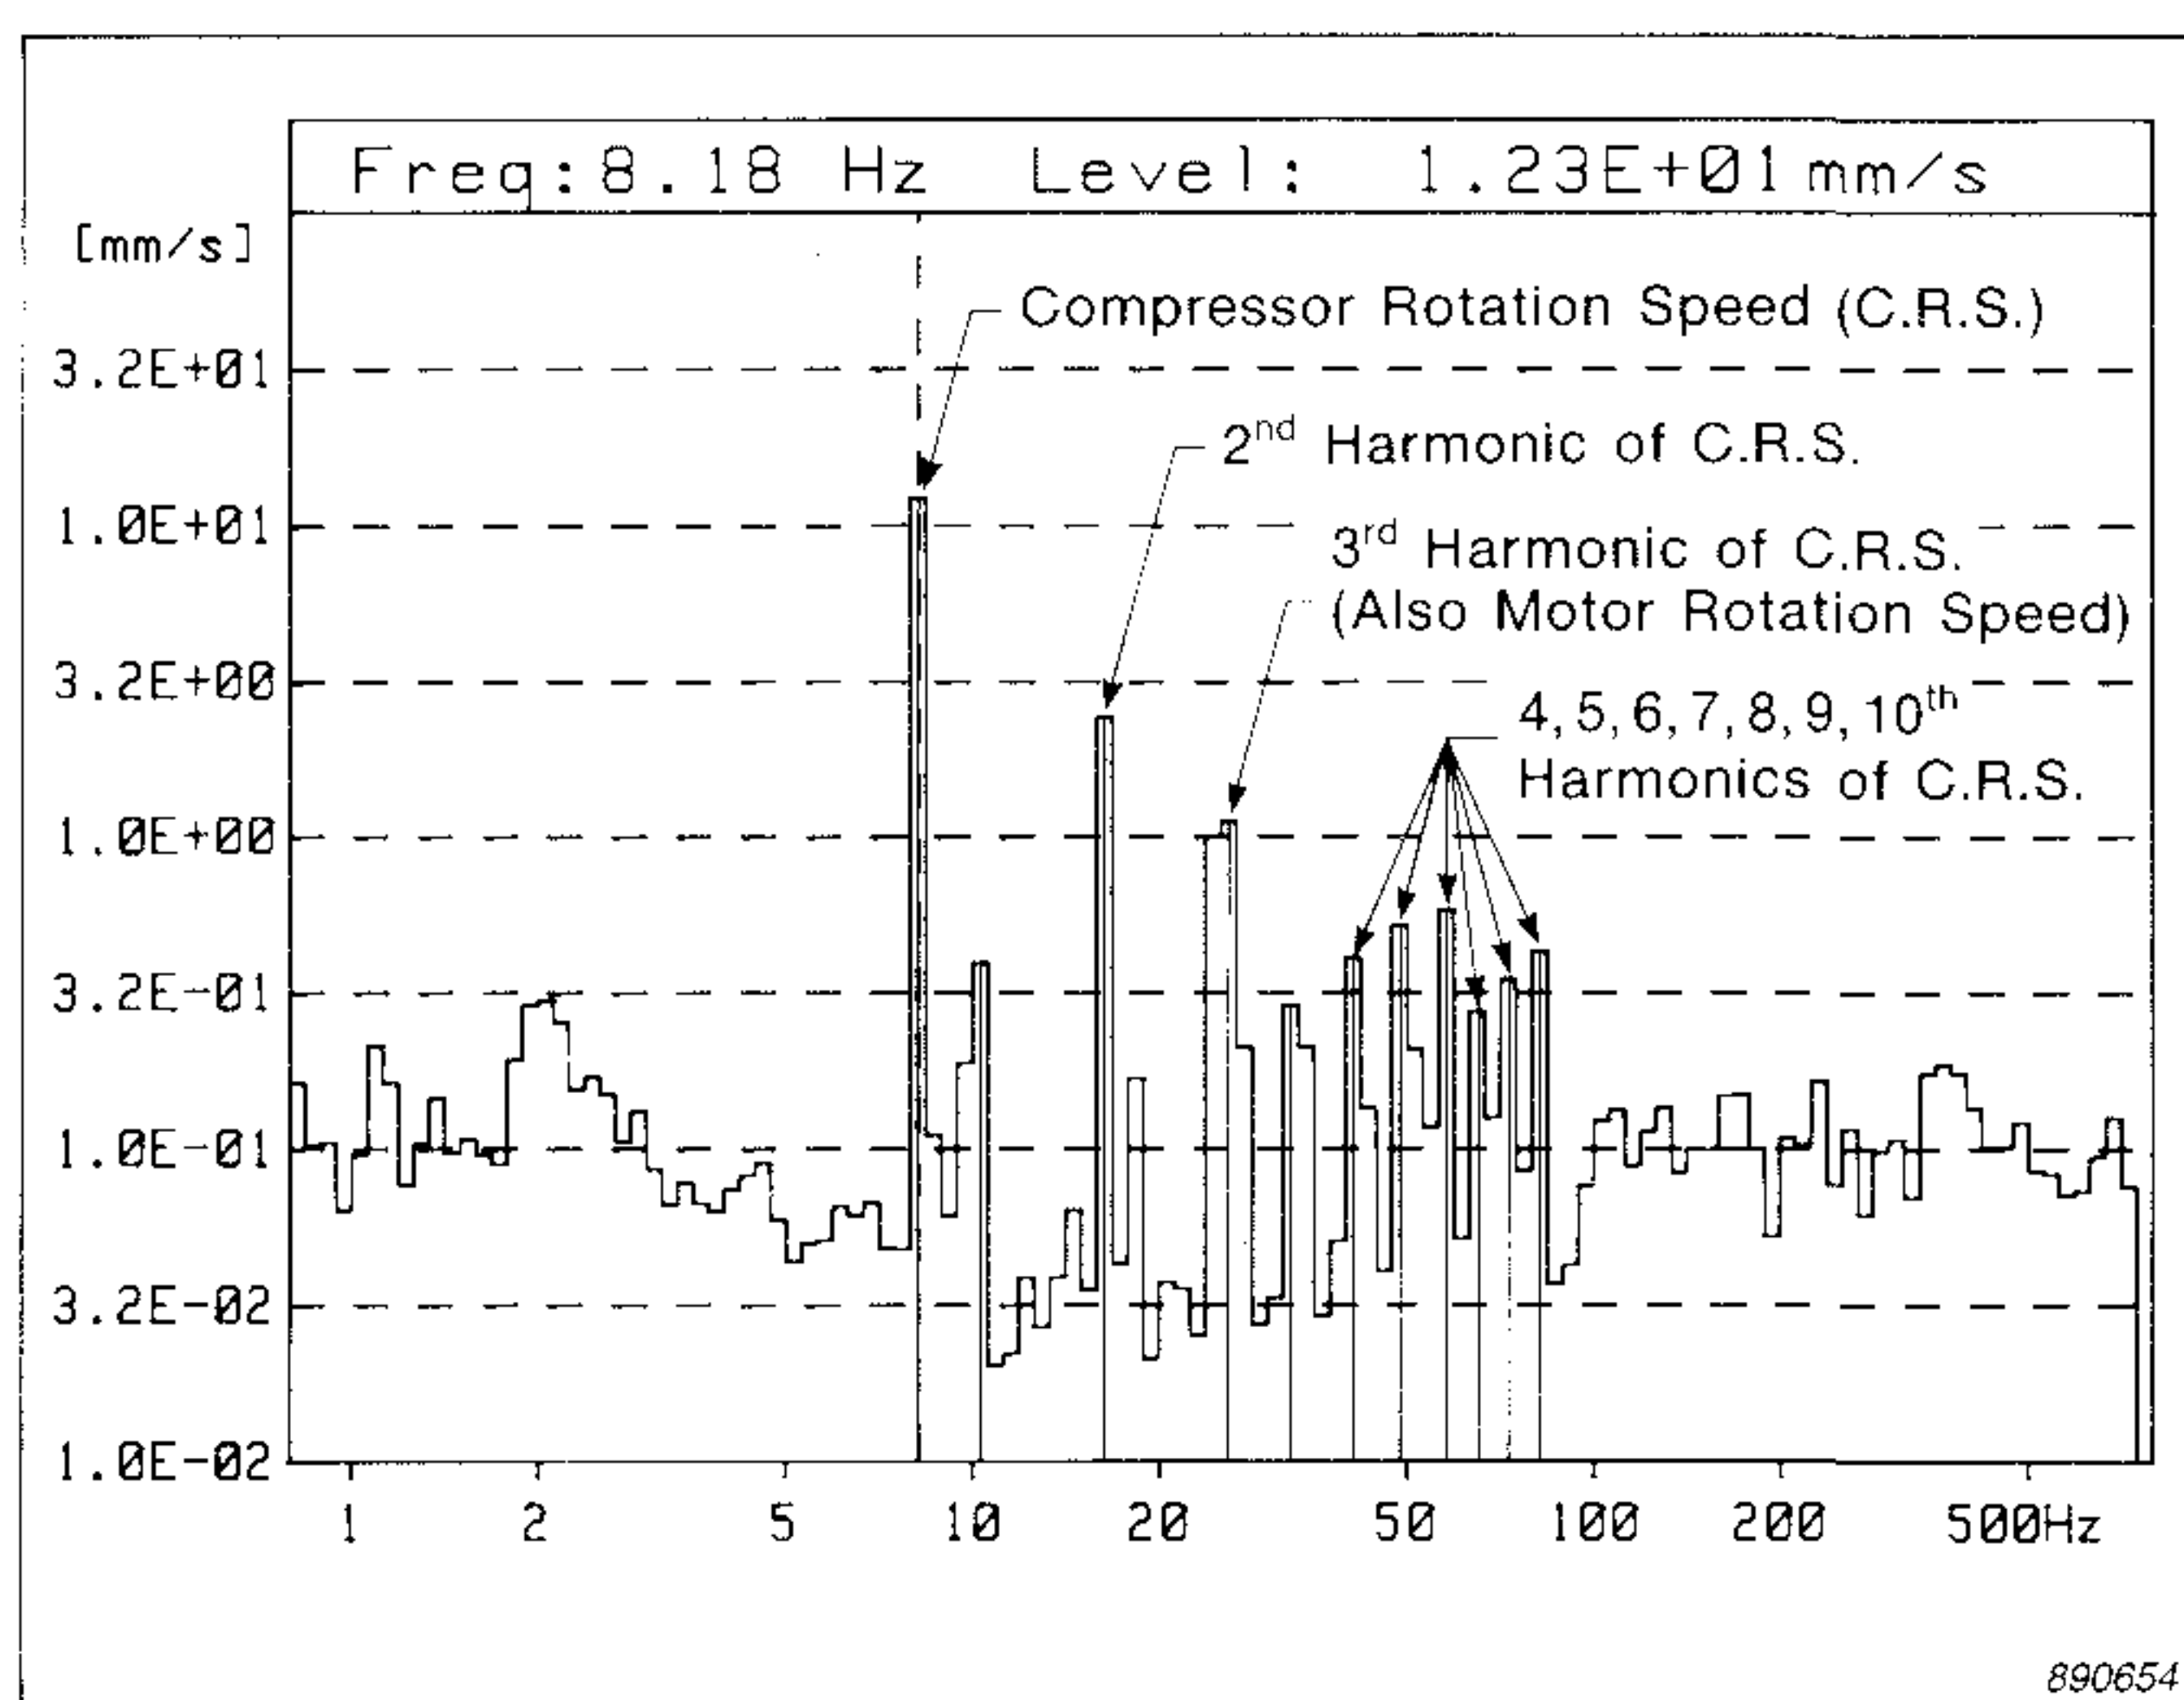
Fig. 3. A vertical measurement (500 Hz, CPB spectrum) from the compressor casing. The prominent harmonic family of the compressor rotation speed indicates looseness

The spectrum from the vertical measurement point is shown in Fig. 3. It contains a harmonic family of the rotation speed. They compared the vertical and horizontal spectra as shown in Fig. 4. The harmonic family in the vertical spectrum exceeds that in the horizontal spectrum, a result which indicates that the excessive vertical vibration is caused by mechanical looseness. Groenpol decided to check the bolts securing the compressor to its foundation.

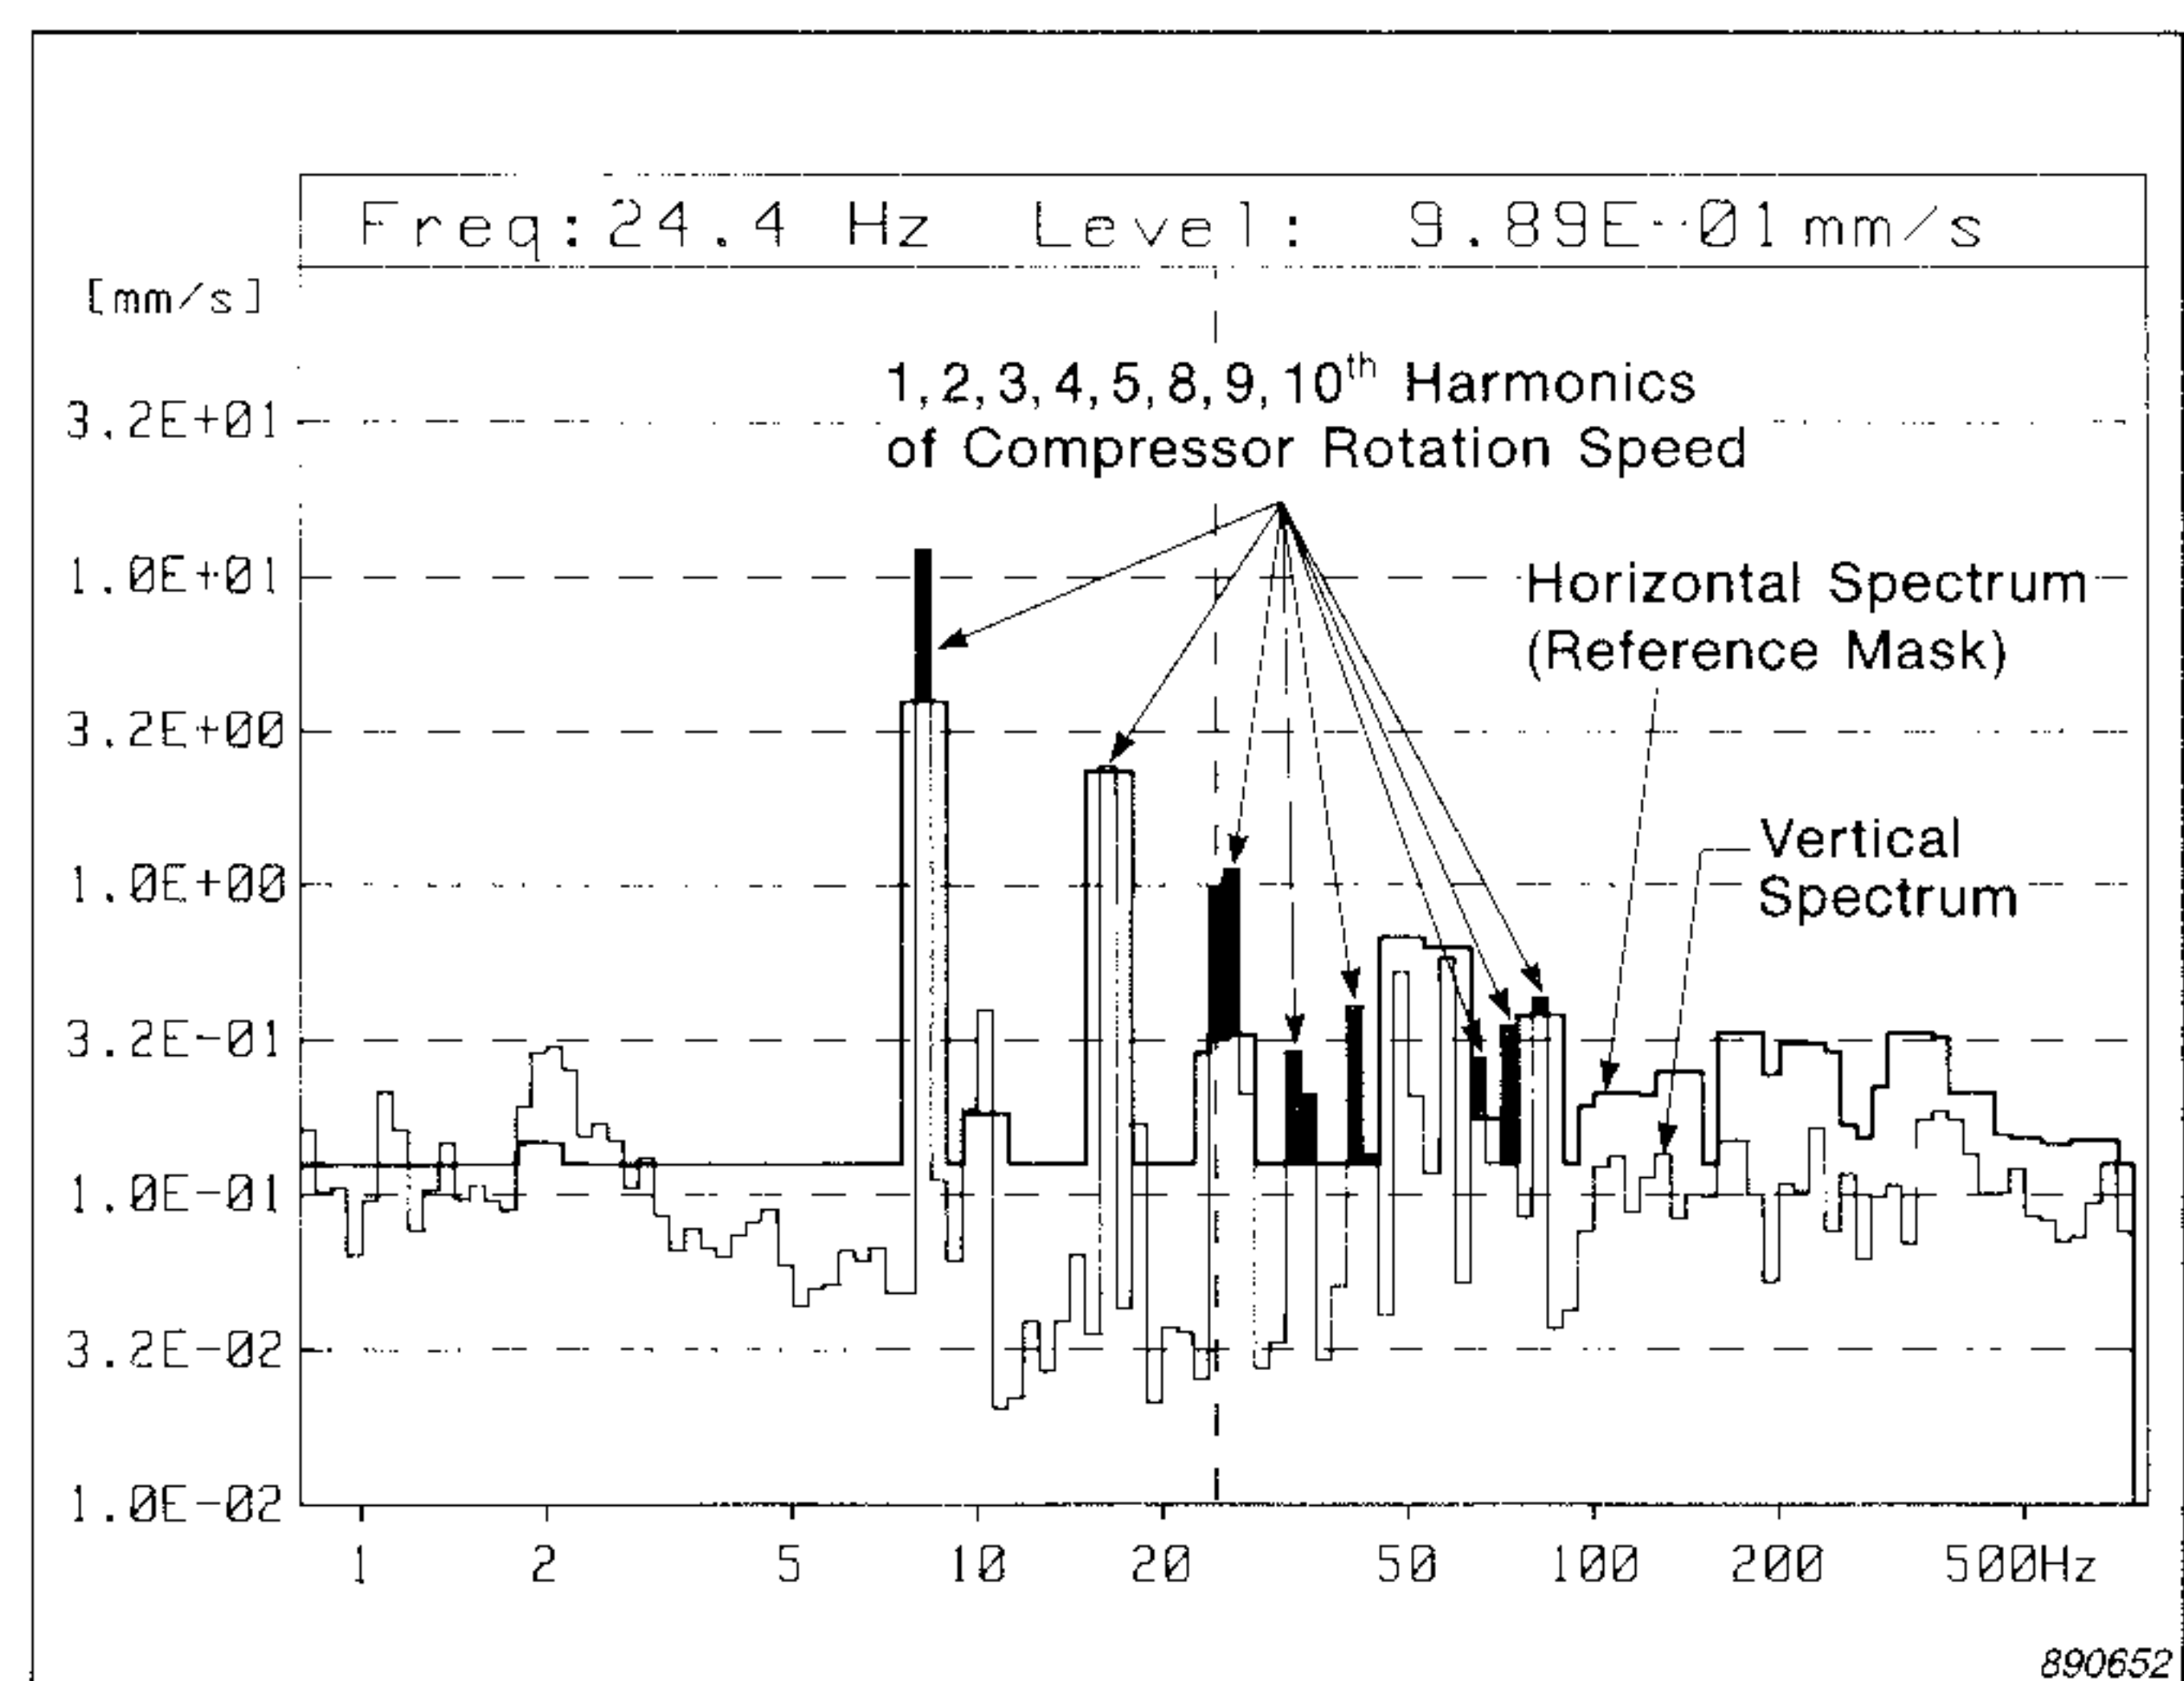
Fig. 4. A comparison of vertical and horizontal measurements (500 Hz, CPB spectra) from the compressor casing. The horizontal measurement is the reference. Note that the vertical exceeds the horizontal at harmonics of the compressor rotation speed

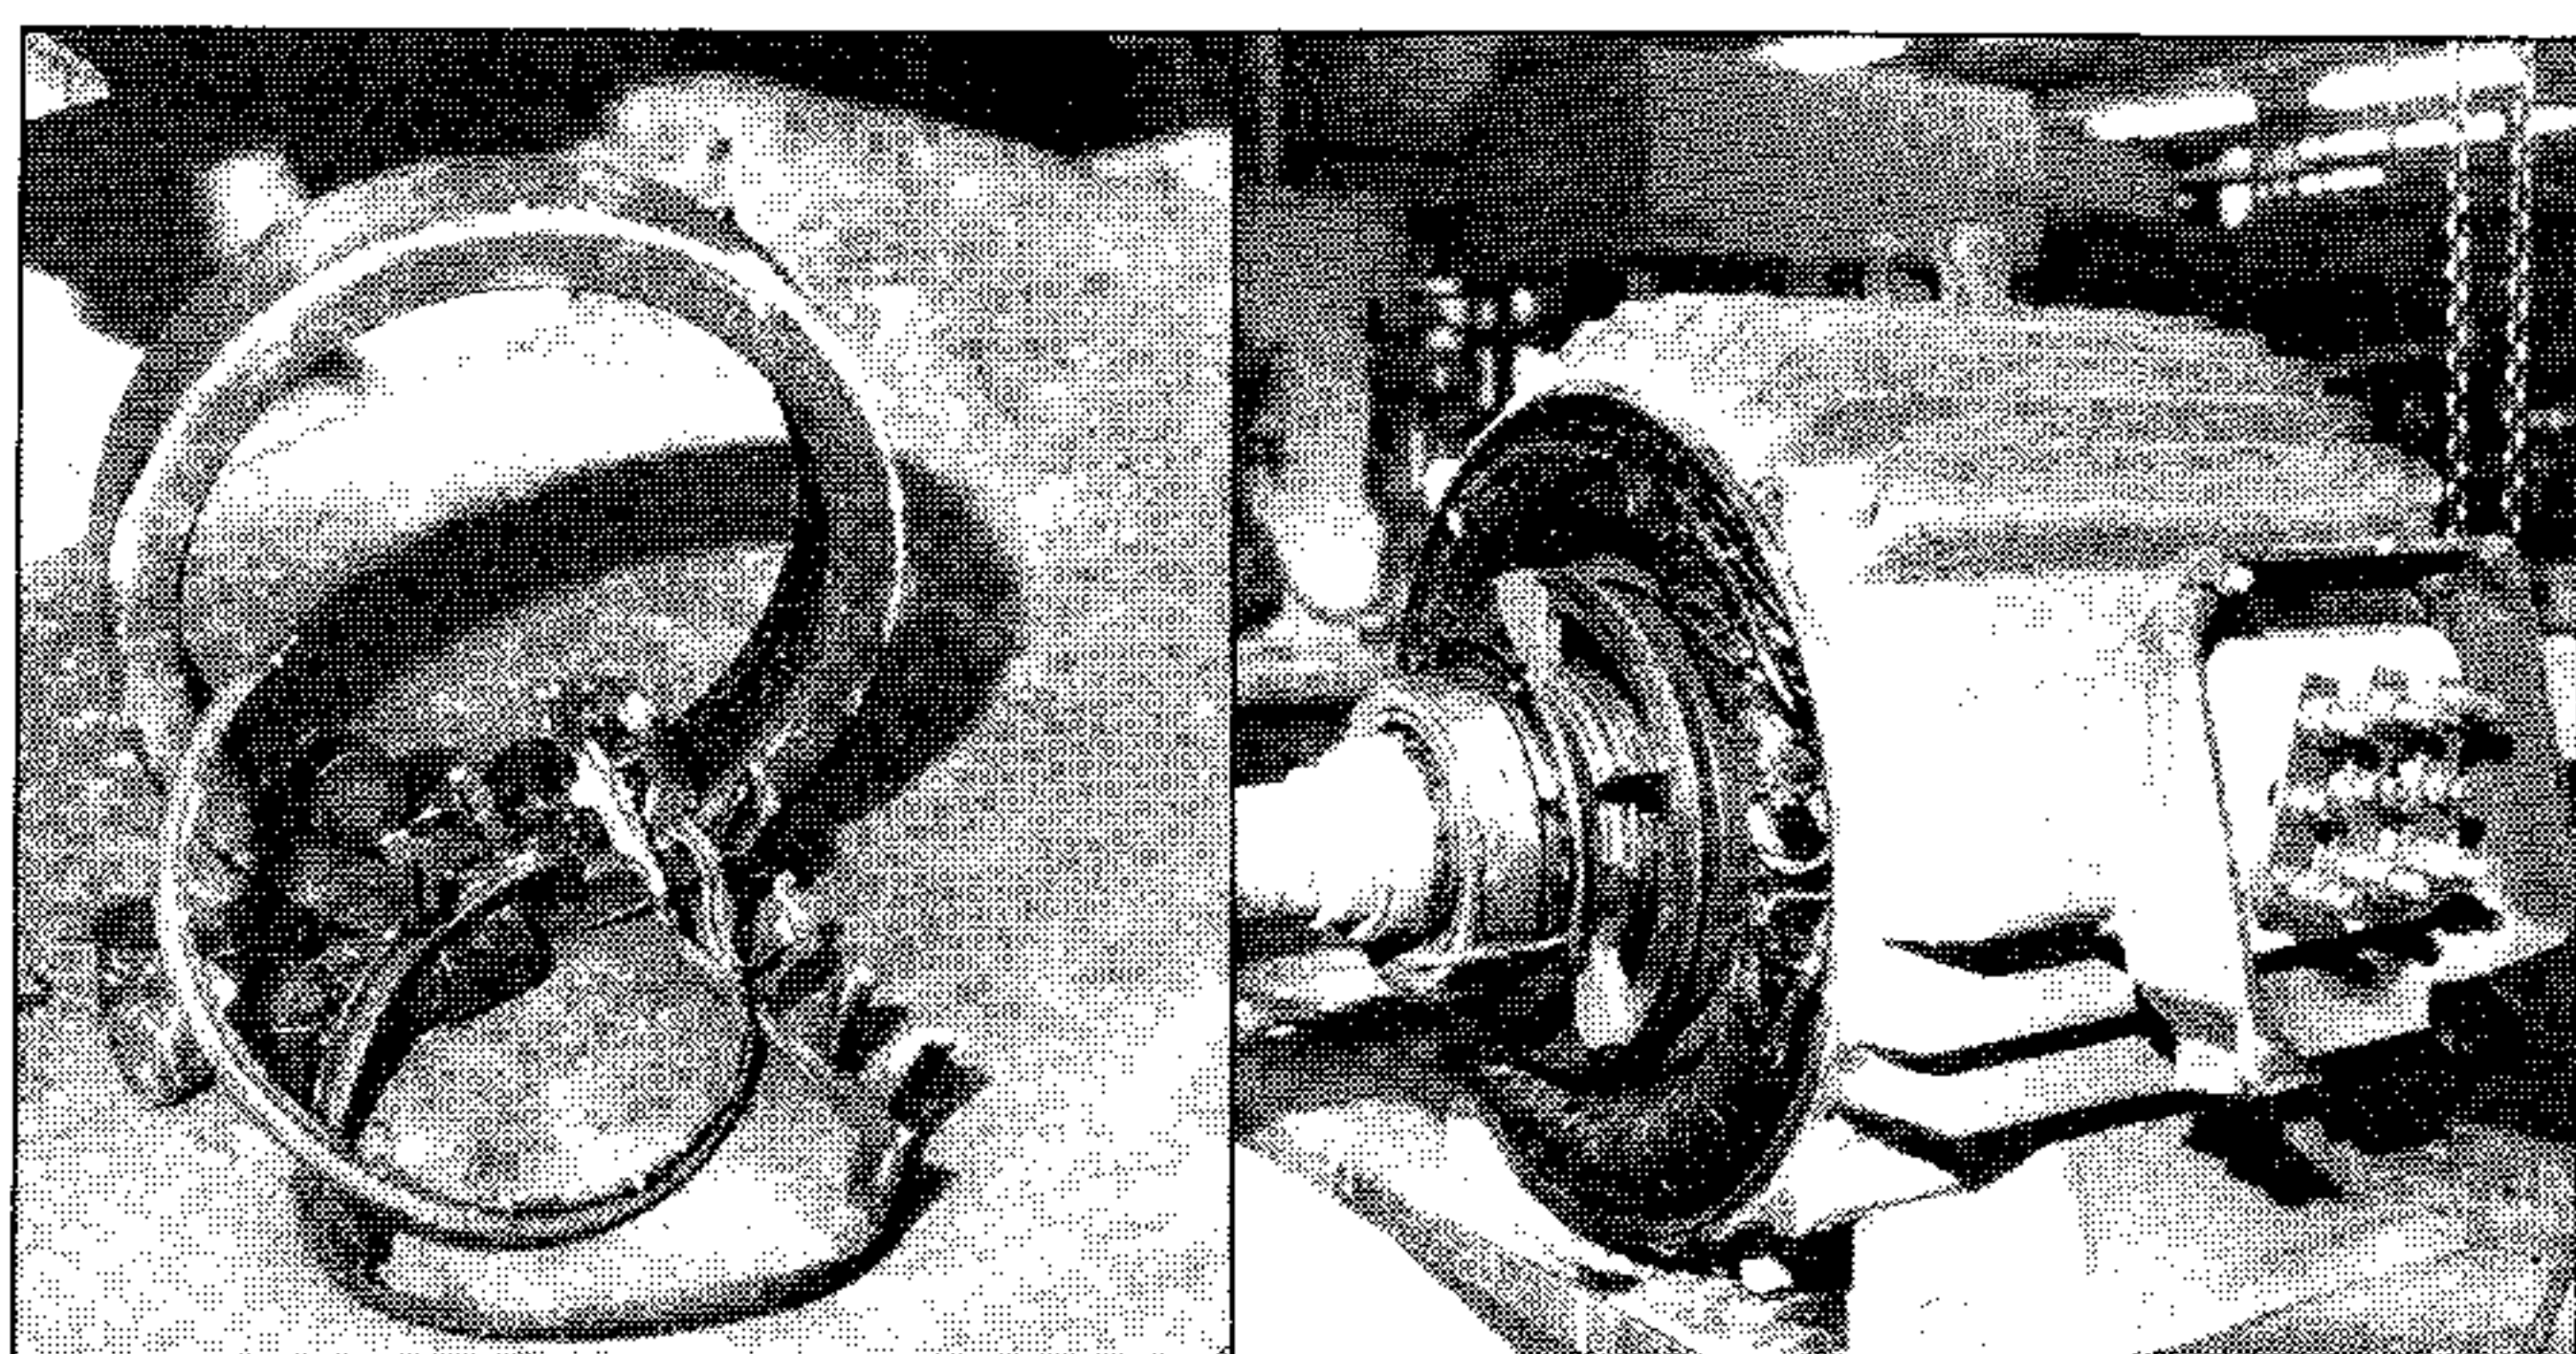
Fig.5. Groenpol have a workshop where they service and repair various types of machines. Here is a damaged roller bearing from a dismantled electric motor

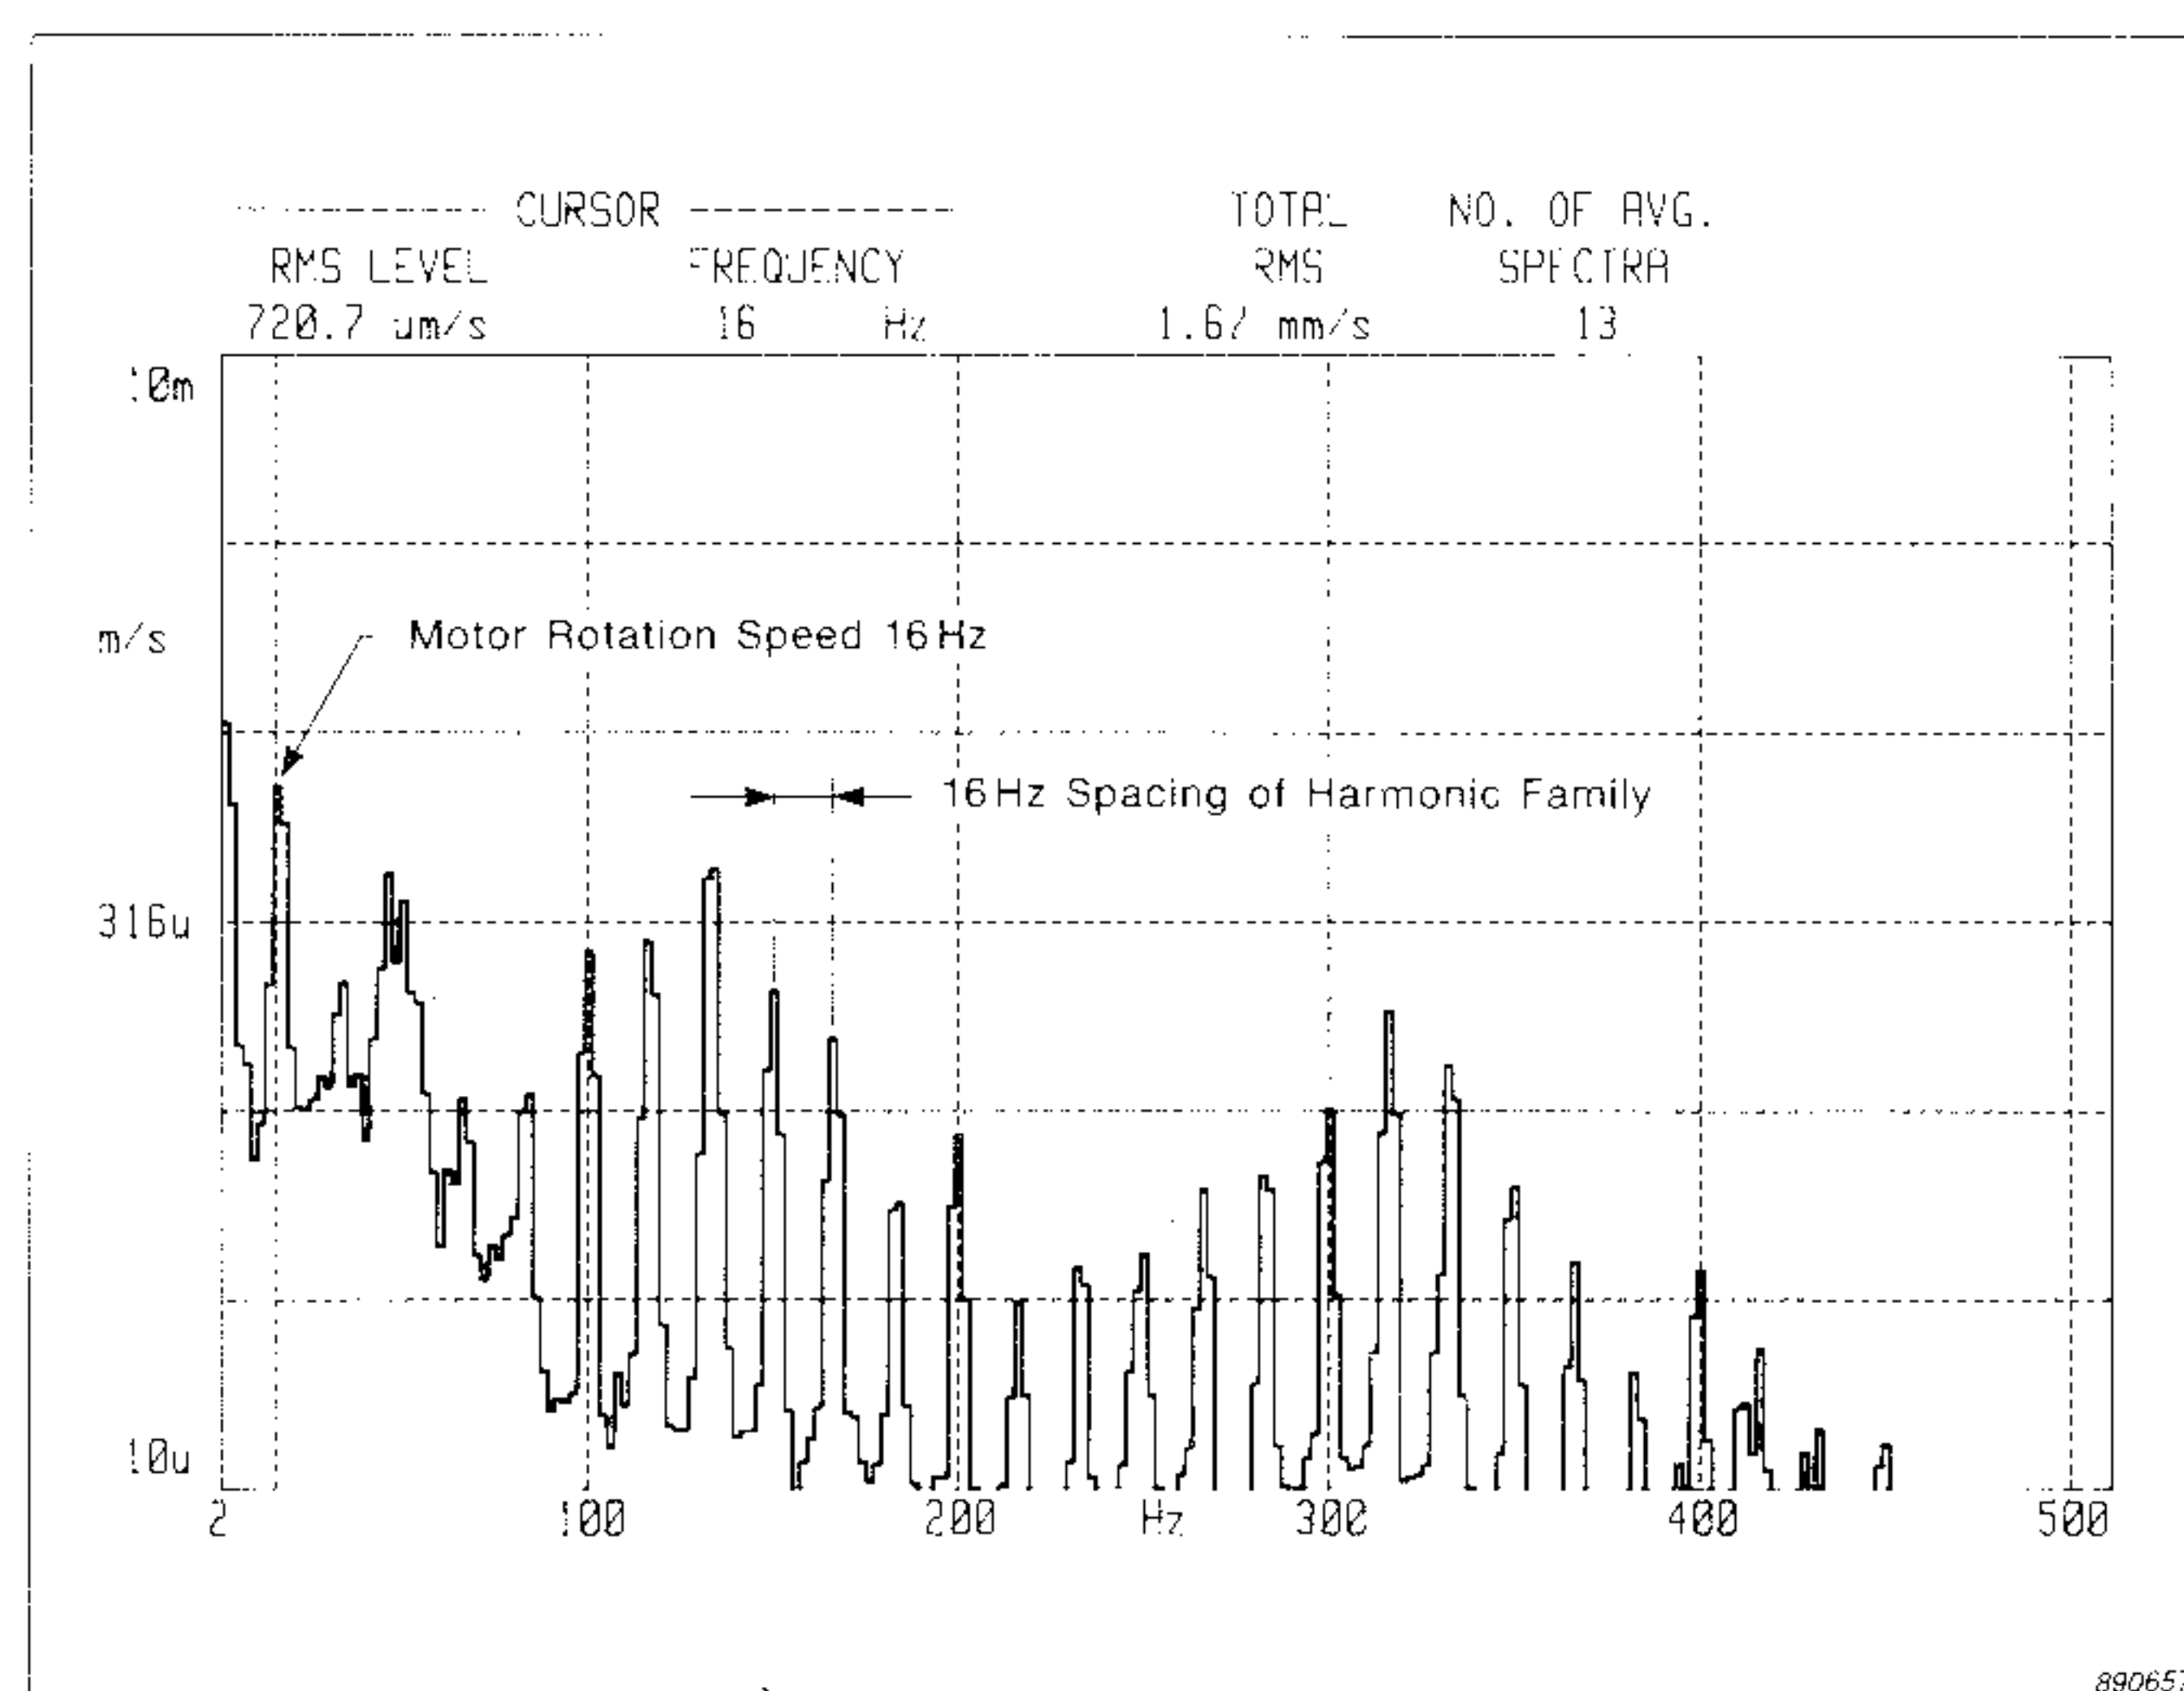
The lift motor had a vibration level of  $1,67 \text{ mms}^{-1}$  in the horizontal direction, so it failed to satisfy VDI 2056. The Type 2515 Vibration Analyzer was used to help diagnose the problem. A linear-baseband spectrum revealed a large family of harmonics of the rotation speed, see Fig.6. This is the classic symptom of mechanical looseness and in the case of an electrical machine, it usually indicates worn rotor

Fig.6. The spectrum from the lift motor, measured at the drive side, horizontal direction. The harmonic family of the rotation speed is the classic symptom of a loose rotor

bearings. Groenpol secured the rotor and, as expected, the motor passed the subsequent vibration test.

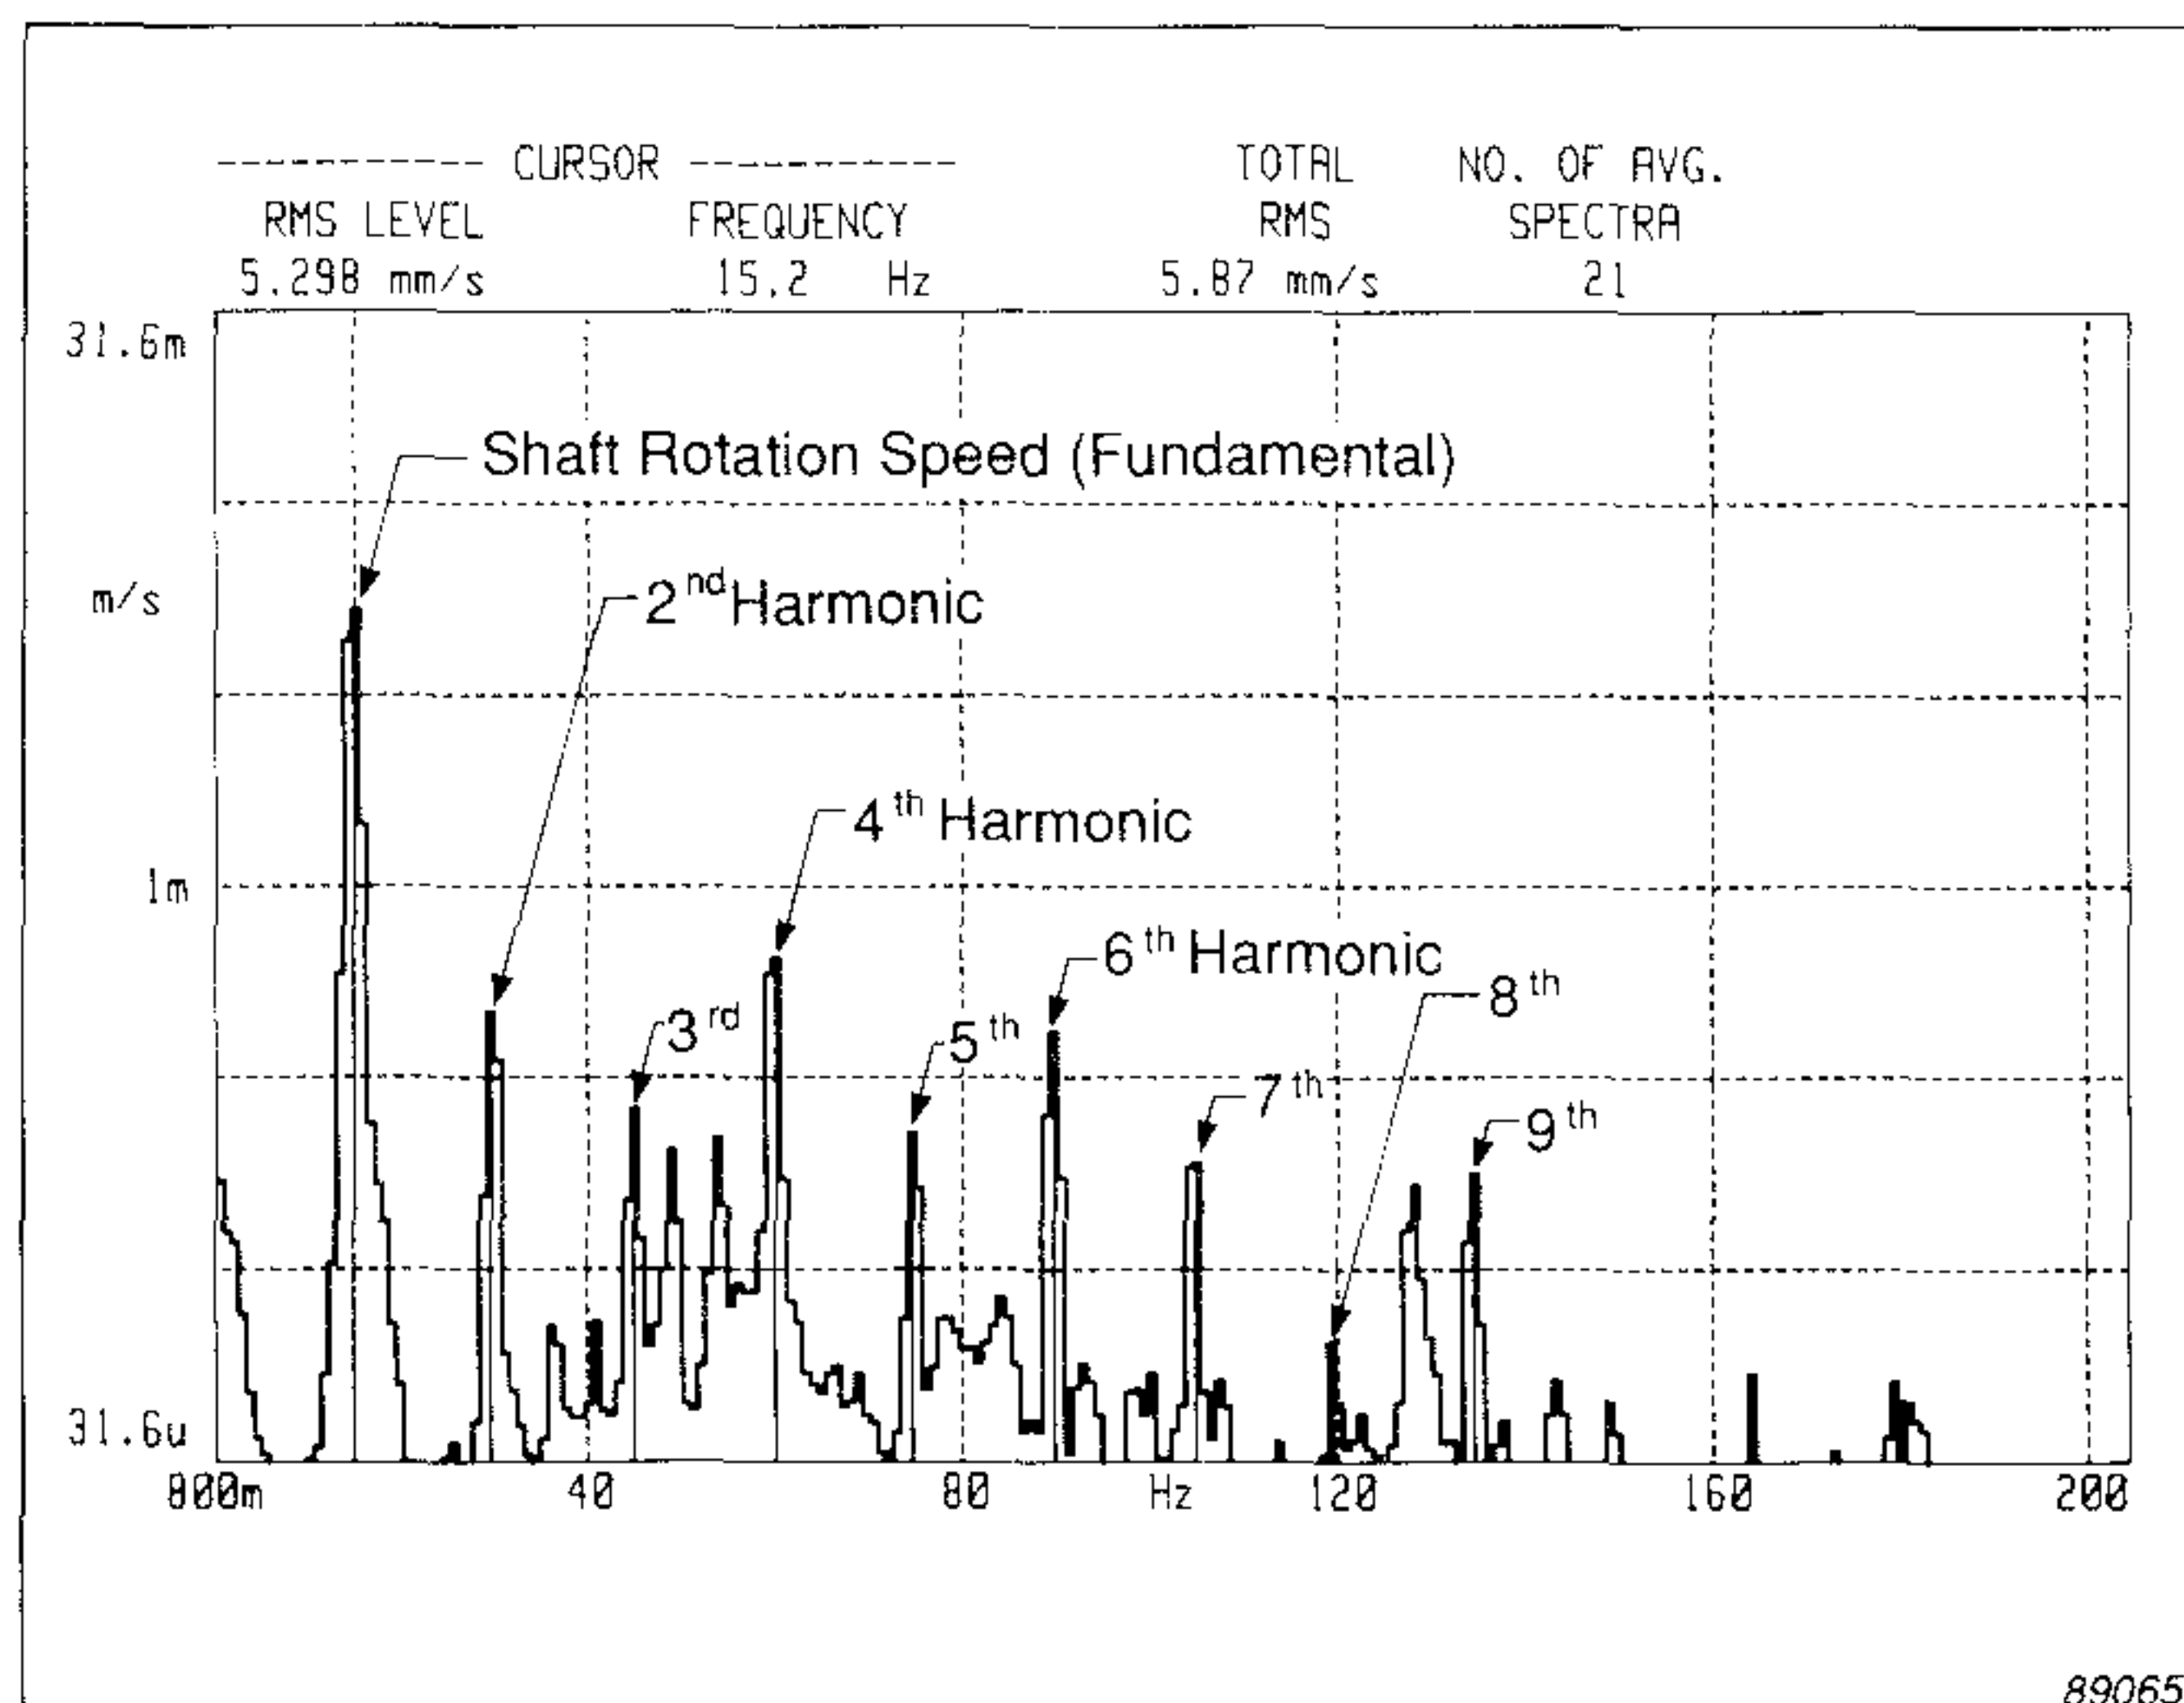
bration level at the motor rotation speed. The spectrum from measurement point 2 is shown in Fig.8. It shows that most of the vibration occurs at the rotation speed; from this Groenpol concluded that the main problem was unbalance.

The 2<sup>nd</sup>, 4<sup>th</sup> and 6<sup>th</sup> harmonics of rotation speed are prominent but their level is much lower; from this Groenpol suspected a misalignment problem at the coupling near measurement point 2.

Fig. 8. A horizontal, linear-baseband spectrum from measurement point 2. The high level at the motor speed indicates that the main problem is unbalance. The prominent  $2 \times$  rotation speed harmonic family suggests a misalignment or coupling problem

Groenpol balanced the two pulleys in-situ. Next they uncoupled the pulleys from the motor and balanced the mo-

tor in-situ. Finally they examined the coupling and they found it was stiff and worn due to lack of grease. After it was cleaned and greased, and the shafts re-coupled, the machine operated normally. An overall RMS measurement confirmed that the vibration level was now acceptable.
