# Application Notes

## Diagnosis of Vibration Problems in Holland

### Case Studies from the Groenpol Vibration Consultancy

Matt o'Sullivan  
Mechanical Engineer  
Brüel and Kjær, Denmark

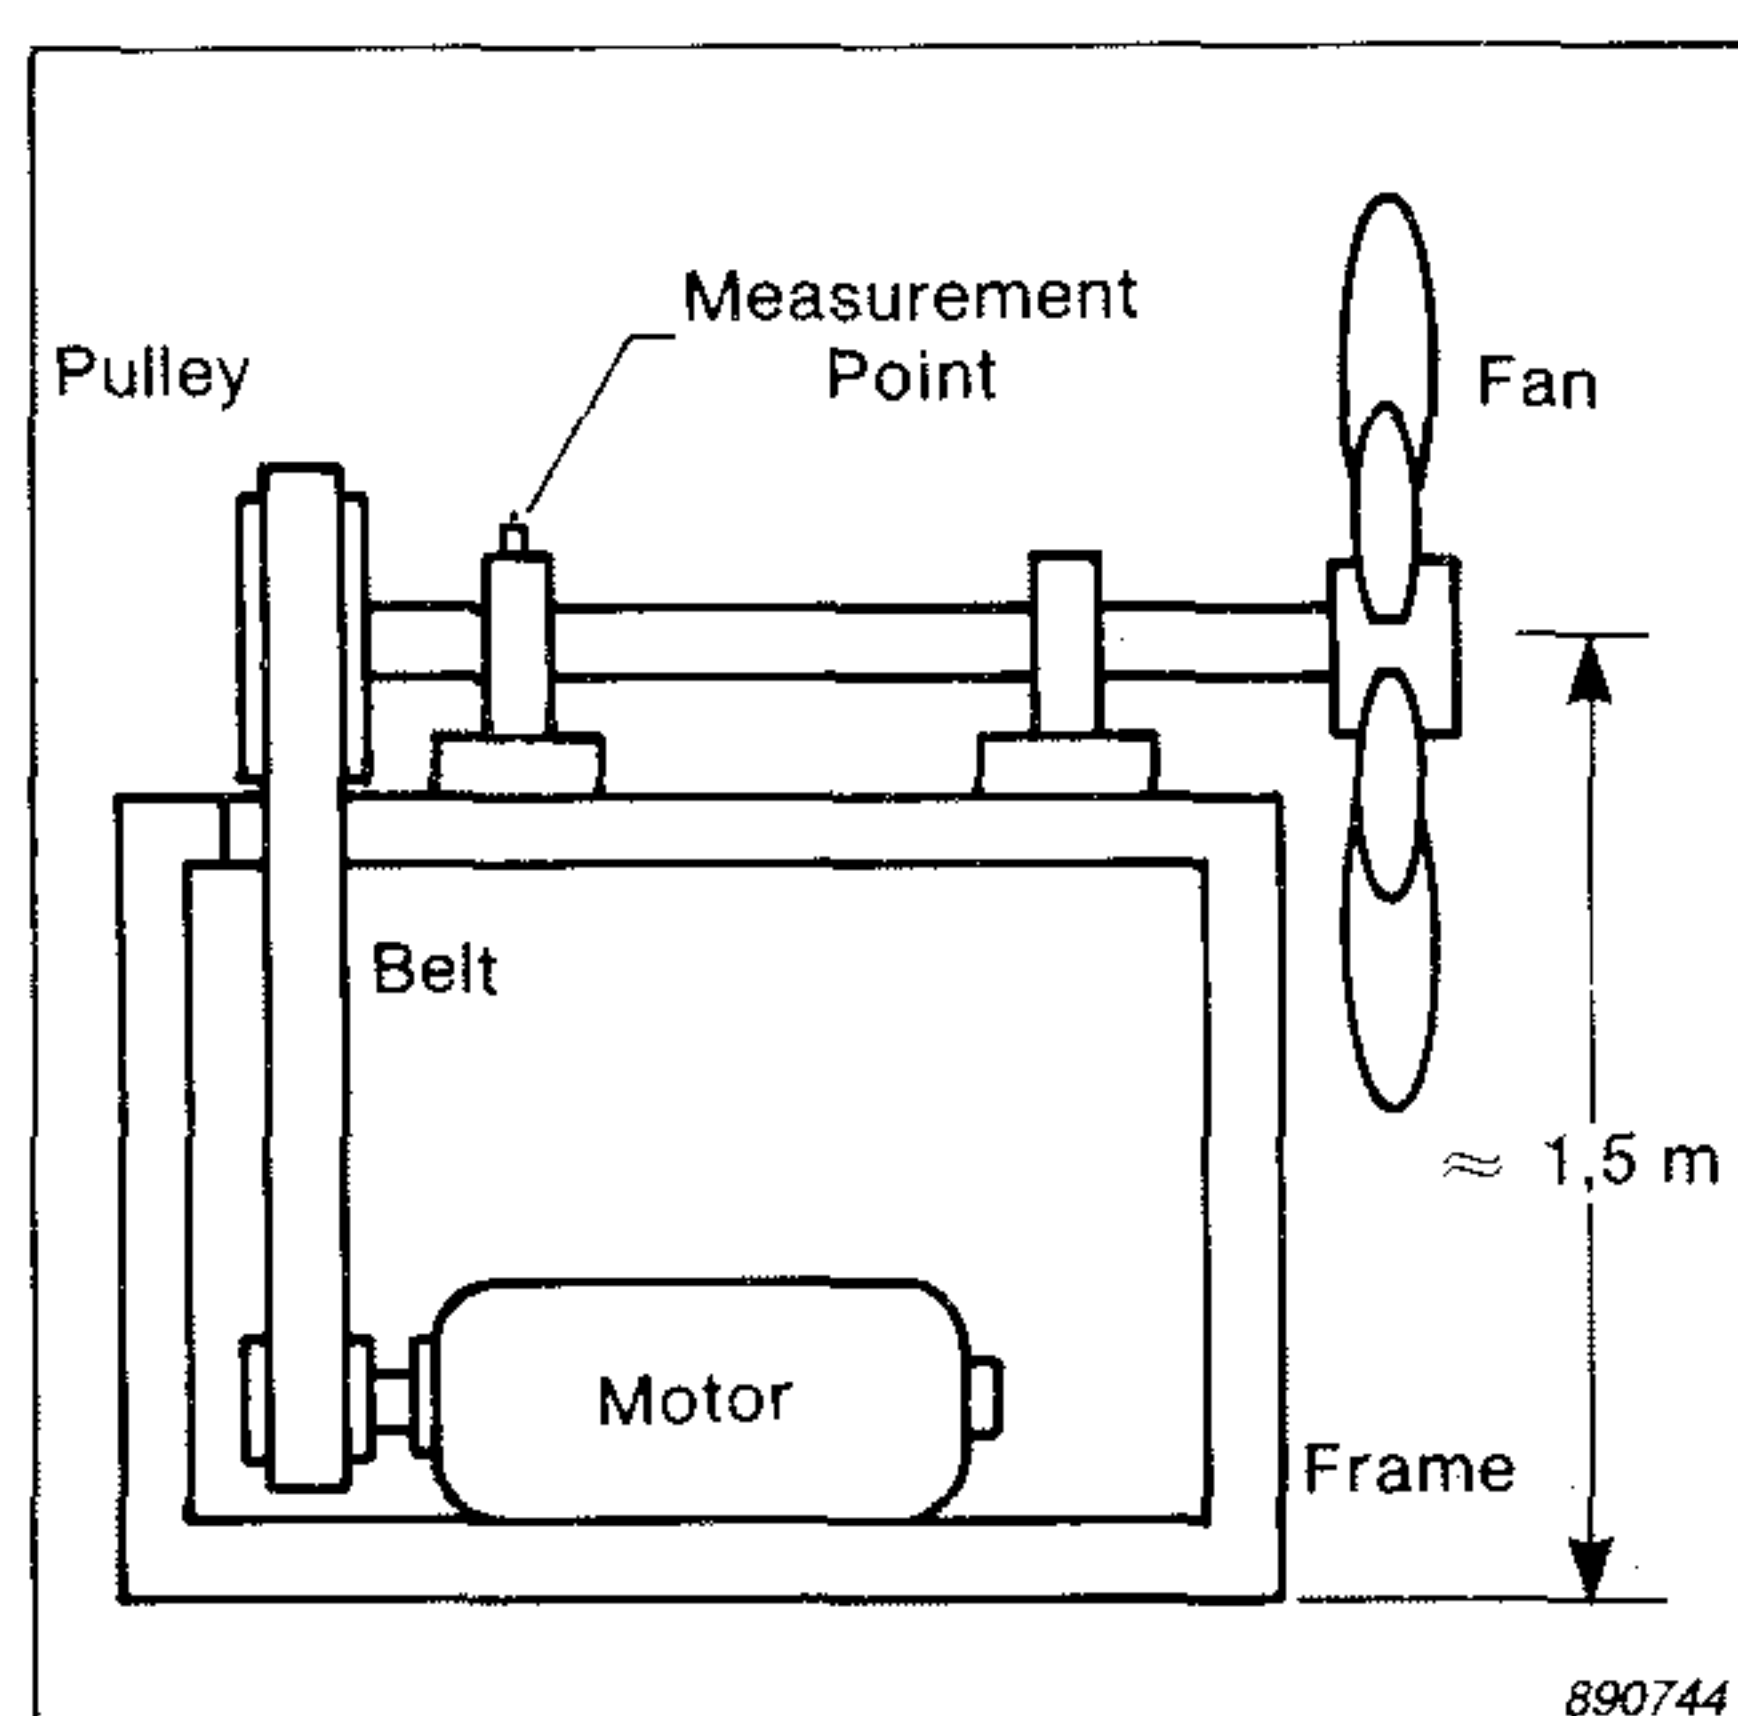
The company in this case manufactures Tarmacadam for road surfacing. The faulty fan is used to extract dust from the manufacturing area. It was located about 1.5 m from ground level, on top of a steel frame which stood unbolted to the floor, see Fig. 9.

Fig. 9. The motor drives the fan through a belt drive as shown. The frame sits loose on the floor

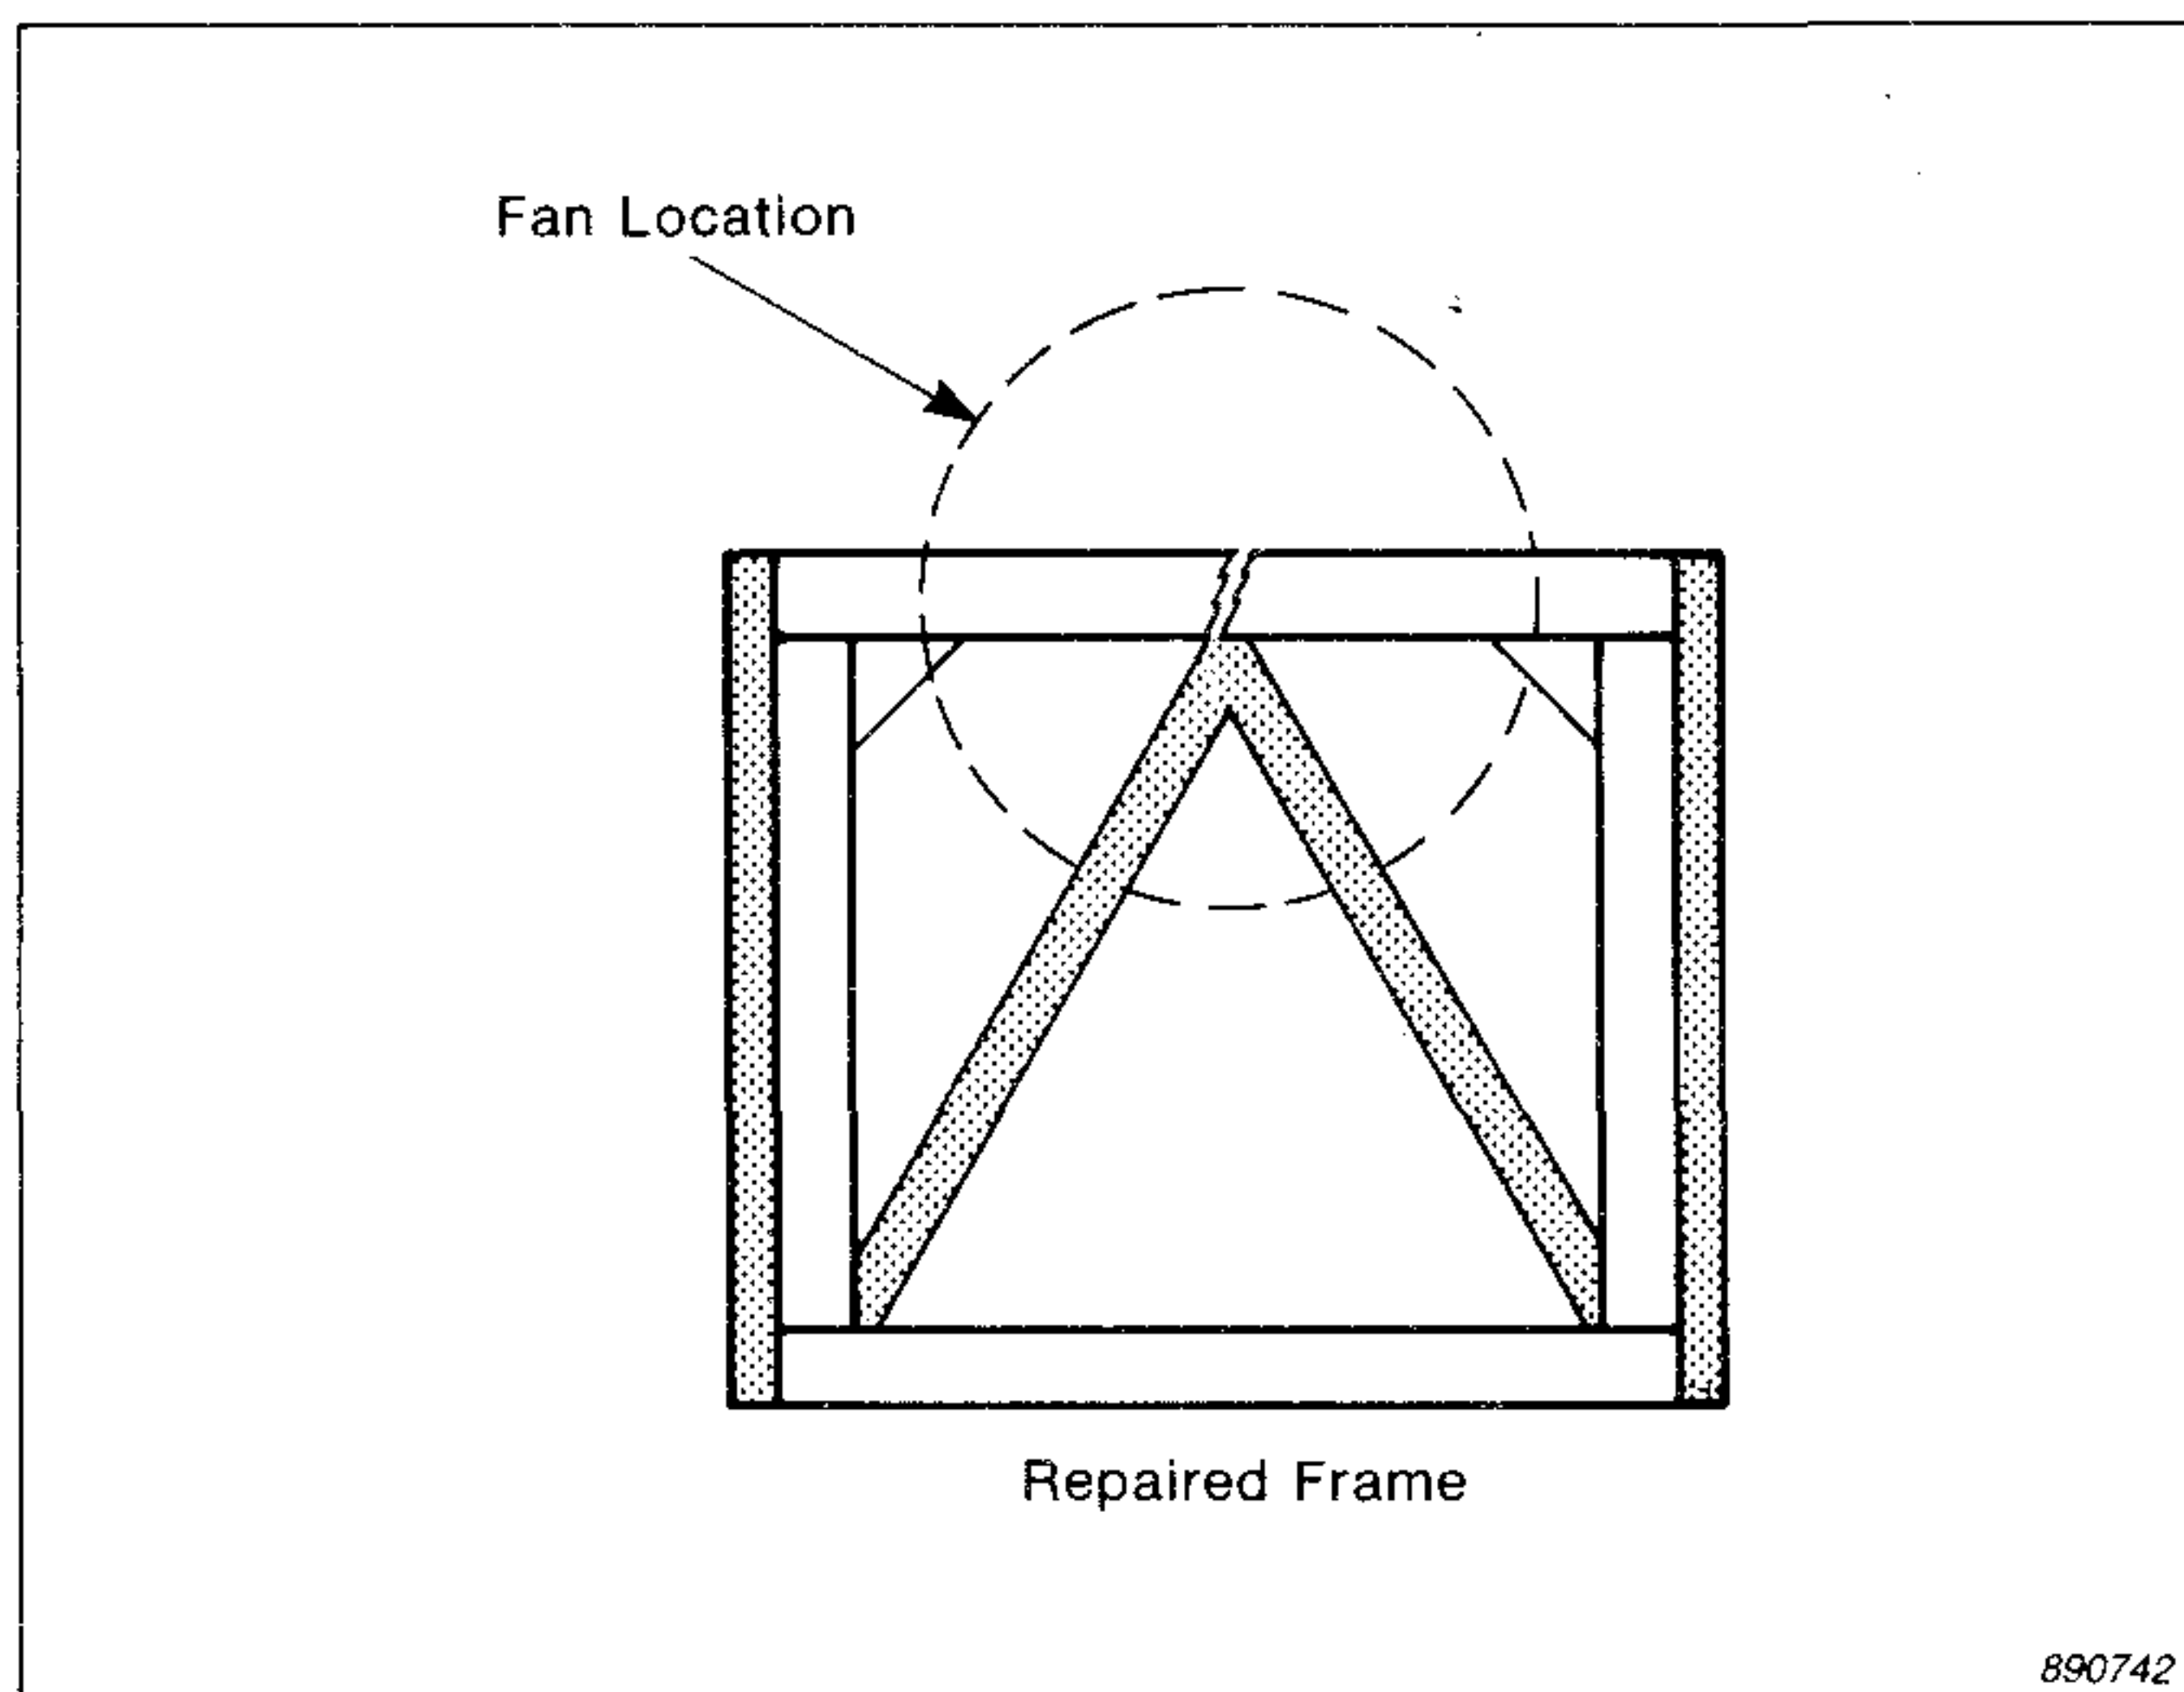
Soon afterwards the vibration level became intolerable again. Groenpol suspected a structural problem and decided to inspect the frame closely, see Fig. 11. On sand-blasting, they found a large crack at the top. This had caused a low-frequency resonance in the frame, near the fan rotation frequency. They advised the company to weld the crack, add stiffeners, and fill the frame with concrete.

Fig. 11. The original frame had a crack near the top. This was welded and stiffeners (shaded sections) were added

The company stiffened the frame as shown in Fig. 11 and this increased the

frequency of the resonance. During subsequent balancing jobs, the 150 g trial mass did not cause dangerous vibration levels and the phase was much more stable.

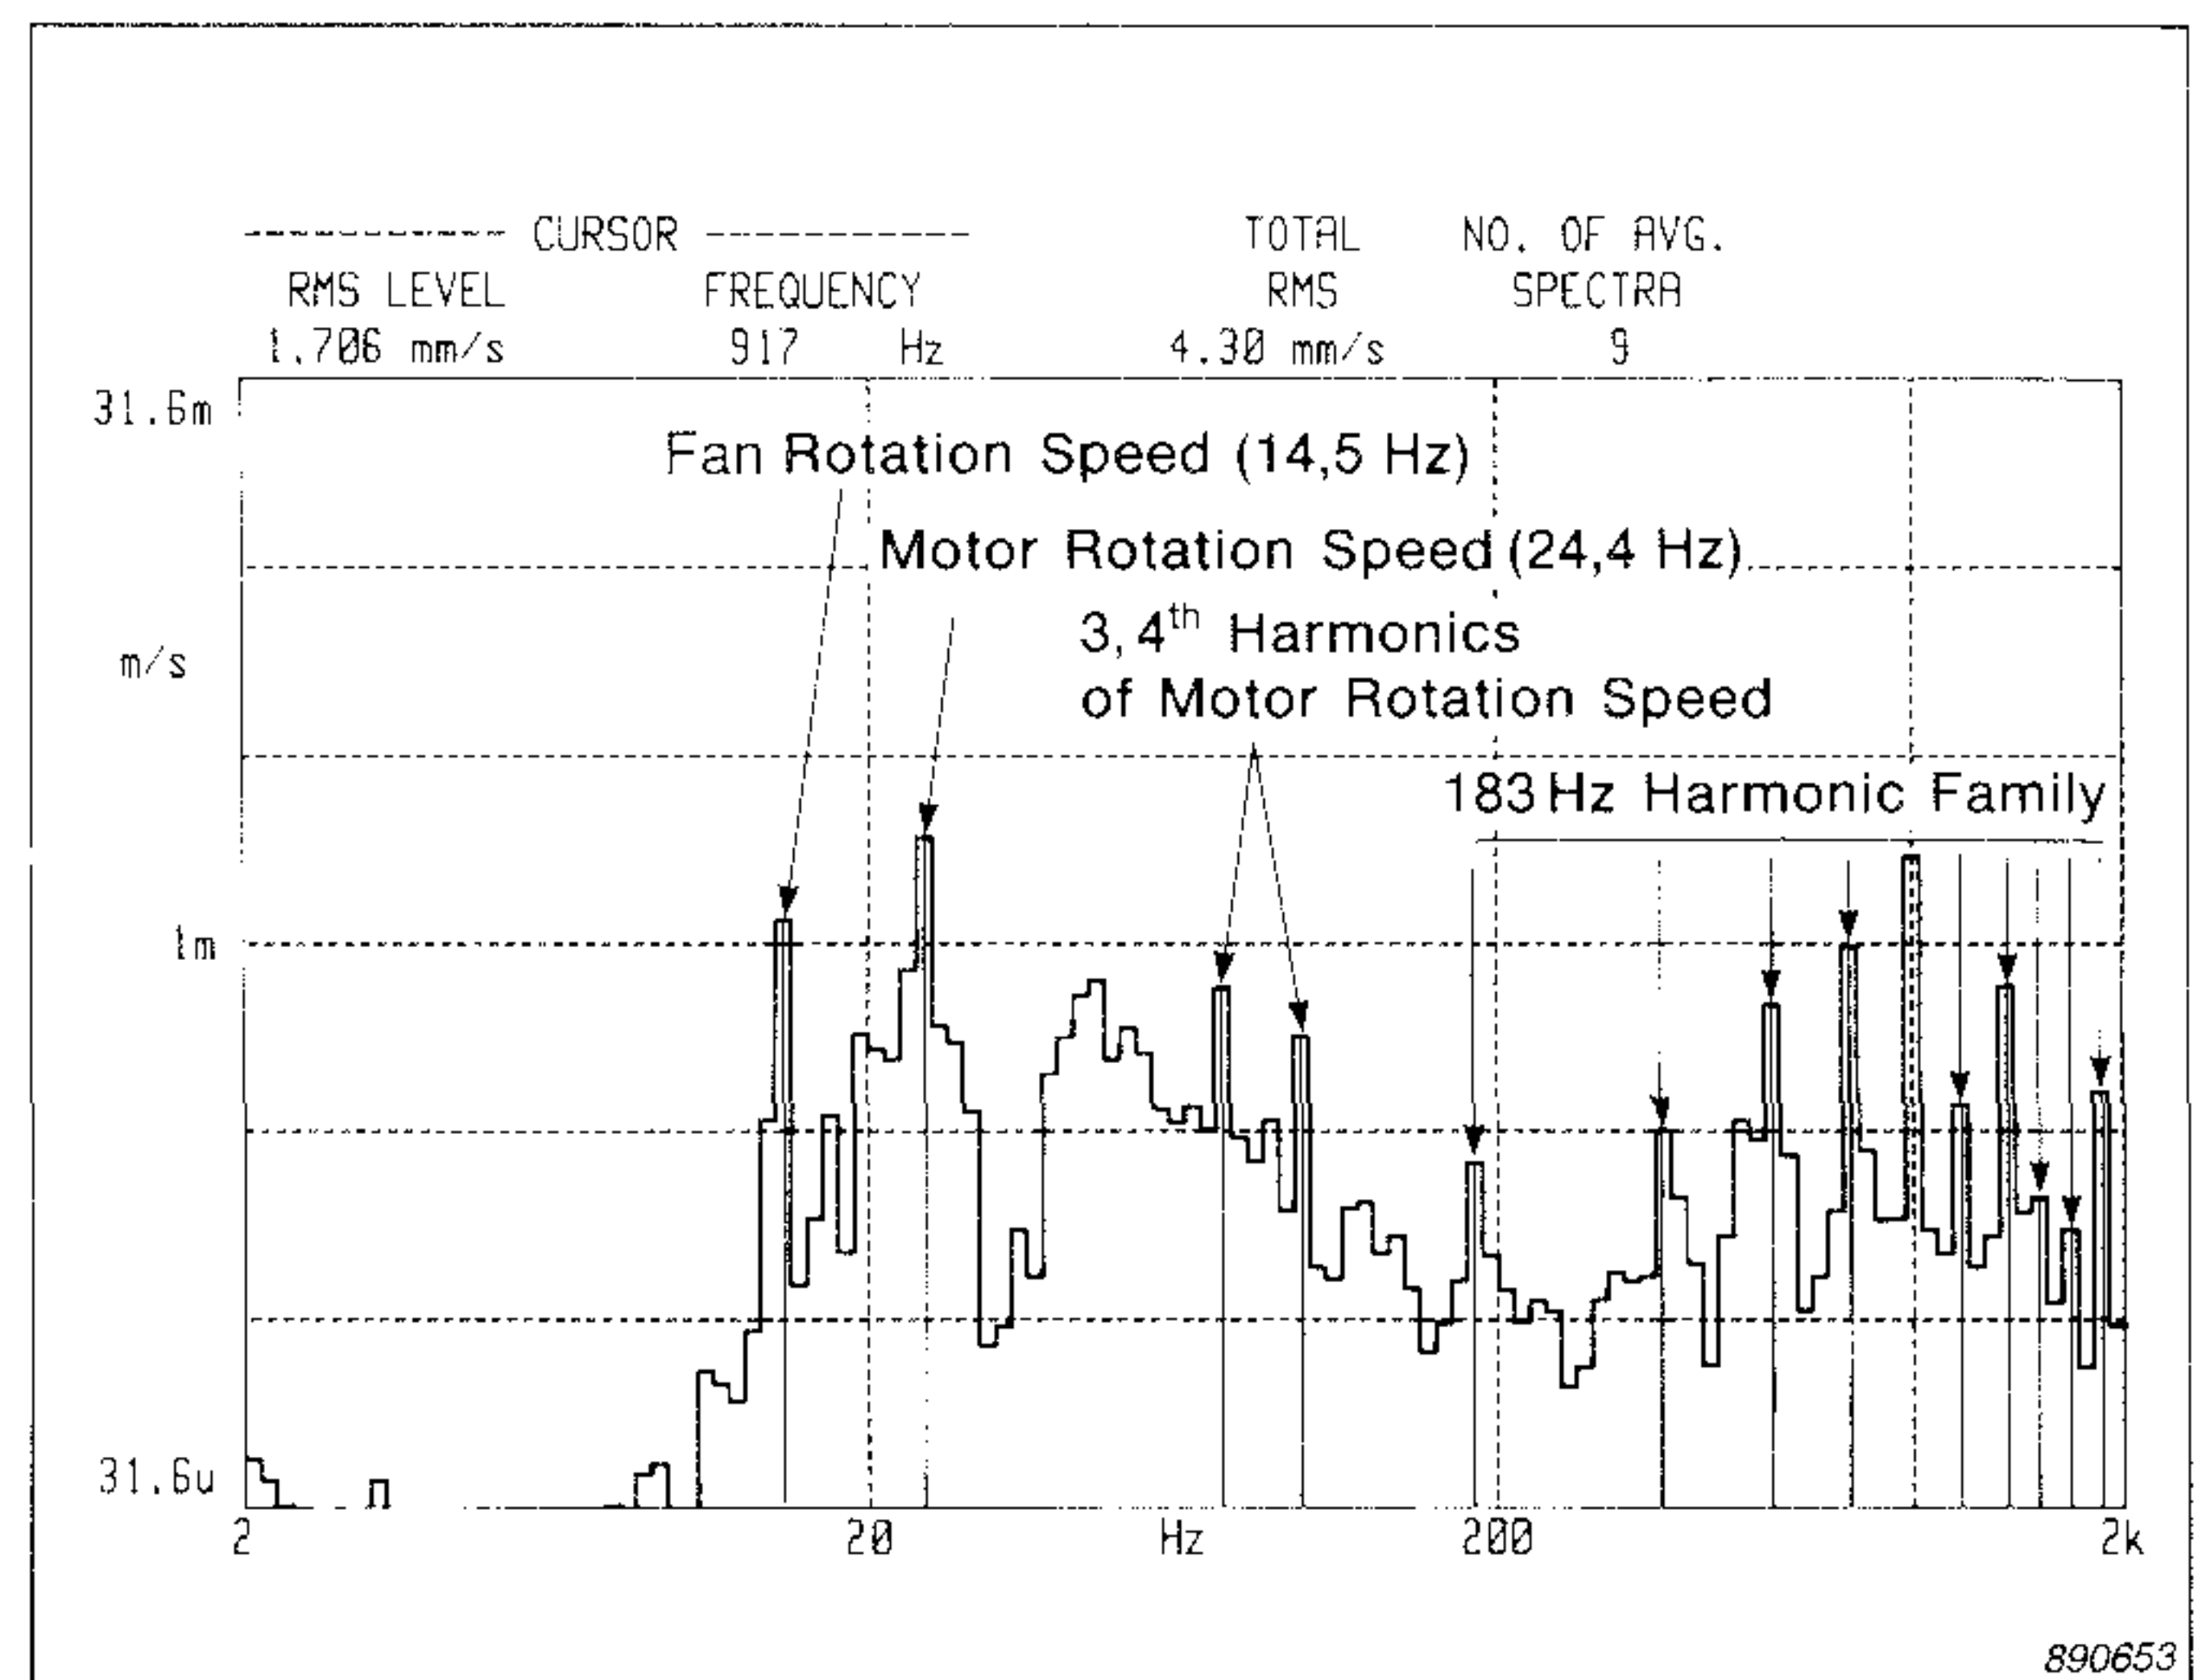
After the repairs were finished, Groenpol measured a horizontal, 2 kHz, 6% CPB spectrum at the bearing casing, at the driven end of the fan, see Fig. 12. The overall RMS level of  $4.3 \text{ mm/s}^{-1}$  was acceptably low. The origin of the main peaks in the spectrum is as follows:

Peak 1 is the fan rotation speed. This indicates residual unbalance in the fan.

Peaks 2, 3 and 4 are harmonics of the motor rotation speed. They are probably caused by the motor exciting the loose frame.

Peaks 5 to 11 are also members of a harmonic family. Peak 5 is the fundamental with a frequency of 183 Hz. This does not correspond to any shaft rotation speeds. Instead it is probably

a characteristic ball-passing frequency of a roller element bearing, which indicates bearing fault. The harmonic family is prominent because it is amplified by resonances in the machine.

Fig. 12. Horizontal, 2 kHz, 6% CPB spectrum. This was measured at the bearing casing, at the driven end of the fan shaft, after the frame was repaired. Note the two harmonic families

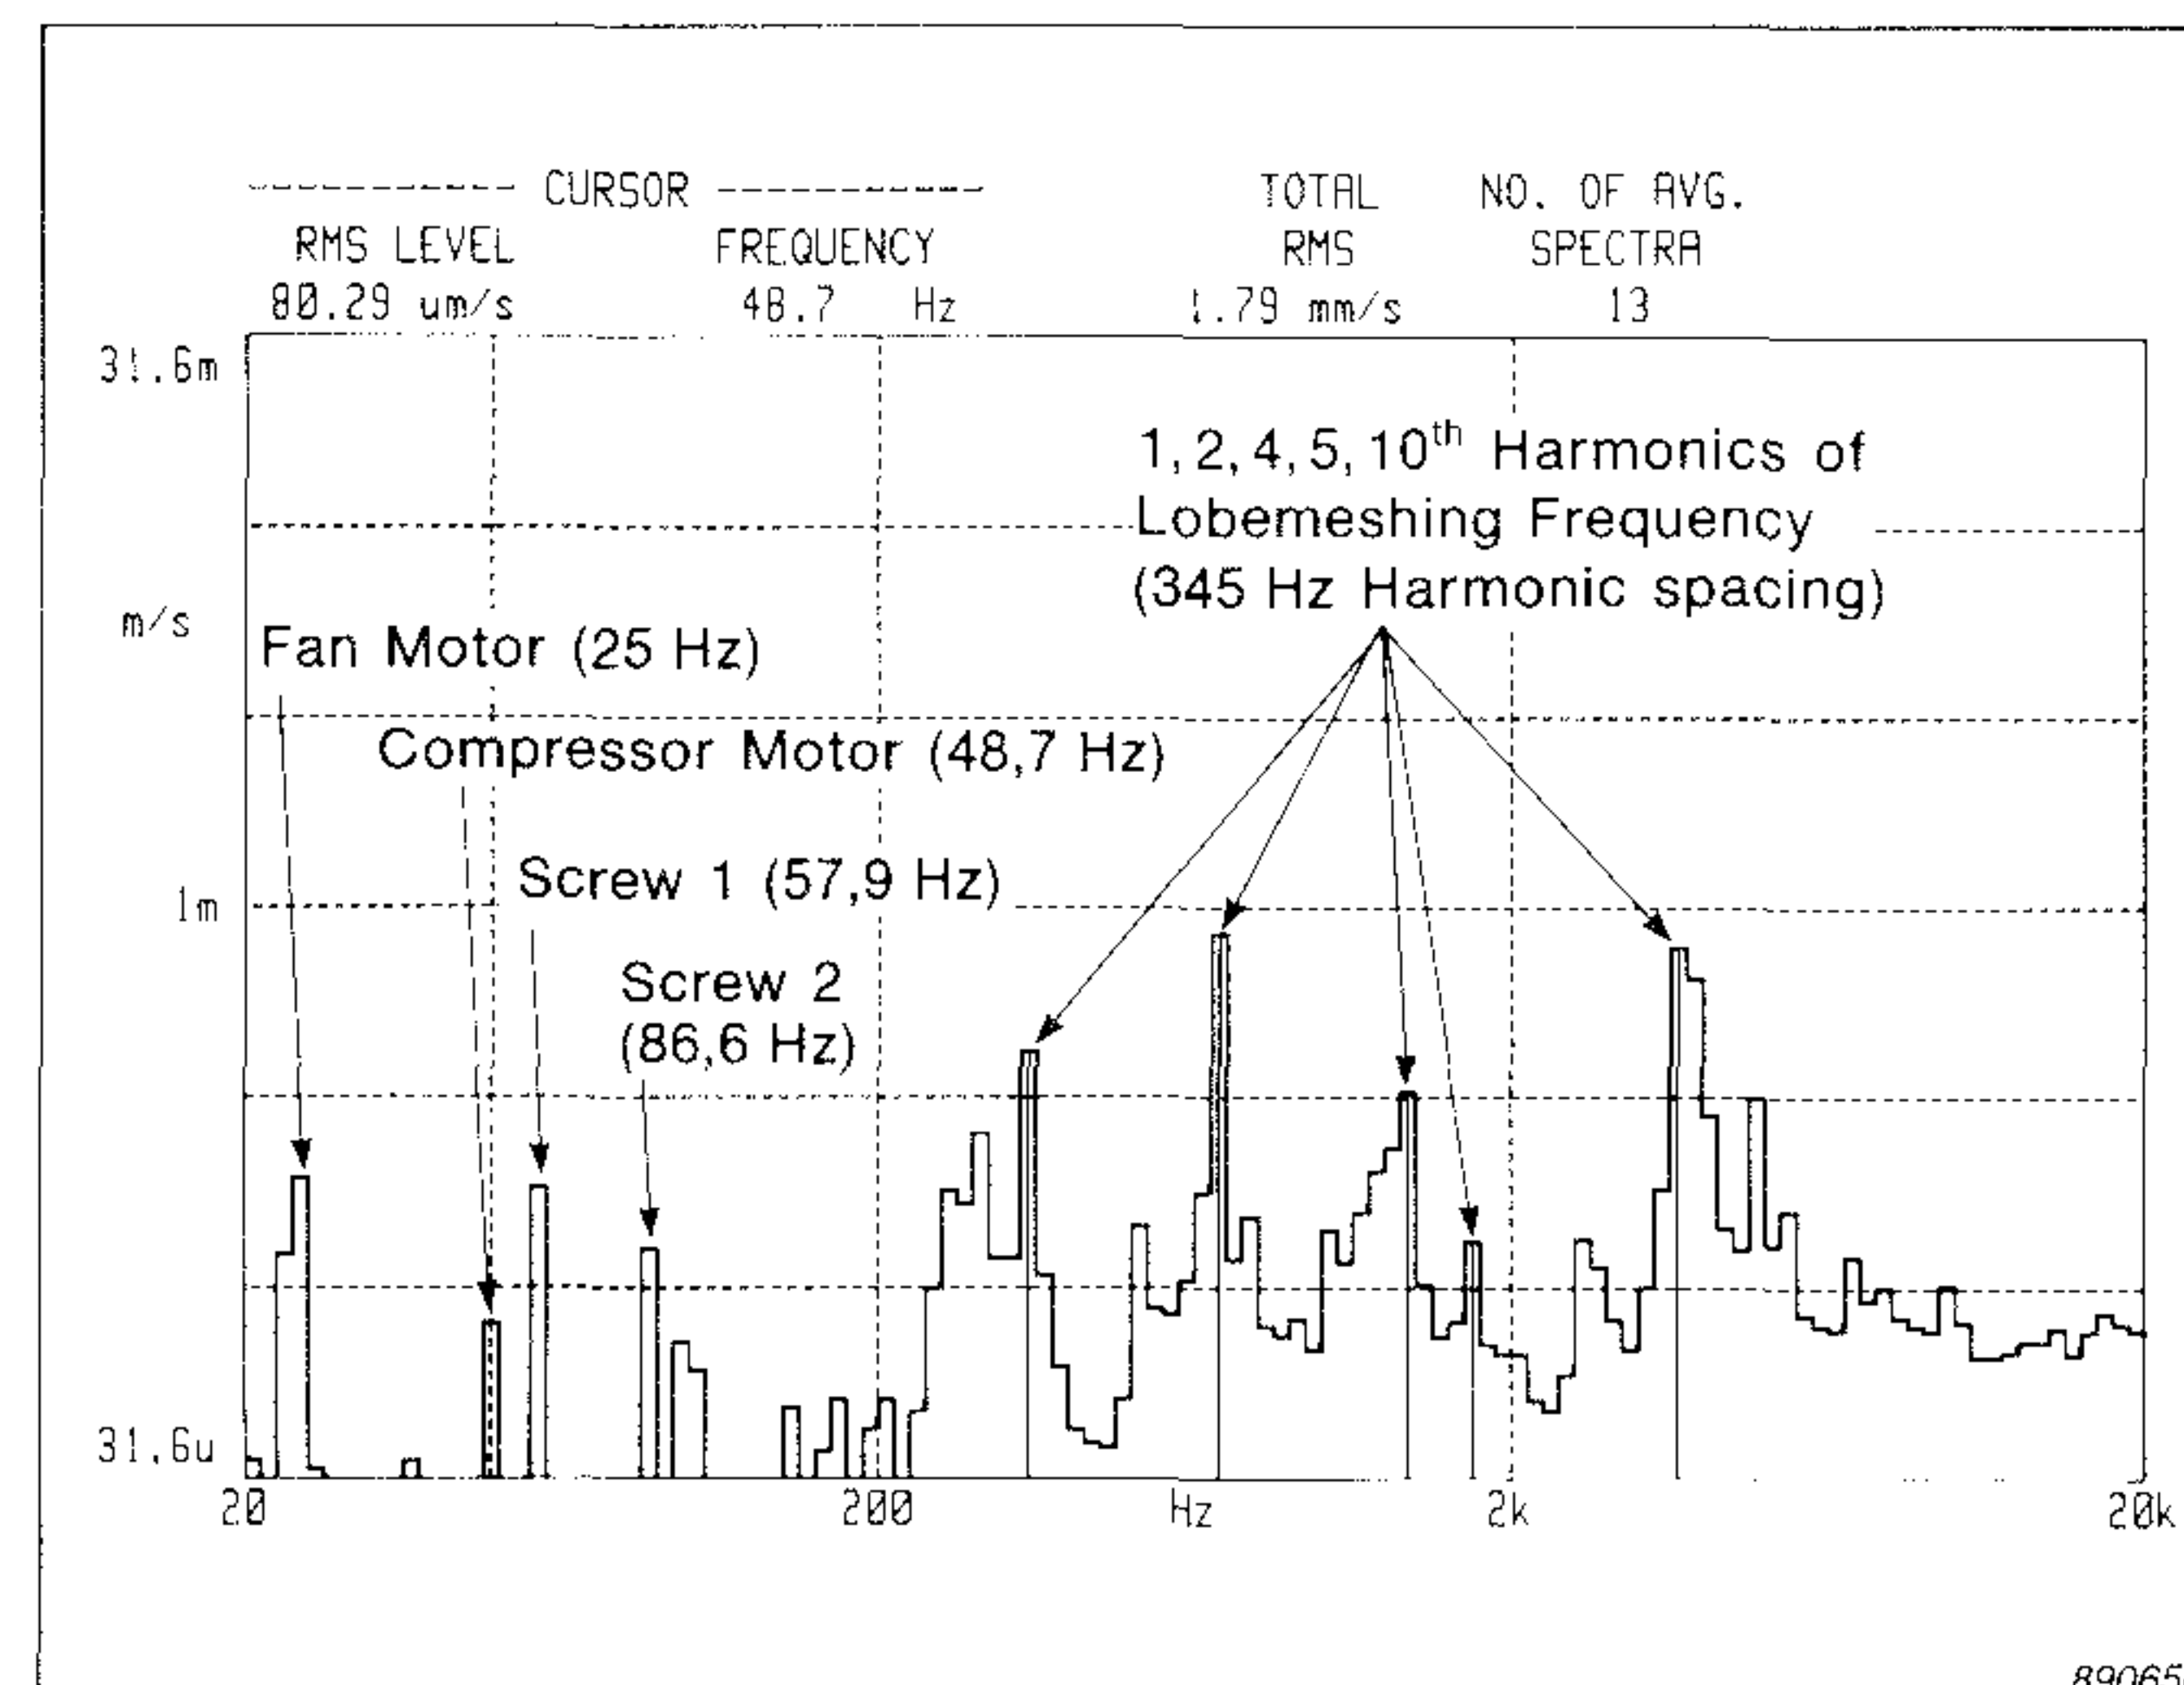
The lobemeshing frequency harmonics are the highest peaks in the spectrum. According to manufacturers of screw compressors, this indicates thrust-bearing damage. When the mechanics removed the thrust bearing they found the suspected damage.

Fig. 15. Axial, 20 KHz, 6% CPB spectrum. Measured at the non-drive end of the compressor motor. Note the harmonic family of the lobemeshing frequency. This is a symptom of thrust-bearing damage

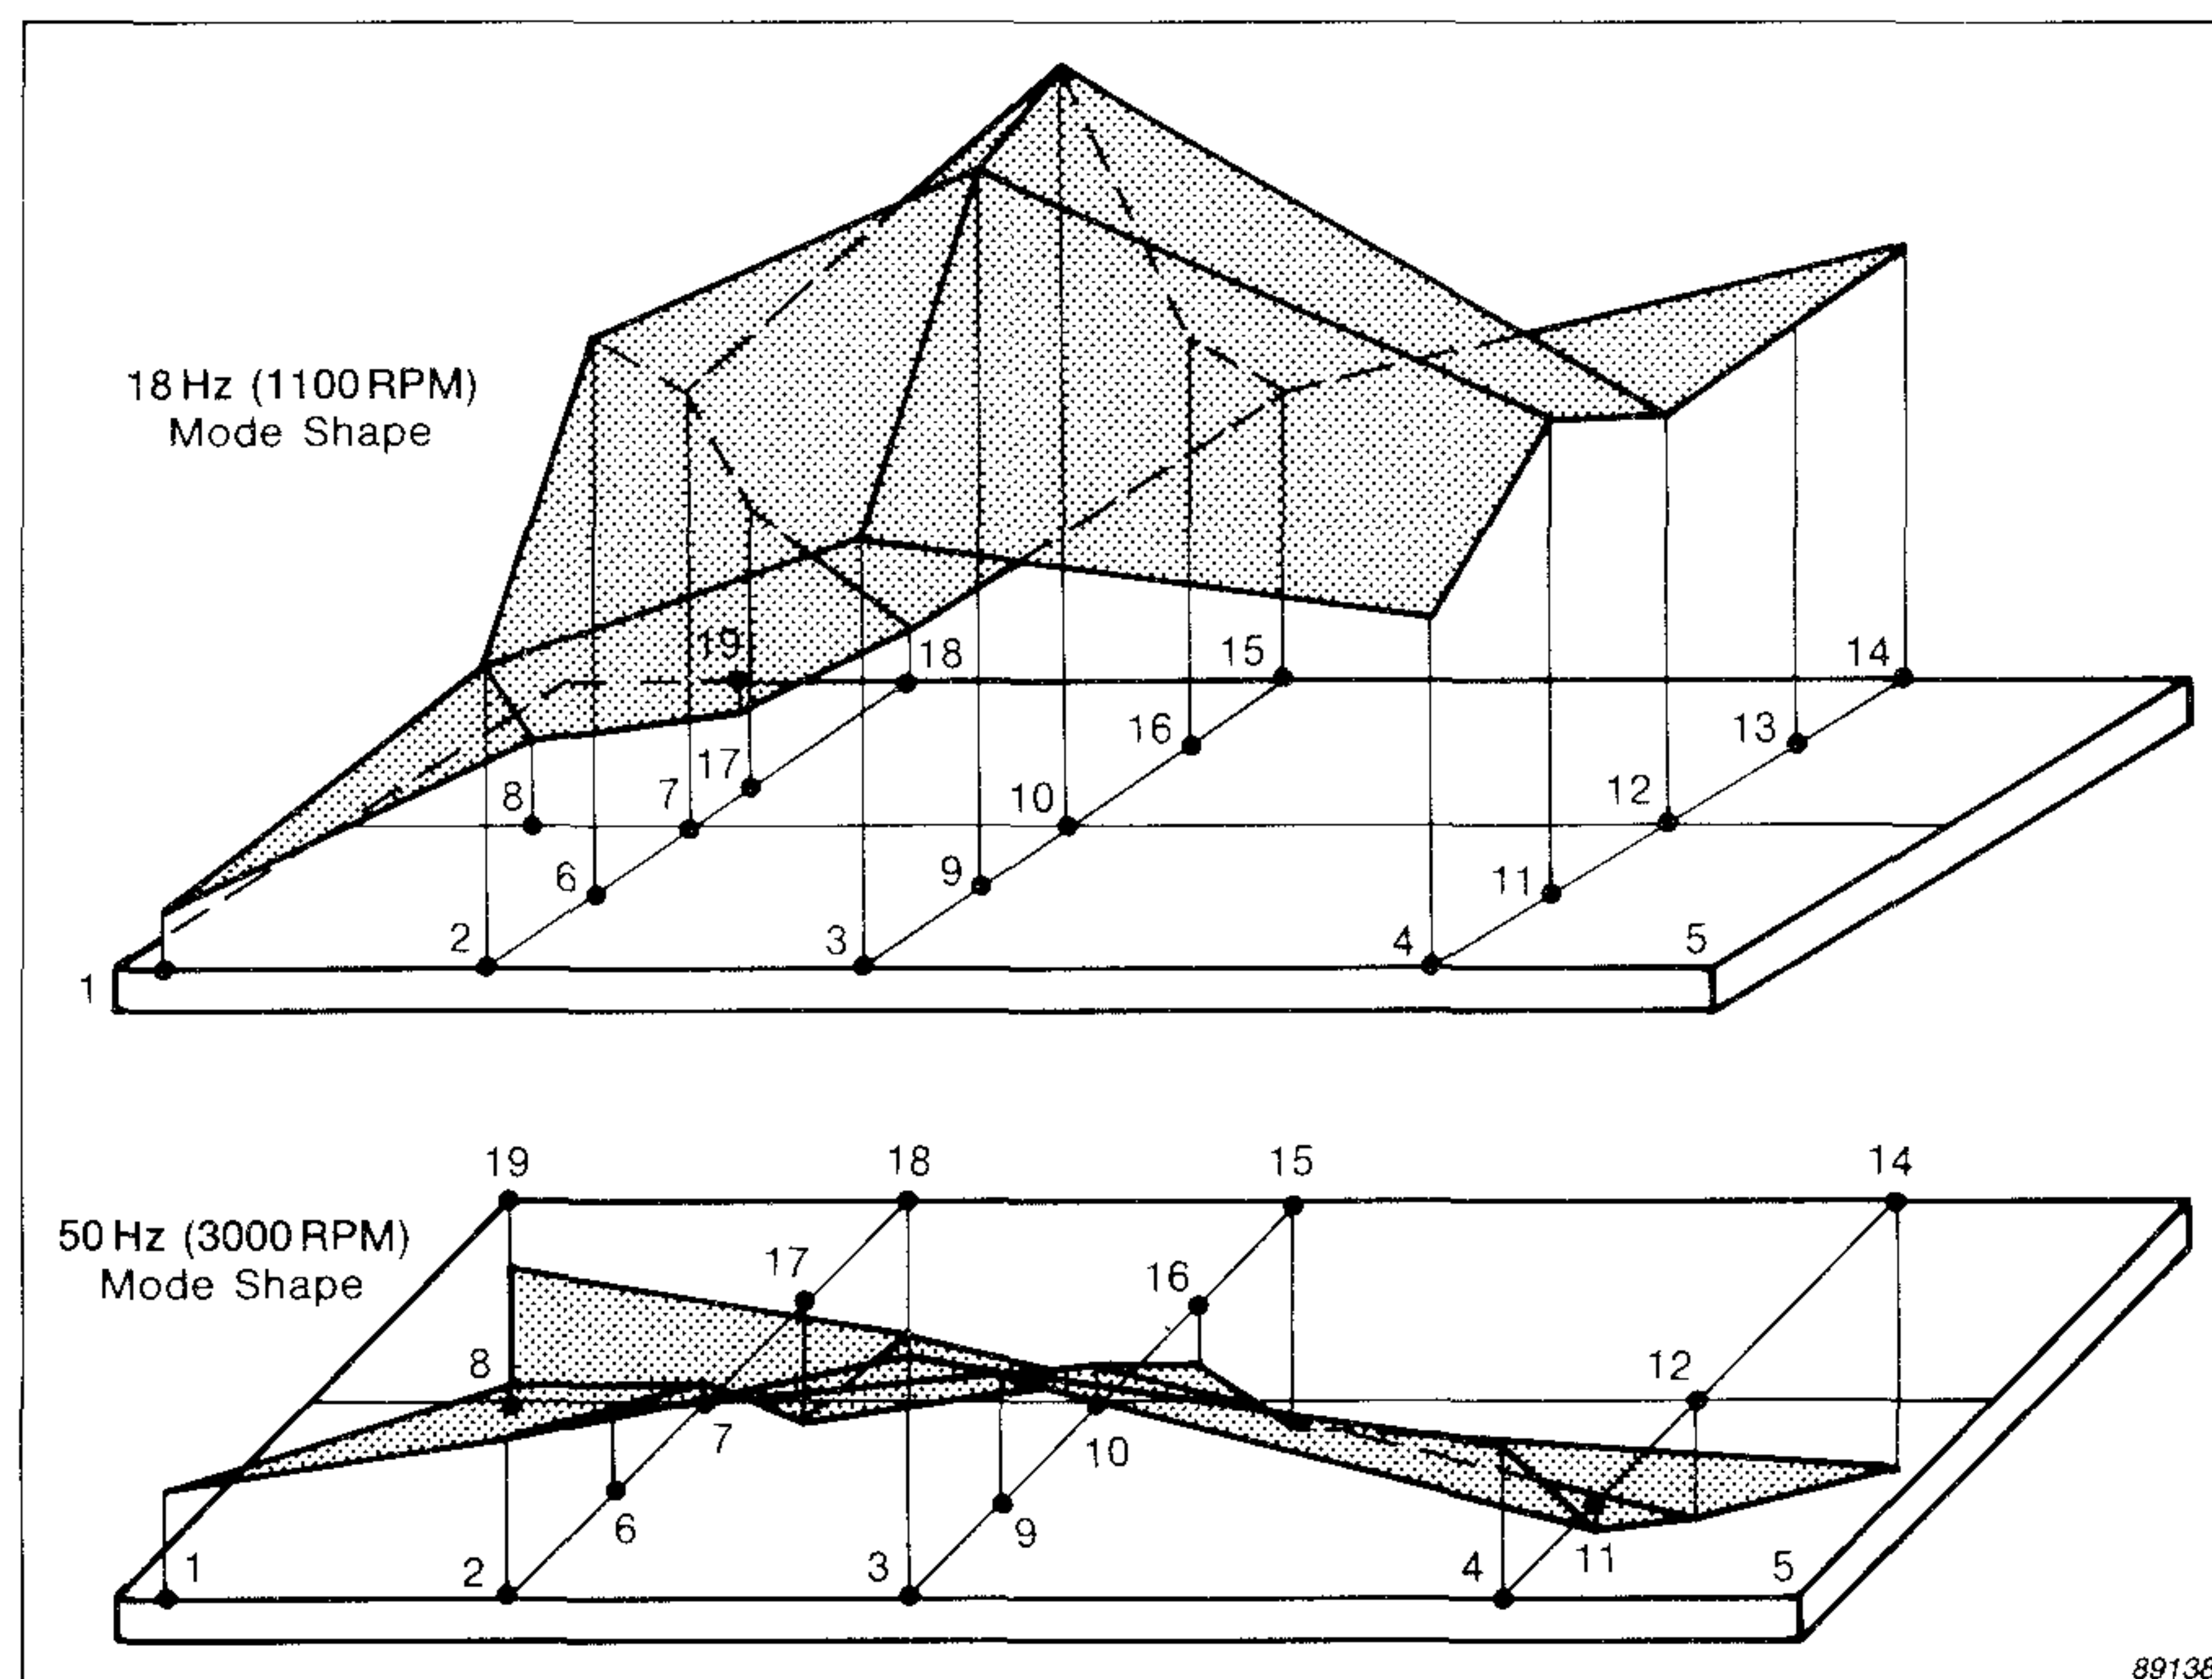
Groenpol decided to investigate the vibration modes of the frame. They used a vibration exciter to shake it sinusoidally and found resonance frequencies at 18 Hz and 50 Hz. They measured the phase with their balancing instrumentation and used the results to plot the mode shapes, see Fig. 16. These show that the frame bent in the middle at the gearbox.

By an unlucky coincidence, the compressor motor speed of 48.7 Hz was exciting the 50 Hz resonance frequency of the frame.

Fig. 16. The 18 Hz and 50 Hz mode shapes of the compressor frame. The 50 Hz mode is excited by the 48.7 Hz rotation speed of the compressor motor

The company could not afford to modify the frame further, so Groenpol decided to insert vibration dampers between the motor and the frame in an attempt to dissipate the 48.7 Hz vibration being transmitted from the motor to the frame. This was successful. The vibration of the frame dropped to an acceptable level and the machine functioned normally.
