Machine-Condition Monitoring Using Vibration Analysis

A Case Study from an Iron-Ore Mine

by D.N.Brown & J.C.Jørgensen
Brüel & Kjær

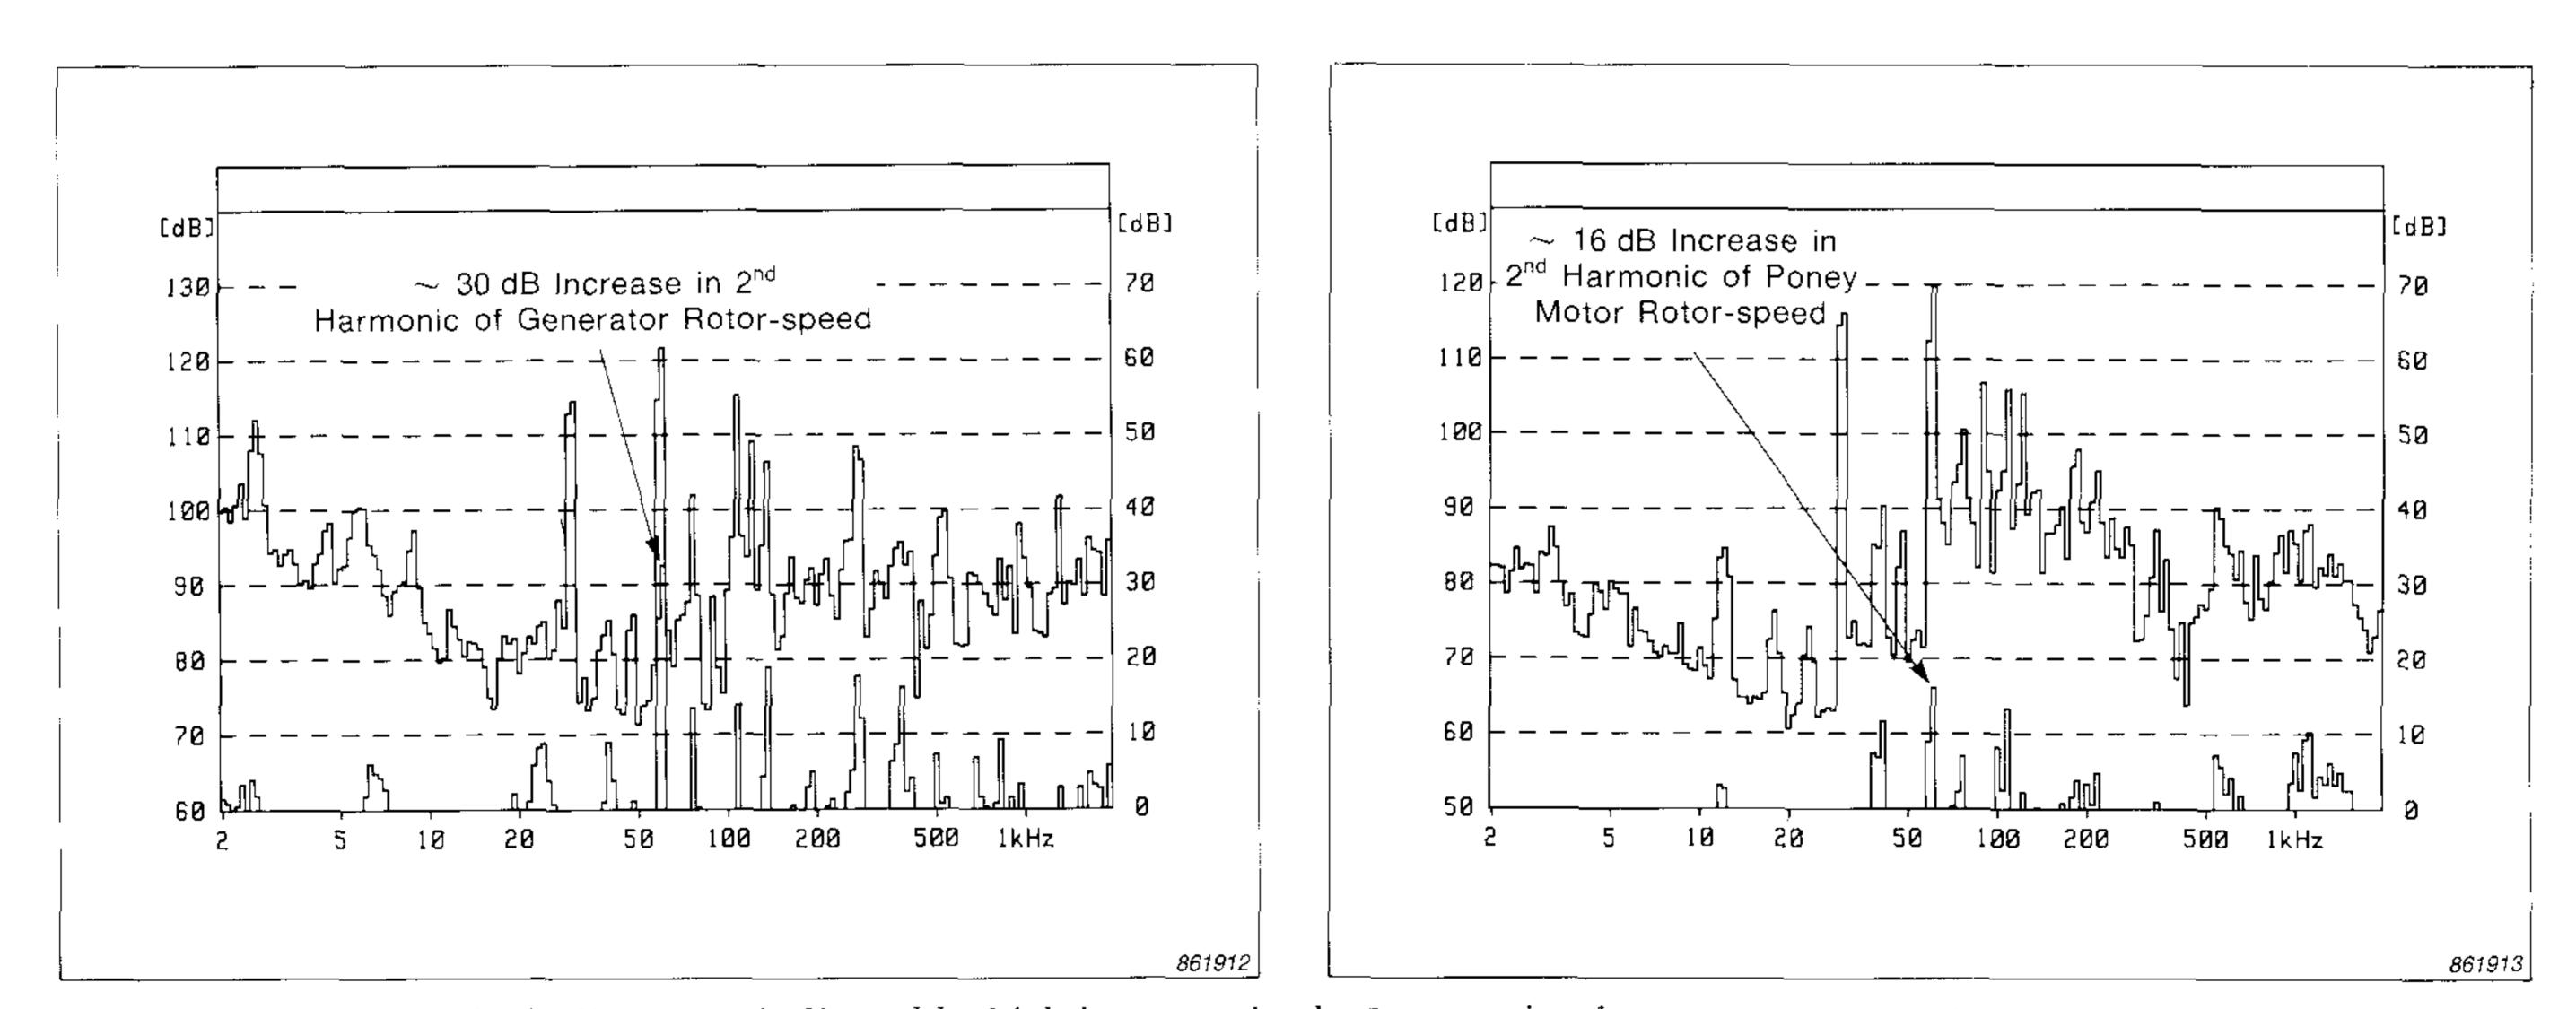
Fig. 6 shows some examples indicating misalignment. The spectrum to the left shows a spectrum comparison on a Swing Generator, indicating a very high (>30dB) increase at the second harmonic, 60 Hz. The spectrum to the right shows an approximate 16 dB increase at the second harmonic on the Poney Motor, used to soft start the MG-Set. The motor is not mount-

ed directly on the MG-Set base, but attached separately on a cantilever arrangement. Due to difficulties in installation, the motor is prone to misalignment problems.

Fig. 6. Two examples of misalignment, indicated by high increases in the $2 \times rotation$ frequency component

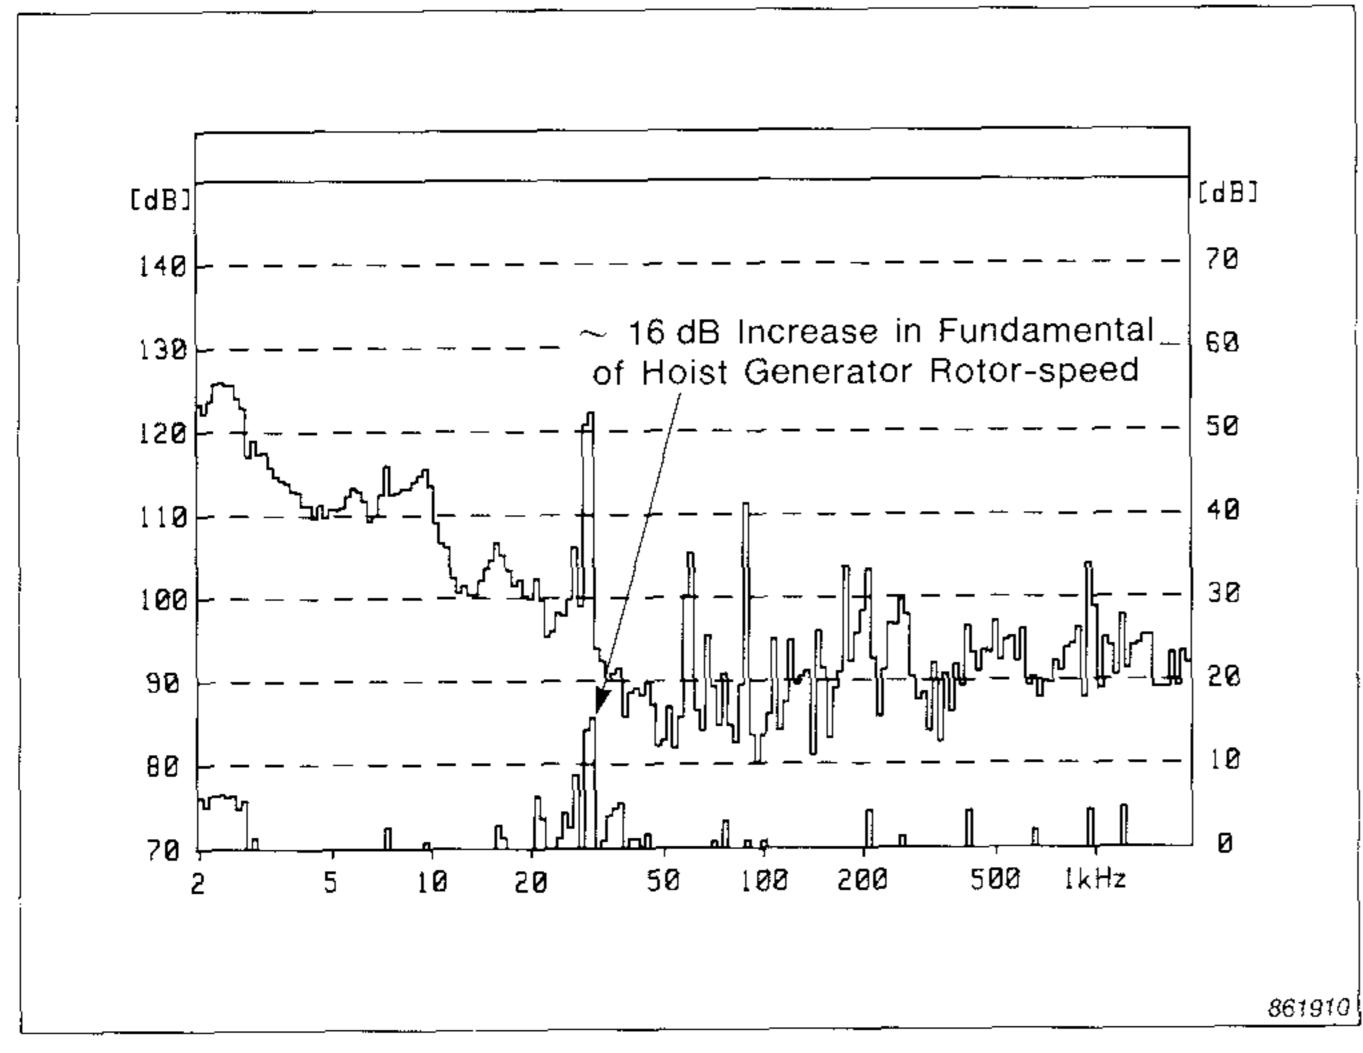
An **unbalance** in any of the components of the MG-Set could be identified by increasing vibration at the shaft rotational frequency. An example of this is shown in Fig.7, which shows a spectrum comparison from a Hoist Generator. This shows an increase of approximately 16 dB at 30 Hz, the Generator rotor frequency.

Fig. 7. An example of unbalance, indicated by a large increase at the rotation frequency

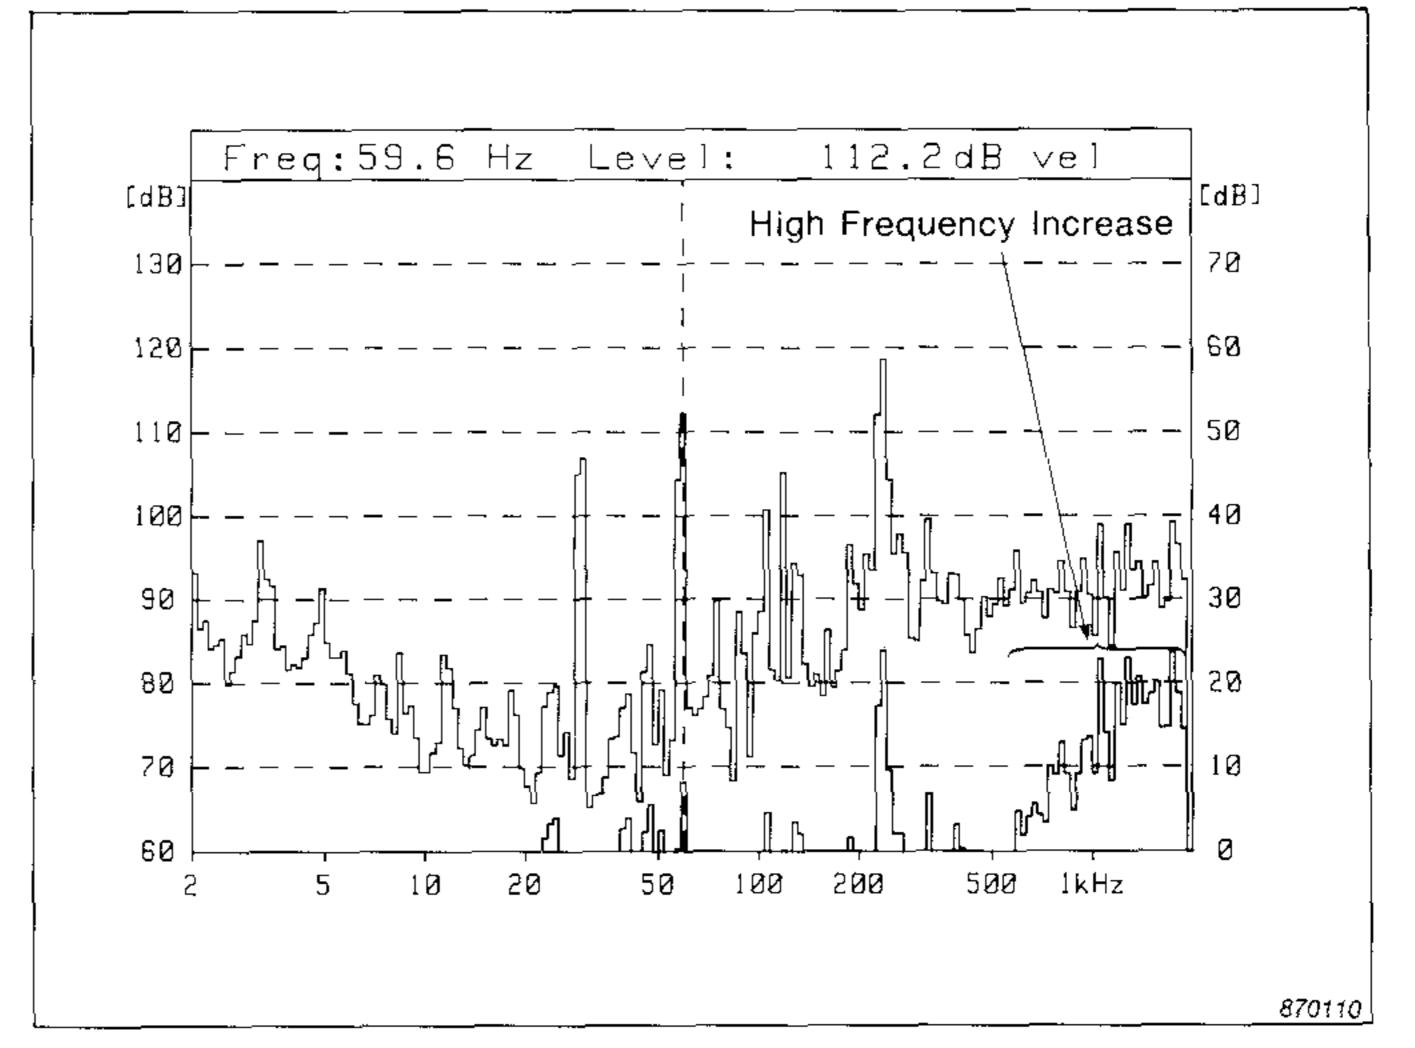
Fig. 8. Example from the Swing Generator. The increase in the 500 - 2000 Hz range was due to a rolling-element bearing problem

The example in Fig. 8 shows how a rolling-element bearing fault was detected on the Swing Generator of an MG-Set. Spectrum comparison measurements on the Swing Generator indicated a wide band of increases in the high frequencies, see Fig. 8. On inspection of the generator it was found that grease was packed in the bearing. This had resulted in poor lubrication, causing direct metal-to-metal contact of the bearing's rollers and races. This contact resulted in excitation of the bearing's resonant frequencies, which lie in the upper frequency range.

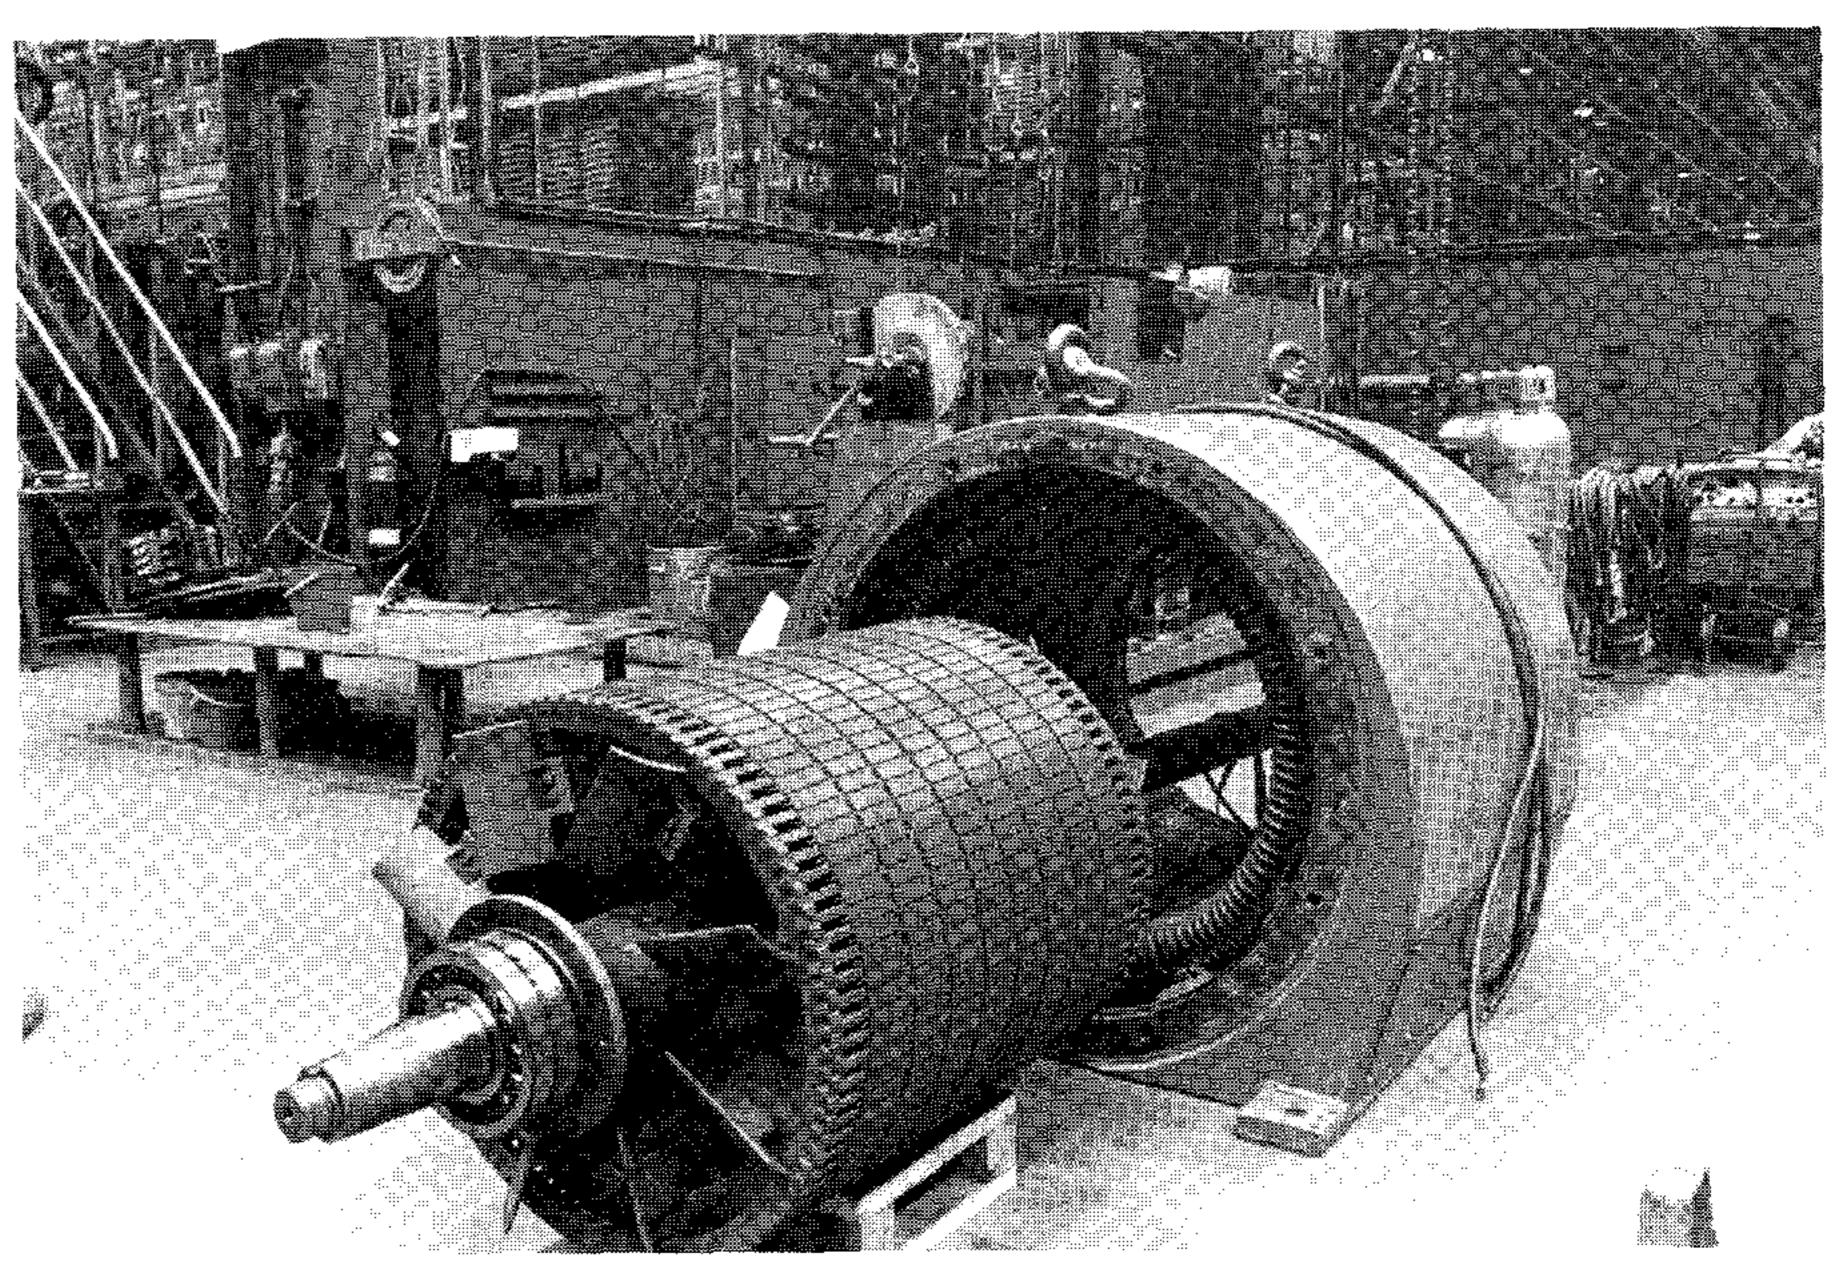
In another example an electromagnetic fault was tracked down on the main motor of an MG-Set, shown in Fig. 9. Following an overhaul, measurements were made on the motor and a strong 10 Hz harmonic series appeared in the frequency spectrum.

During measurement trials, it was discovered that cutting the power to the motor caused these harmonics to disappear immediately. This indicated an electrical/electromagnetic problem.

The motor was sent for inspection, and the clearance between rotor and stator was measured to be 1,2 mm on one side and 0,7 mm on the other. There had obviously been a machining problem when machining the fit for the bearing at the original overhaul. The electromagnetic vibration was therefore the result of the difference in magnetic field on the two sides of the rotor. This was corrected for and the measurements remade. The 10 Hz harmonic series had disappeared.

Fig. 9. The MG-set main motor on which the electromagnetic fault was diagnosed

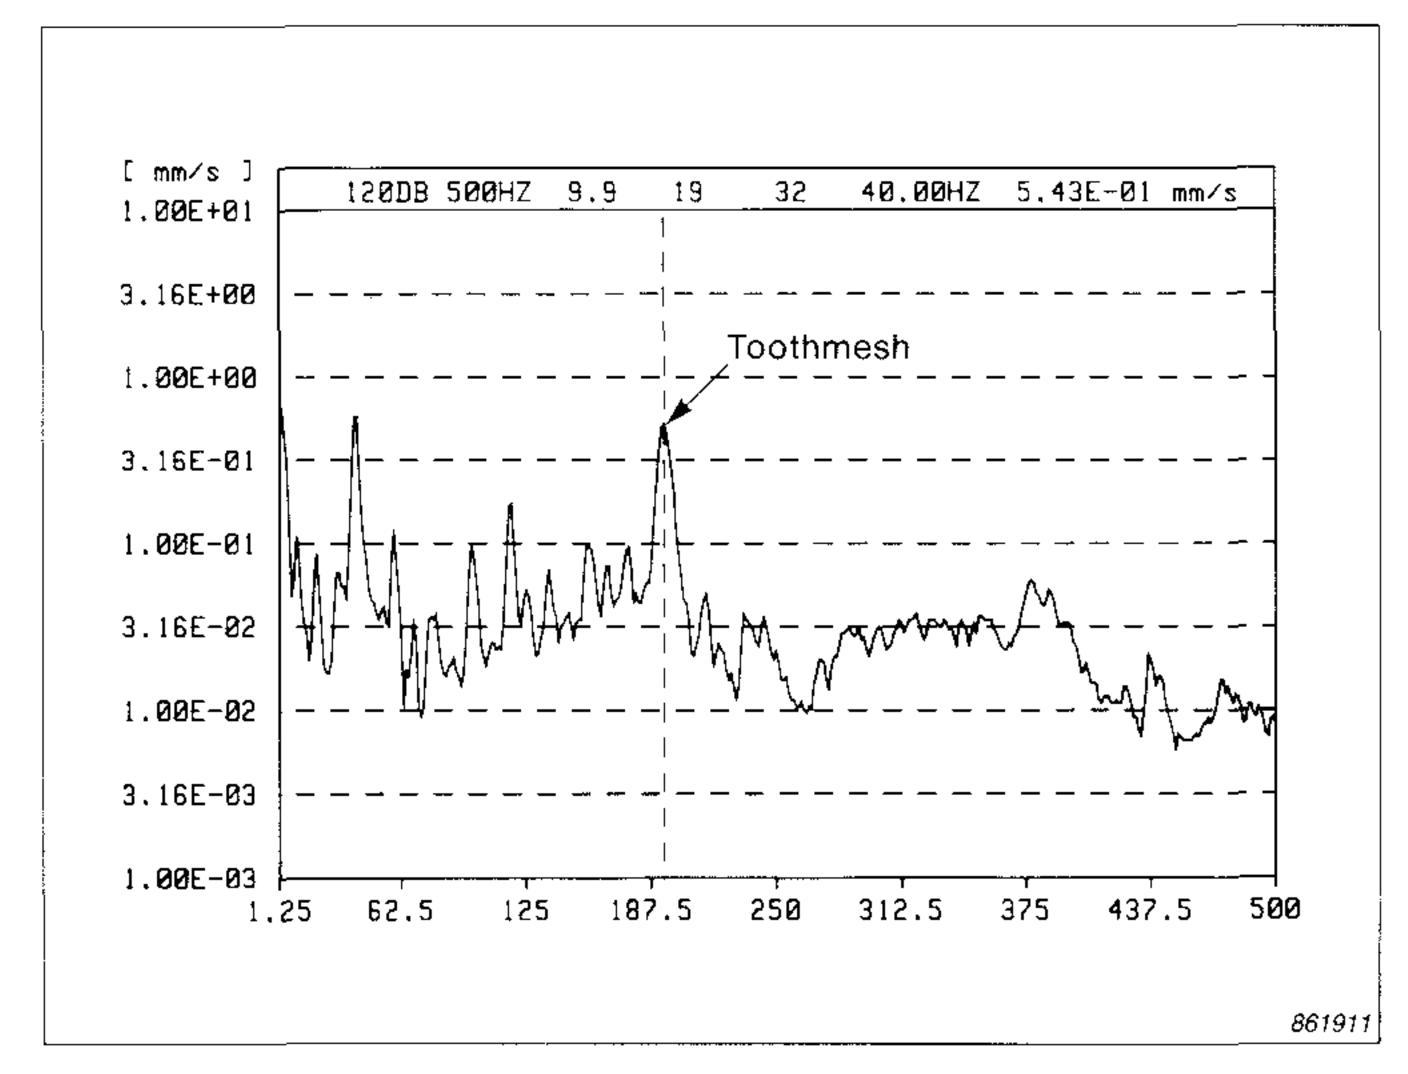
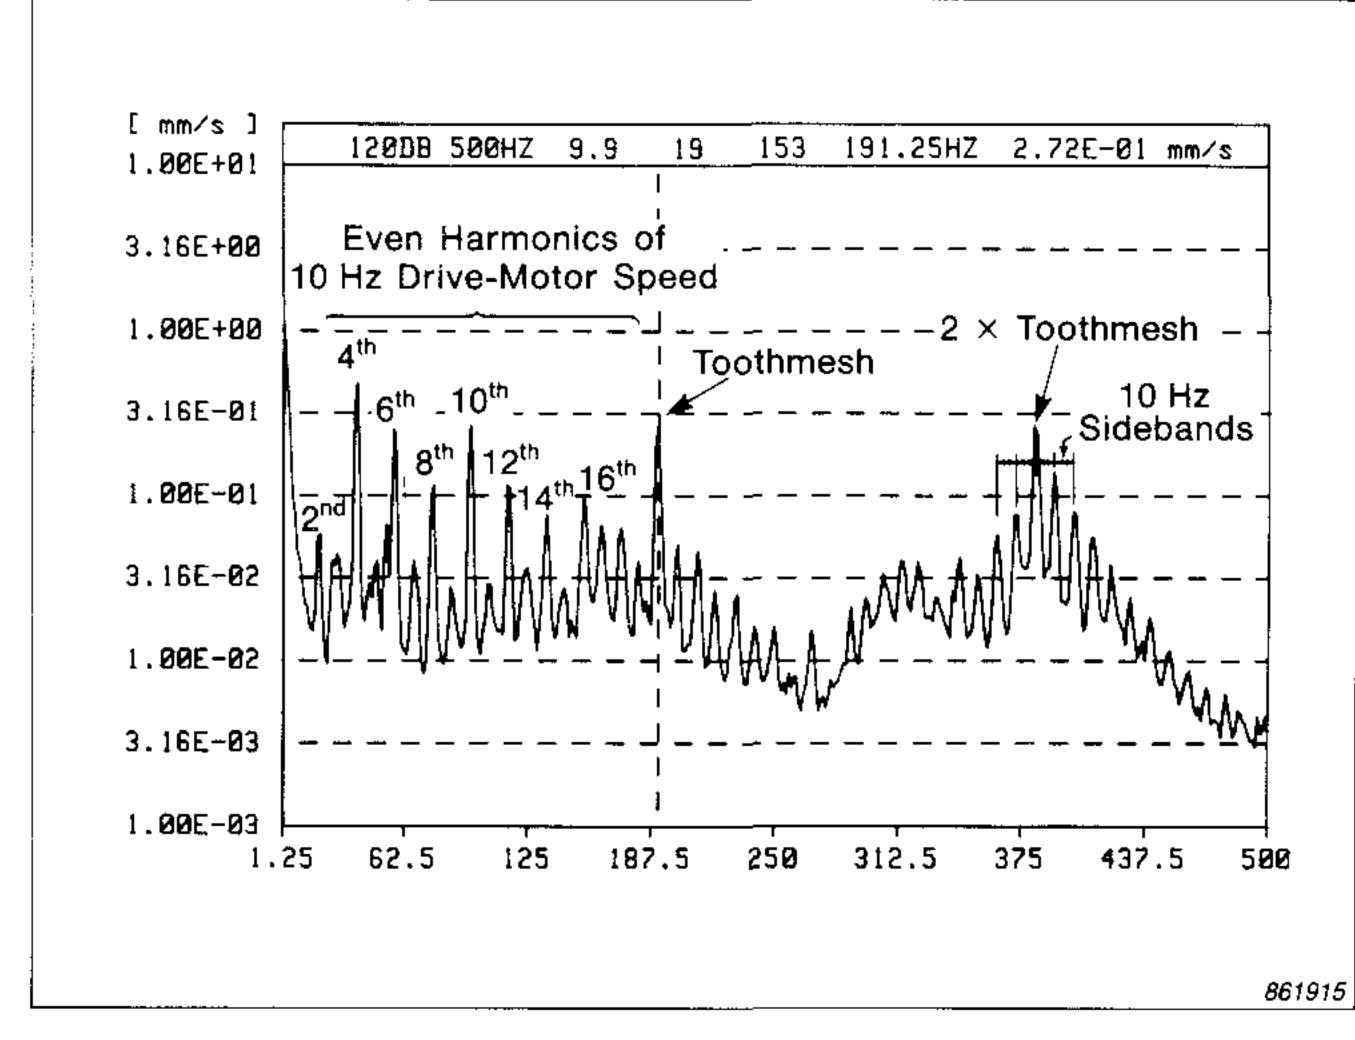
Fig. 12 shows narrowband spectra from two different Magnetorques. The spectrum to the left indicates normal running conditions. The spectrum to the right, however, shows an uncommon problem — that of misalignment between the Magnetorque and the hoist gears. The misalignment shows itself clearly as a series of even harmonics of the drive motor fundamental (10 Hz), and a series of sidebands around the toothmeshing frequency (191,25 Hz) and its harmonics. The sideband spacing corresponds to the speed of the drive motor (10 Hz).

Fig. 12. Narrowband spectra from the Magnetorque[®]. The spectrum to the left shows the normal running conditions, whilst that to the right shows a misalignment problem

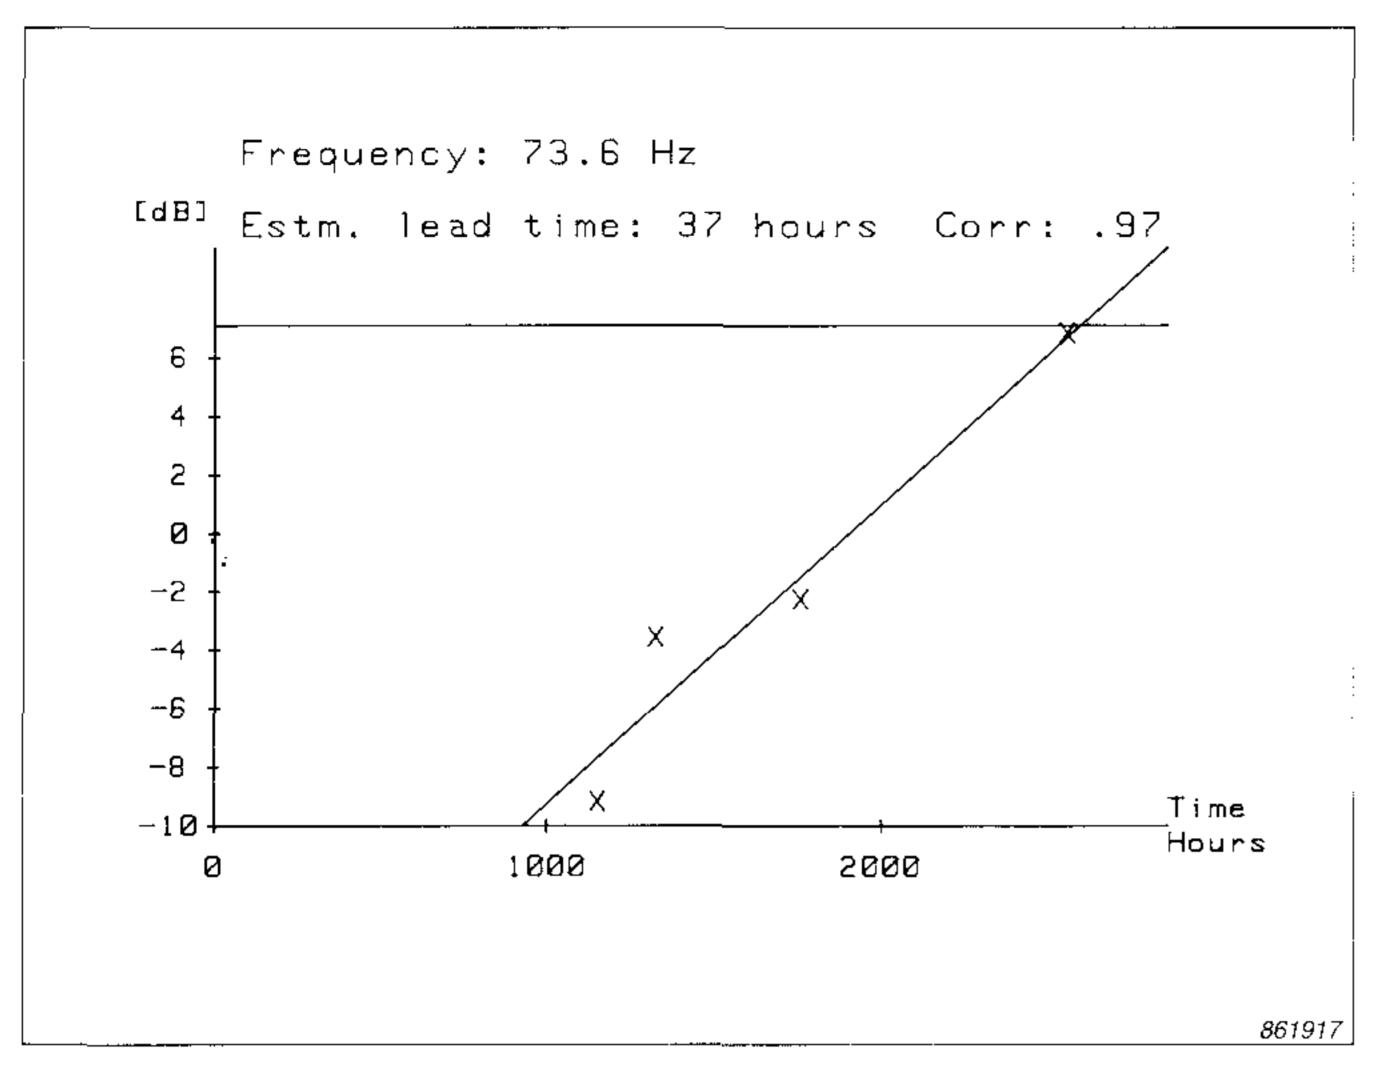
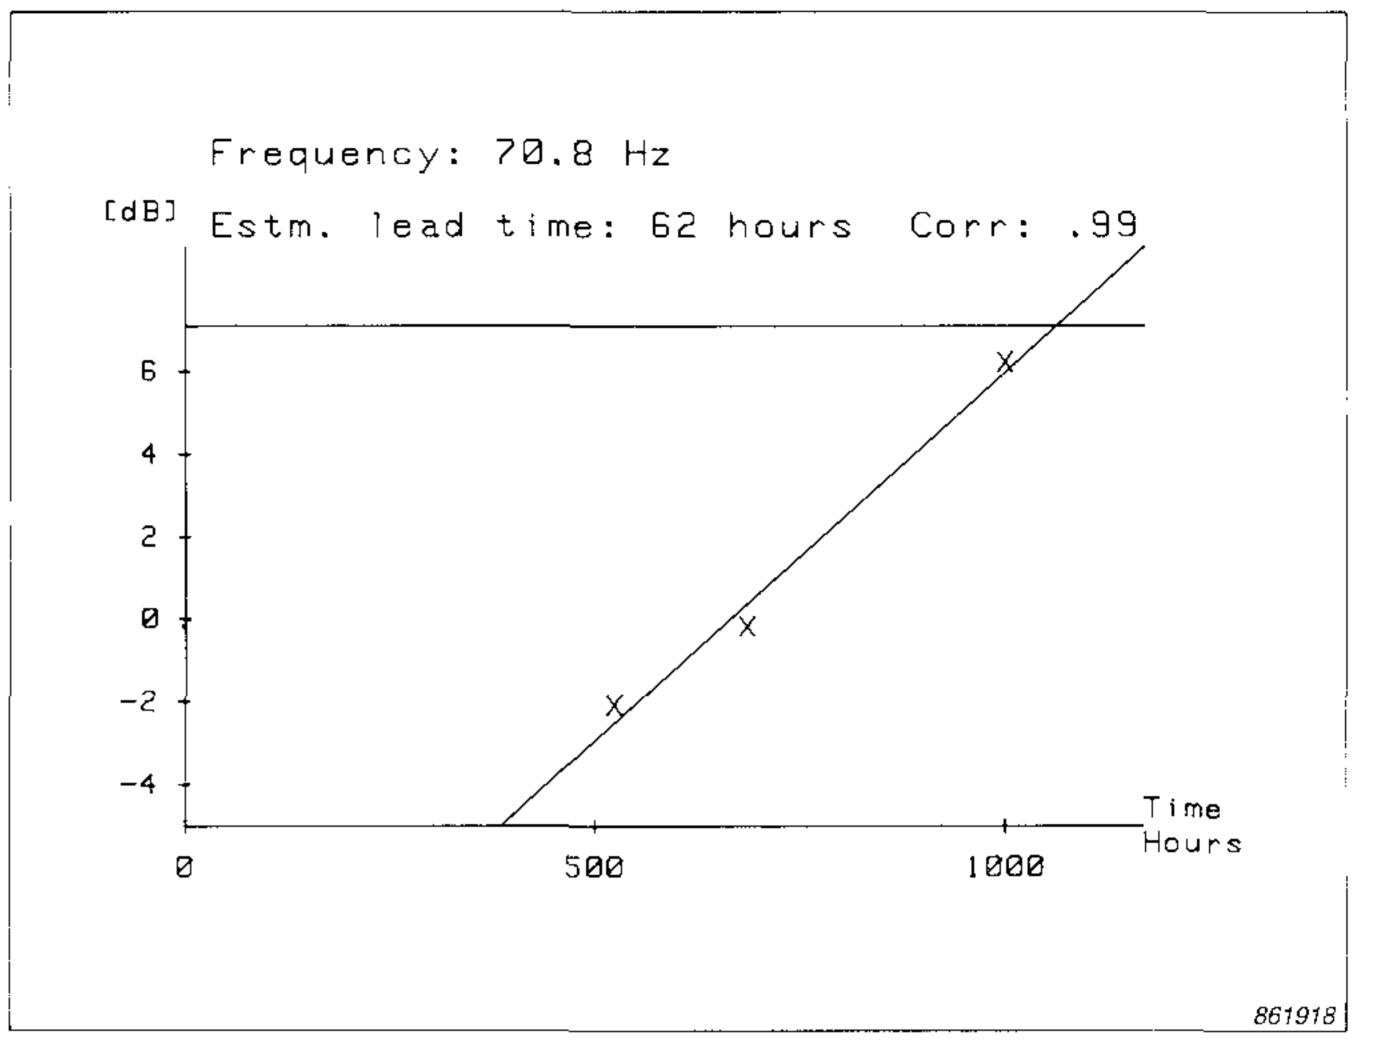
Fig. 14. Trend curves at blower drive-shaft rotational frequency. The trend to the left is for 73,6 Hz, and that to the right for 70,8 Hz

The problem was monitored using the spectrum comparison and trending facilities of the system. The problem could be characterised by an increasing vibration component at the rotation frequency of the blower drive-shaft. Fig. 14 shows trend curves made at this rotation frequency. The blower drive-shaft rotation frequency

was 73,6 Hz or 70,8 Hz depending on the engine-test speed. The upper danger level shown is the maximum vibration level tolerated before repair. Fig. 15 shows a schematic layout of the engine, indicating the position of the Roots Blower and the measuring point used to detect the fault. Fig. 16 shows the blower drive-shaft.

This fault was detected on four trucks. In each case this resulted in the drive shaft and hubs being changed, at a cost of approximately 1% of the cost of a complete engine rebuild — a total saving of some \$630000.

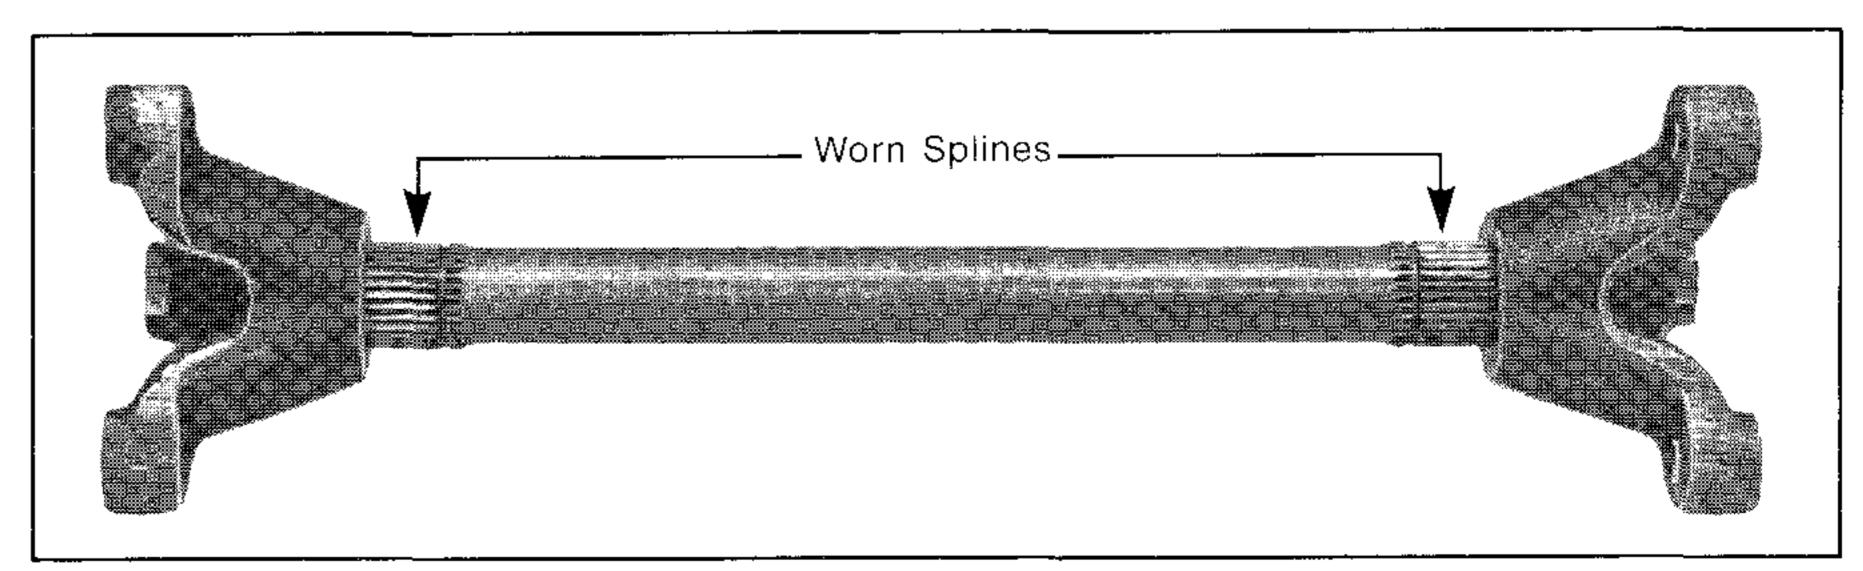
A major problem arose concerning the drive shaft for the Roots Blower. A number of engines were destroyed after the splines locating the shaft into the drive-hubs stripped. The engine governor is driven by this shaft and, in the event of the shaft stopping, the engine would overspeed and eventually destroy itself. At a replacement cost in the region of \$160000, such breakdowns could not be tolerated.

The problem first arose after a modification to the engine. This had an unfortunate side-effect which resulted in the blower-drive being constantly loaded and unloaded, and eventually wearing the splines at the end of the drive shaft. At this point, due to the seriousness of the problem, the life of a blower was restricted to 5000 hours. A decision was therefore made to monitor this problem with the aid of the vibration monitoring system. This proved successful and the blower life was raised to 15000 hours. The engine manufacturer was duly informed of the problem, and the design subsequently changed.

Fig. 16. The blower drive-shaft with the worn splines indicated

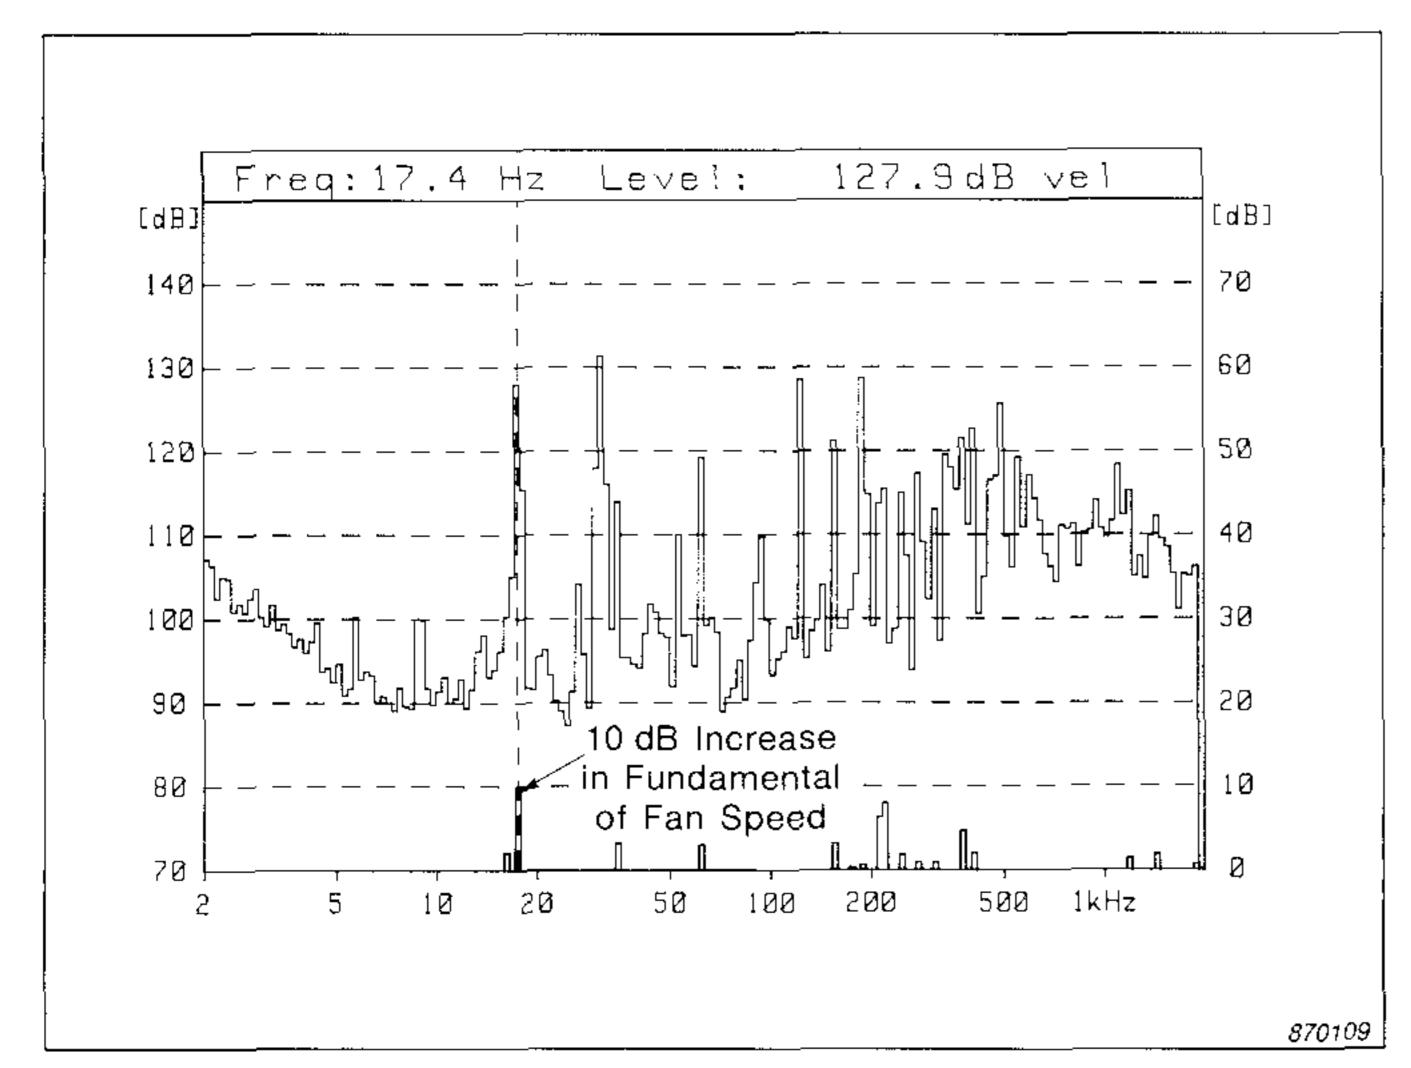
Fig. 17 shows a spectrum compari-

son clearly indicating the beginning of a problem at 17,8 Hz, the fan rotational frequency. Fig. 18 shows a trend curve at this frequency. The upper danger level shown is the maximum vibration level tolerated. The fan was subsequently rebalanced, and the levels dropped to normal values.

Fig. 17. Spectrum comparison showing the fan problem

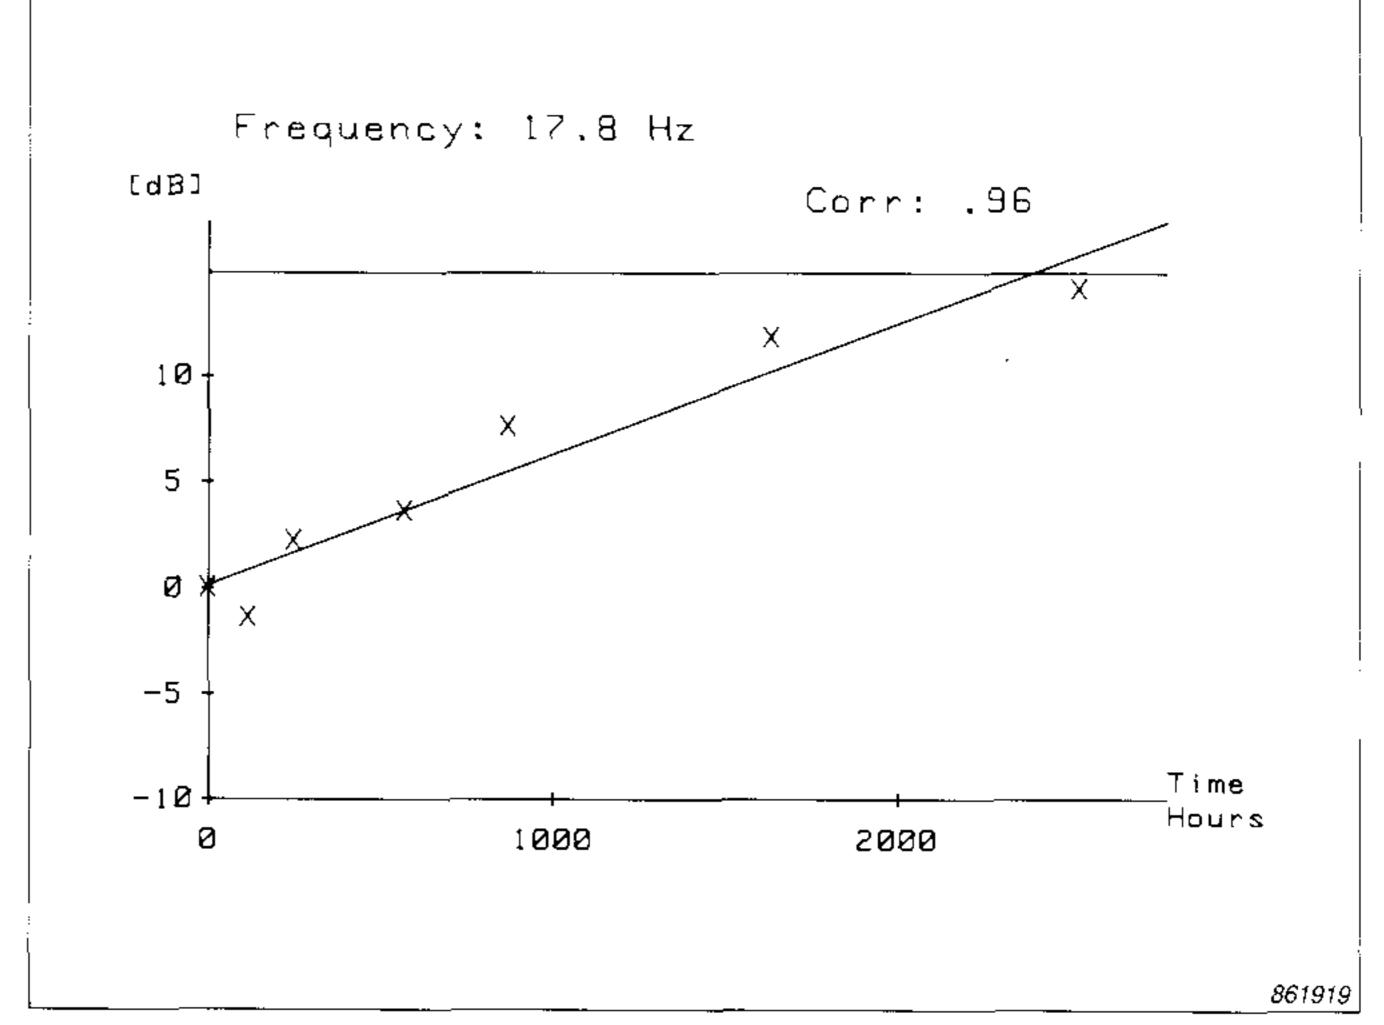
Fig. 18. Trend curve at fan rotational frequency clearly showing the fan problem

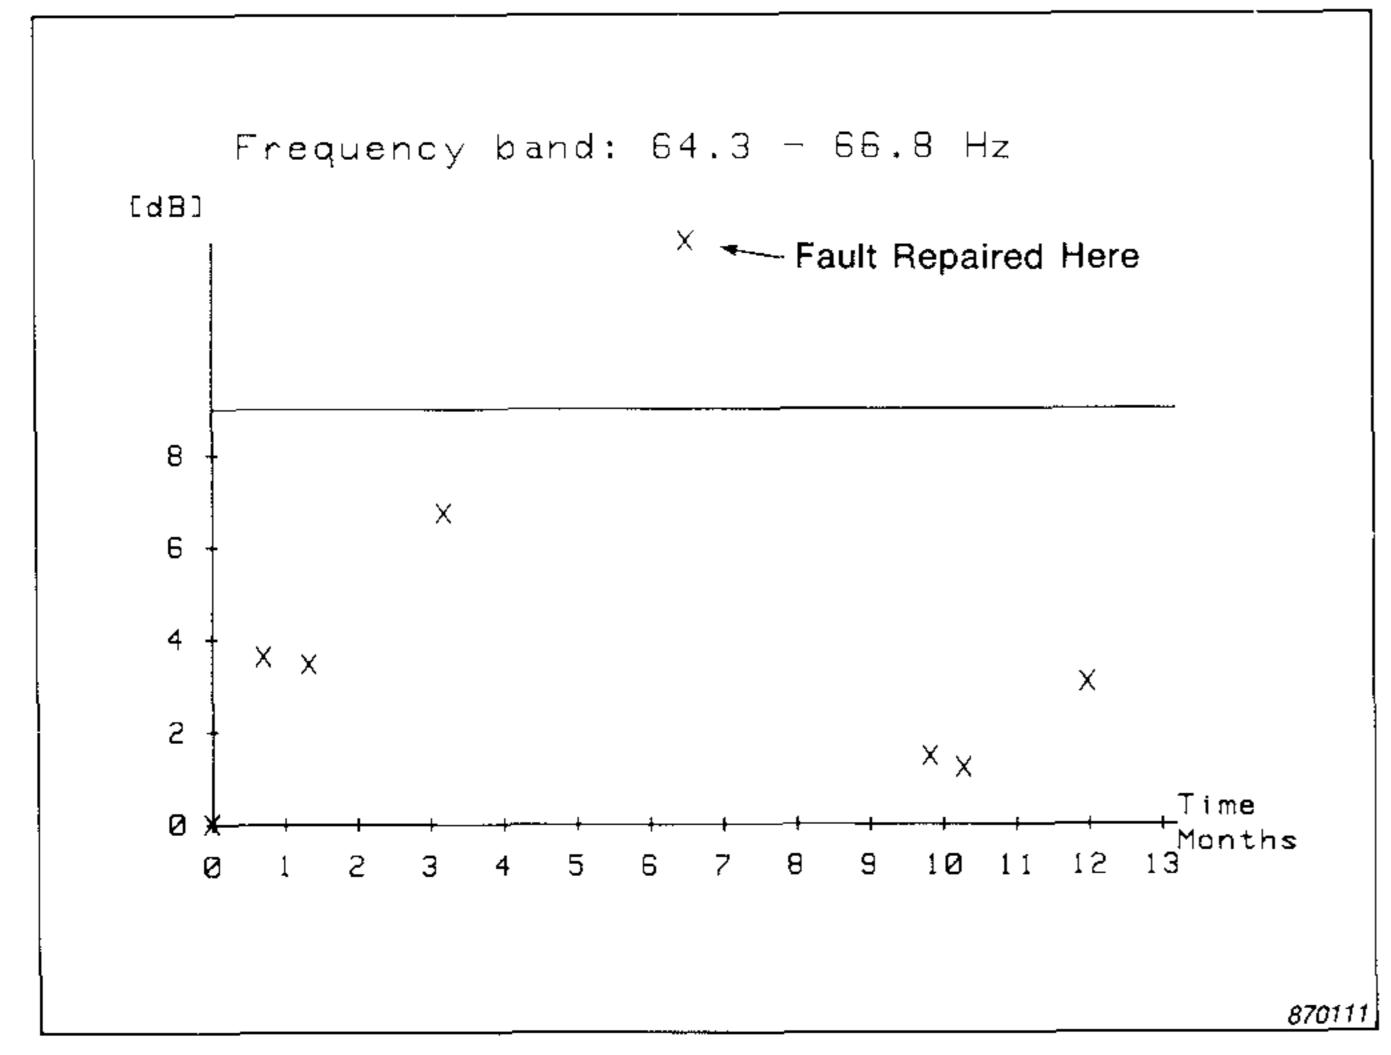
The supply air for the blower is unfiltered, and a common problem is one of dirt on the blower causing an unbalance. In the example shown in Fig. 19,

Fig. 19. Trend curve at the blower-exciter rotational frequency. The vibration level is seen to increase to danger levels and then drop-off after repair

dangerous vibration levels were recorded from the assembly, as shown in the trend curve measured at the blower speed. The blower was subsequently removed and cleaned and the levels seen to drop.

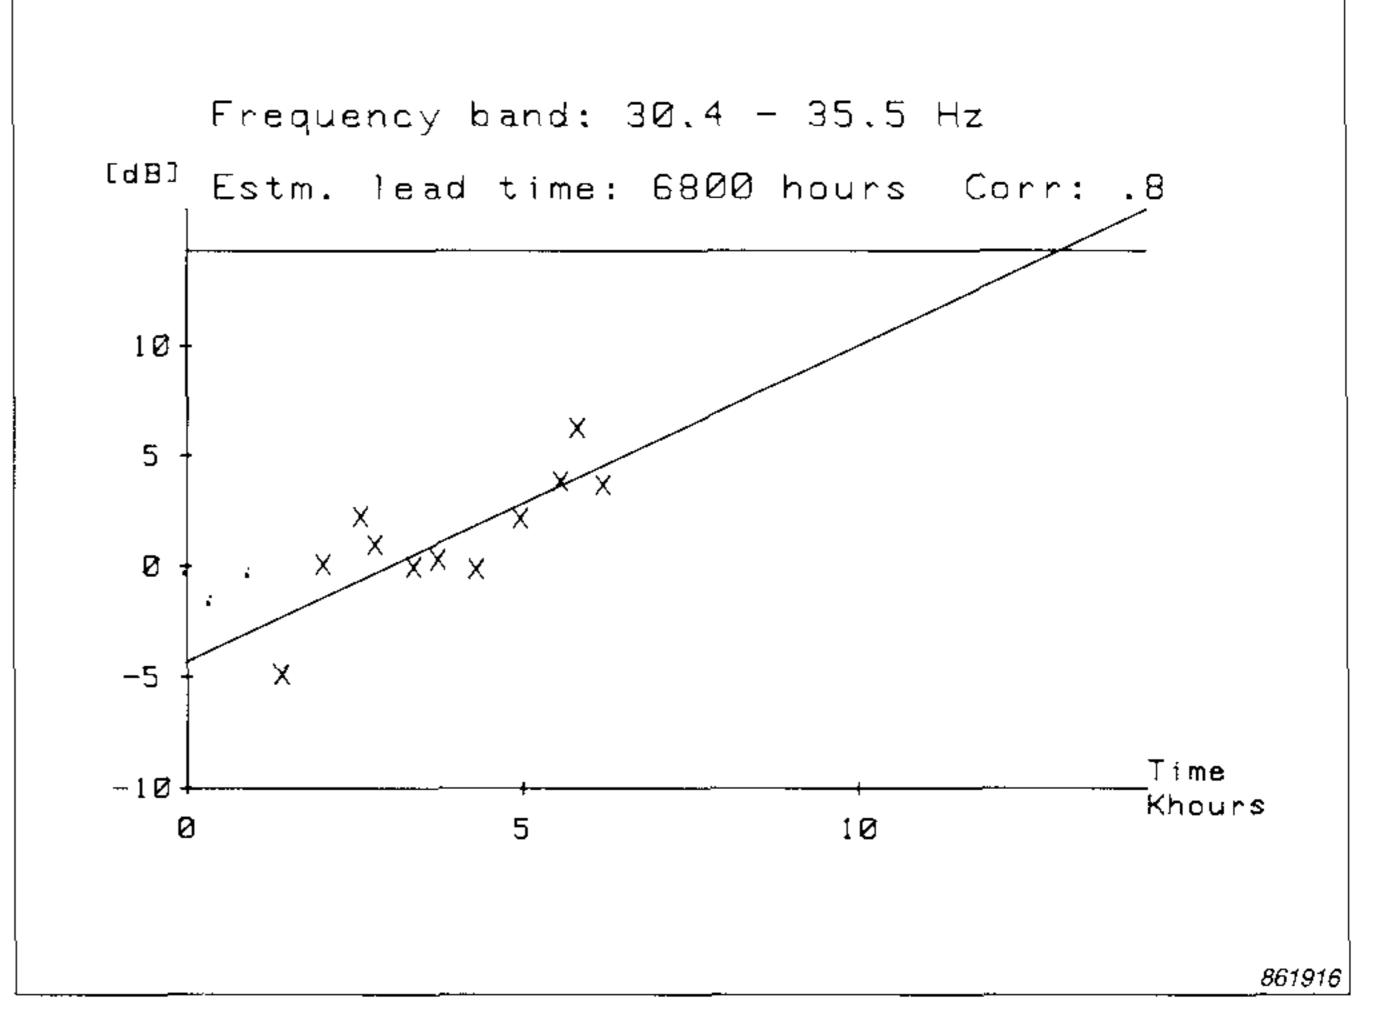
The trend curve shown in Fig. 20 shows some interesting results. The curve indicates a steady upward trend in vibration level at the crankshaft frequency. This type of trend curve, in conjunction with other "health" indicators on the engine, could be effectively used as an indication of general wear in the engine. As soon as the vibration level approaches the danger level, an overhaul can be scheduled.

Fig. 20. Trend curve at the crankshaft frequency
