Machine-Condition Monitoring Using Vibration Analysis

A Case Study from an Iron-Ore Mine

by D.N.Brown & J.C.Jørgensen
Brüel & Kjær

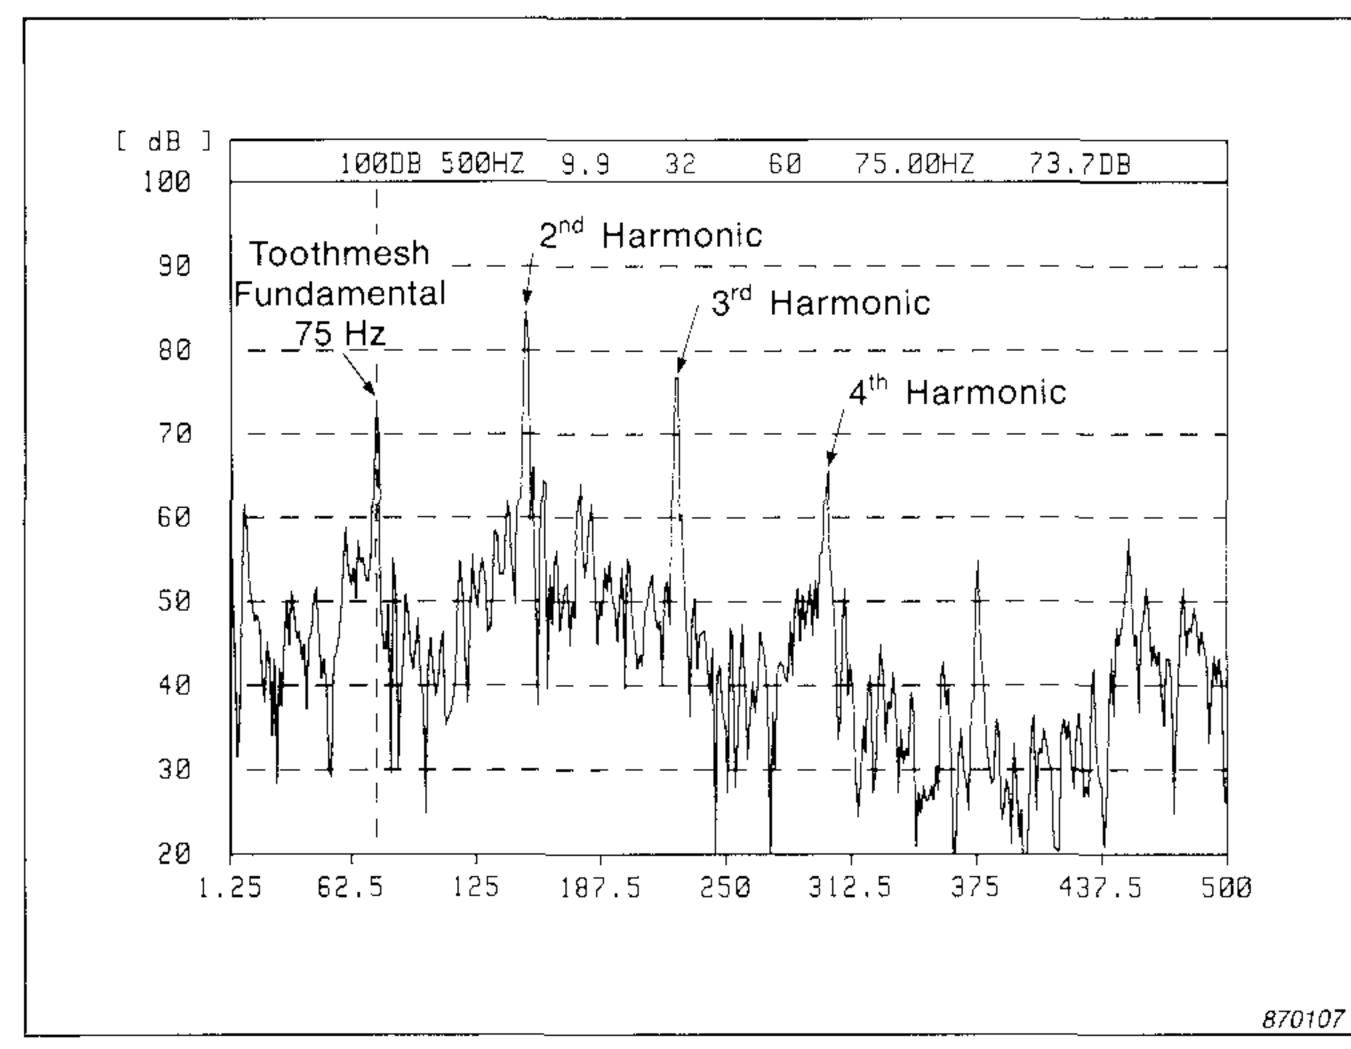
Figs. 22 and 23 show examples of narrowband spectra taken from the gearbox. In Fig. 22 can be seen a very dominant toothmesh frequency from the pinion and mill bull-gear, together with a strong harmonic series. Fig. 23 shows a zoomed narrowband spectrum around the toothmesh fundamental,

Fig. 22. Narrowband spectrum from the mill gearbox, showing a strong harmonic series at the pinion/bull-gear toothmesh frequency

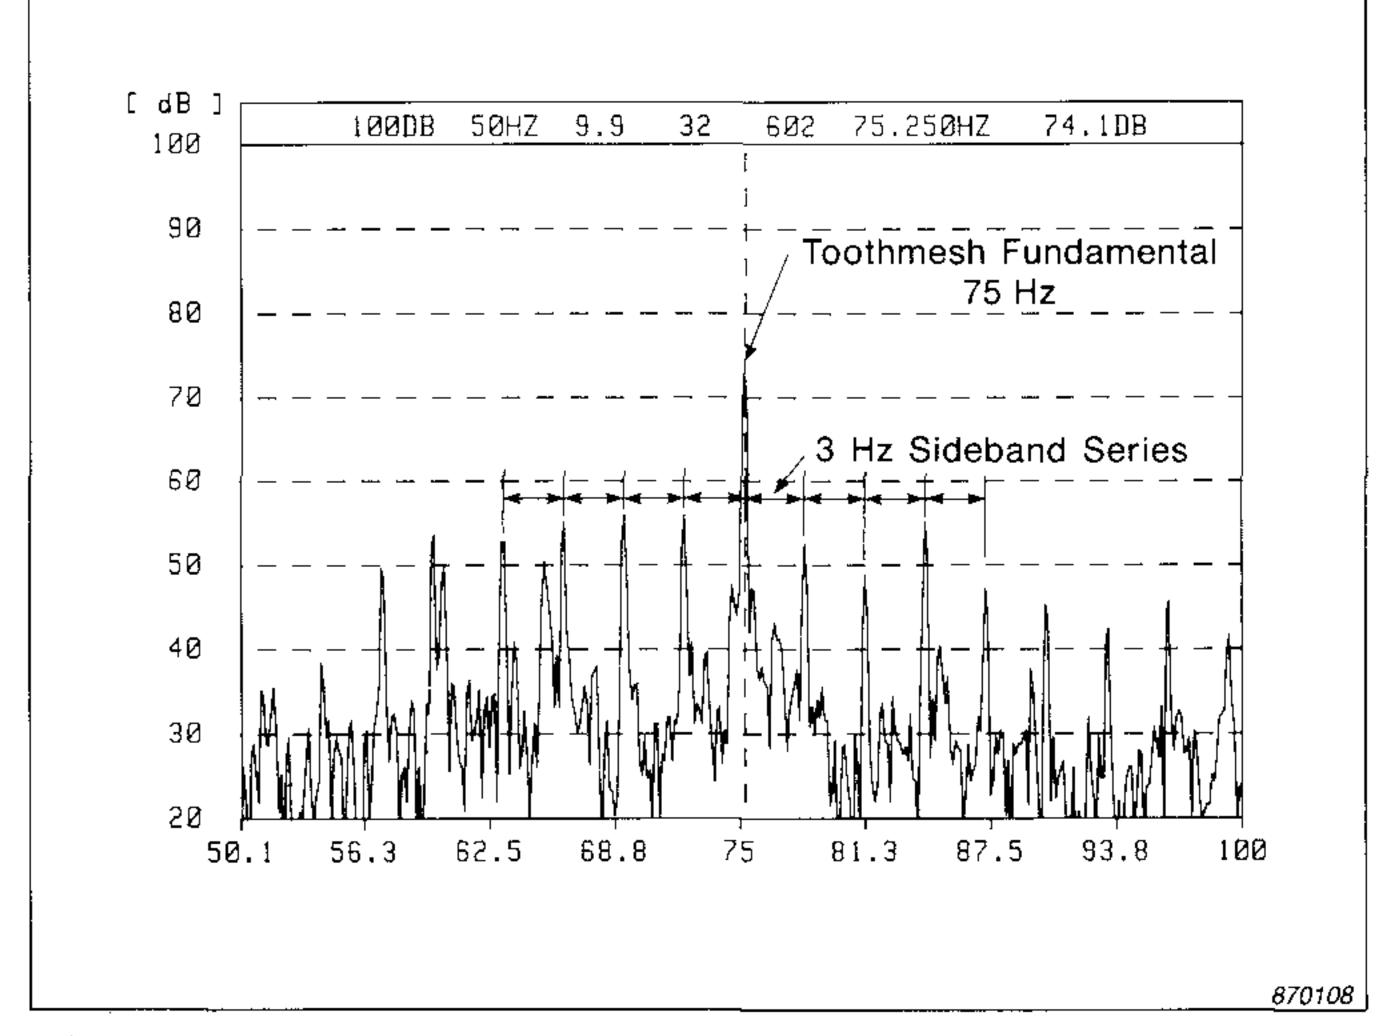
showing a pattern of sidebands with a spacing of 3 Hz, which corresponds to the pinion gear rotational frequency. At first it was thought that the problem was one of misalignment. However, after careful examination of the spectra, it was deduced that the cause of these prominent patterns in the spectra was from a mismatch in wear patterns between the pinion and bull-gear, and possibly slight eccentricity of the pinion gear. The pinion gear was relatively new, whereas the bull-gear had not been changed for sometime.

Fig. 23. Zoomed narrowband spectrum about the pinion/bull-gear toothmesh, showing a marked sideband pattern
