# Machine-Condition Monitoring Using Vibration Analysis

A Case Study from a Petrochemical Plant

by D.N.Brown & J.C.Jørgensen  
Brüel & Kjær

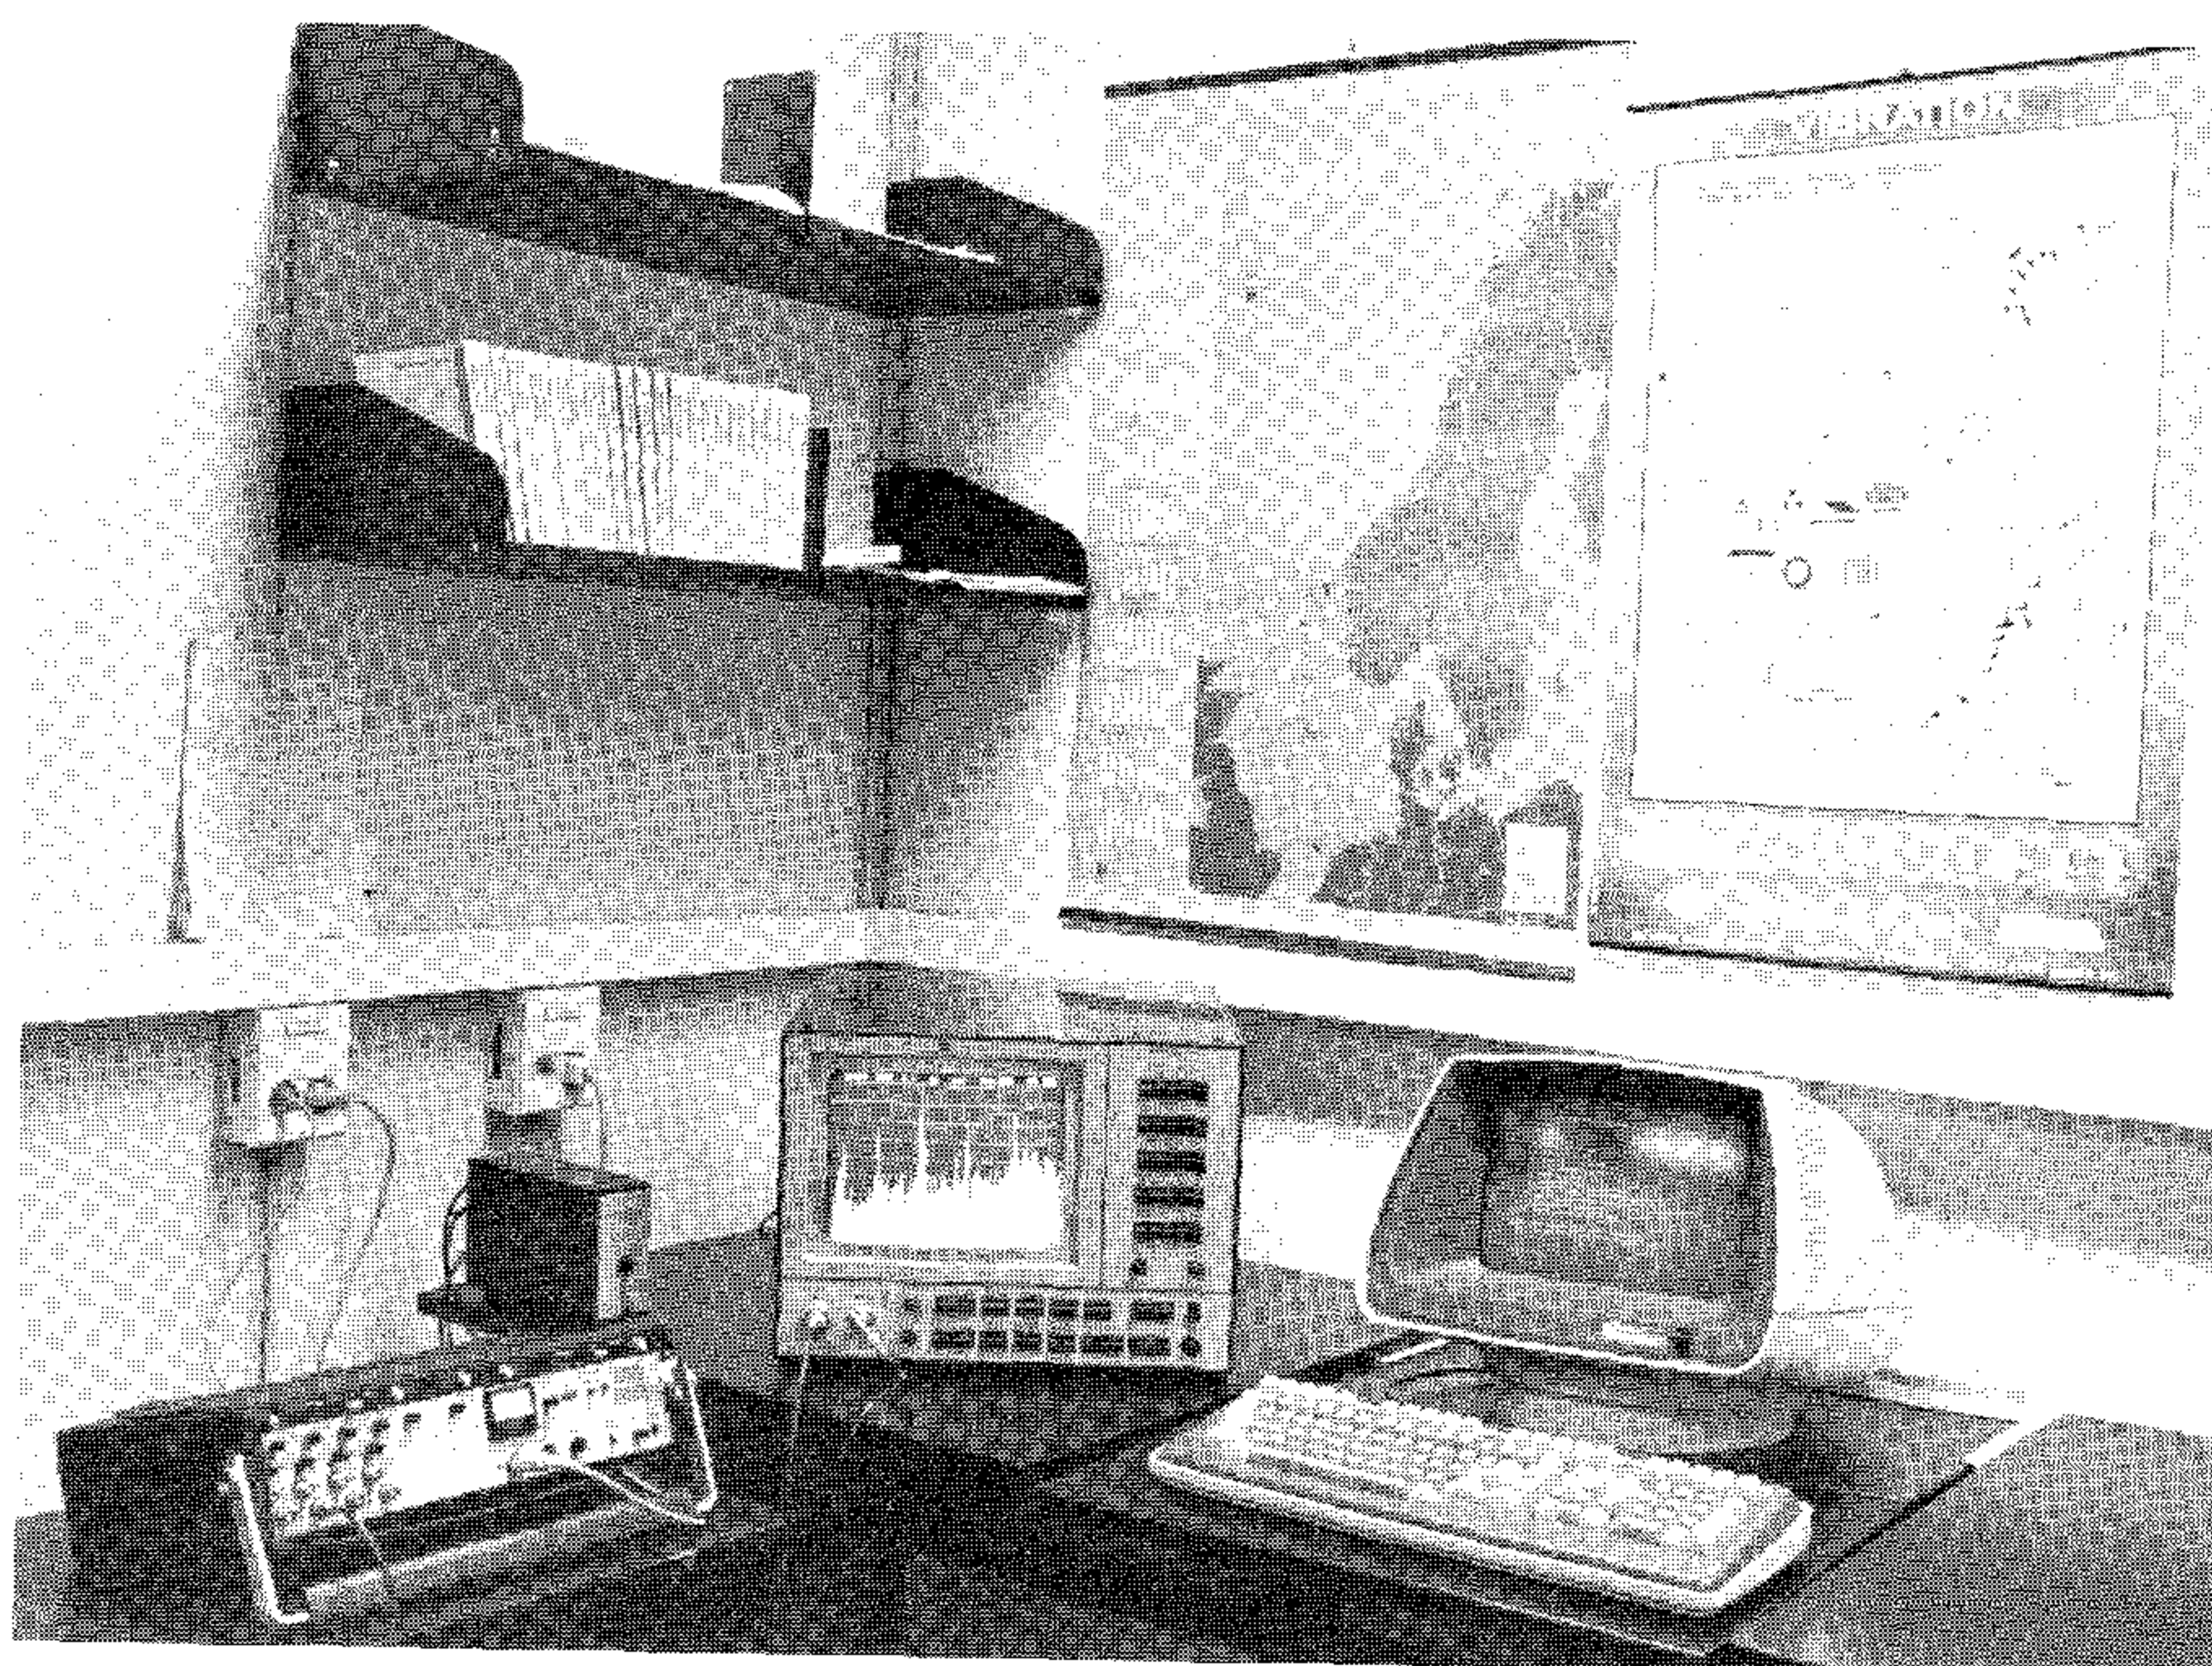
Fig. 2. The computer terminal and FFT Analyzer are placed in the engineer's office next to the central control room. An alarm printer is placed in the actual control room.
