# Machine-Condition Monitoring using Vibration Analysis

## Permanent Monitoring of an Austrian Paper Mill

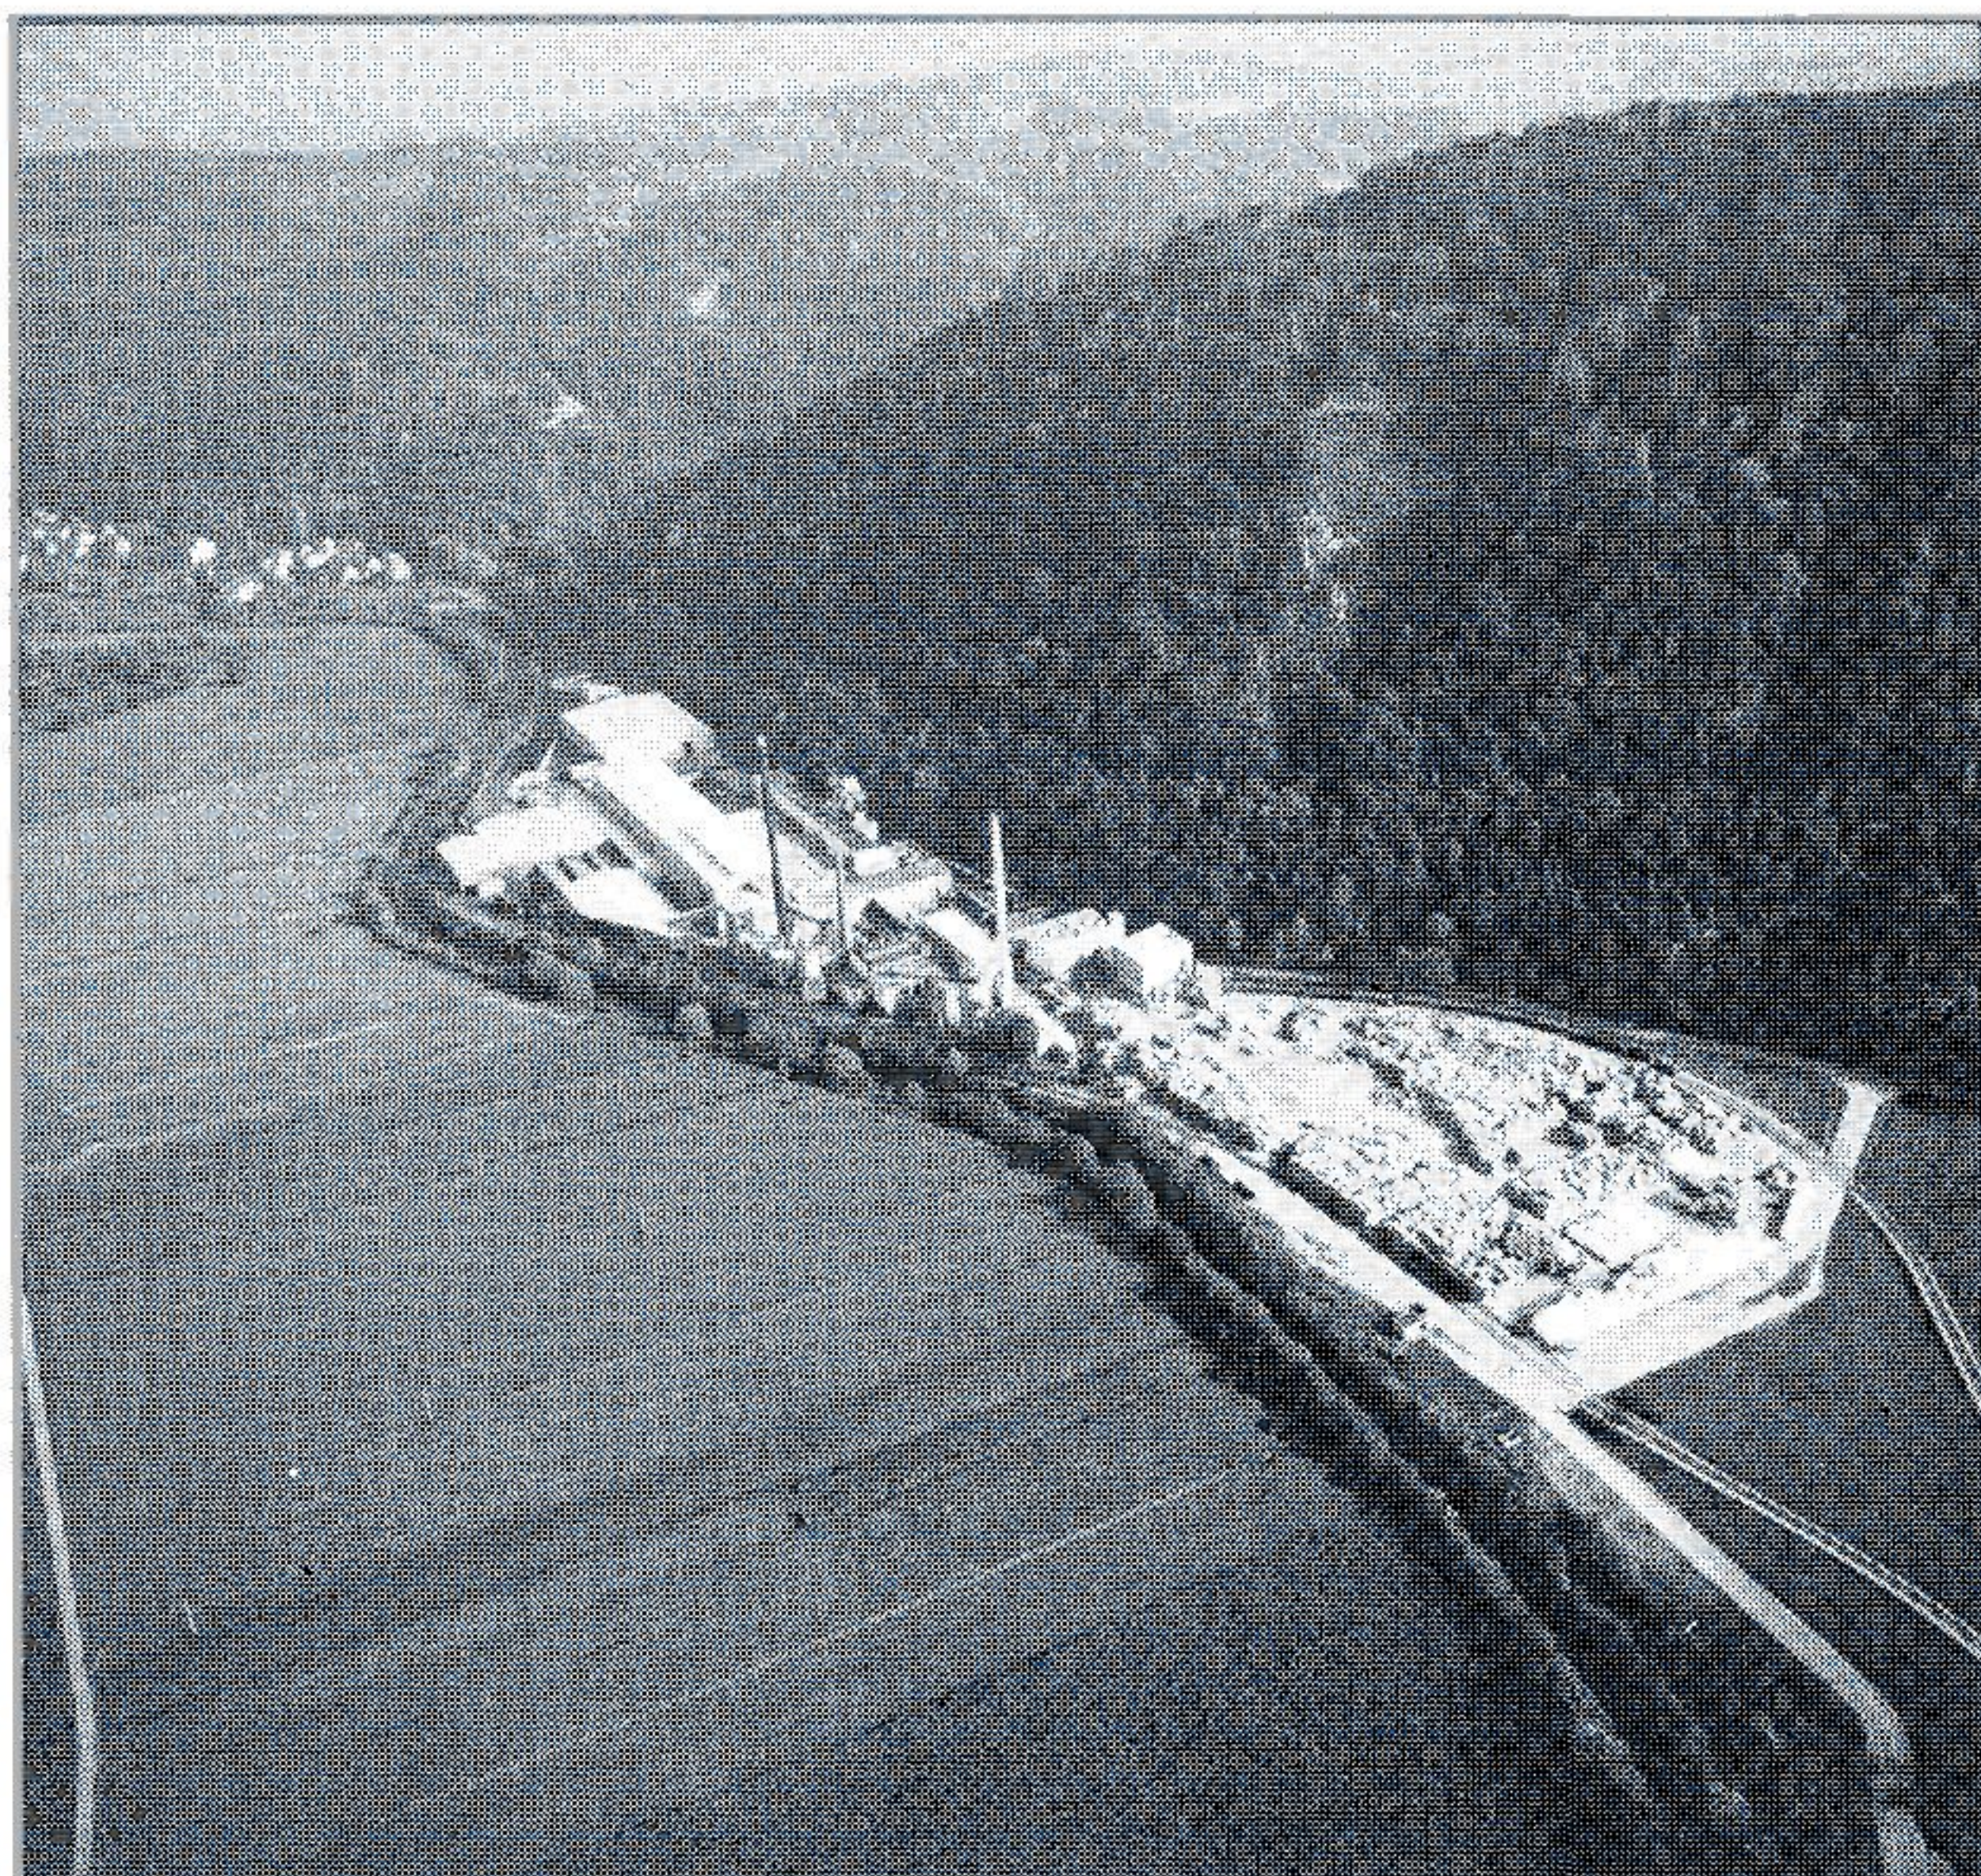
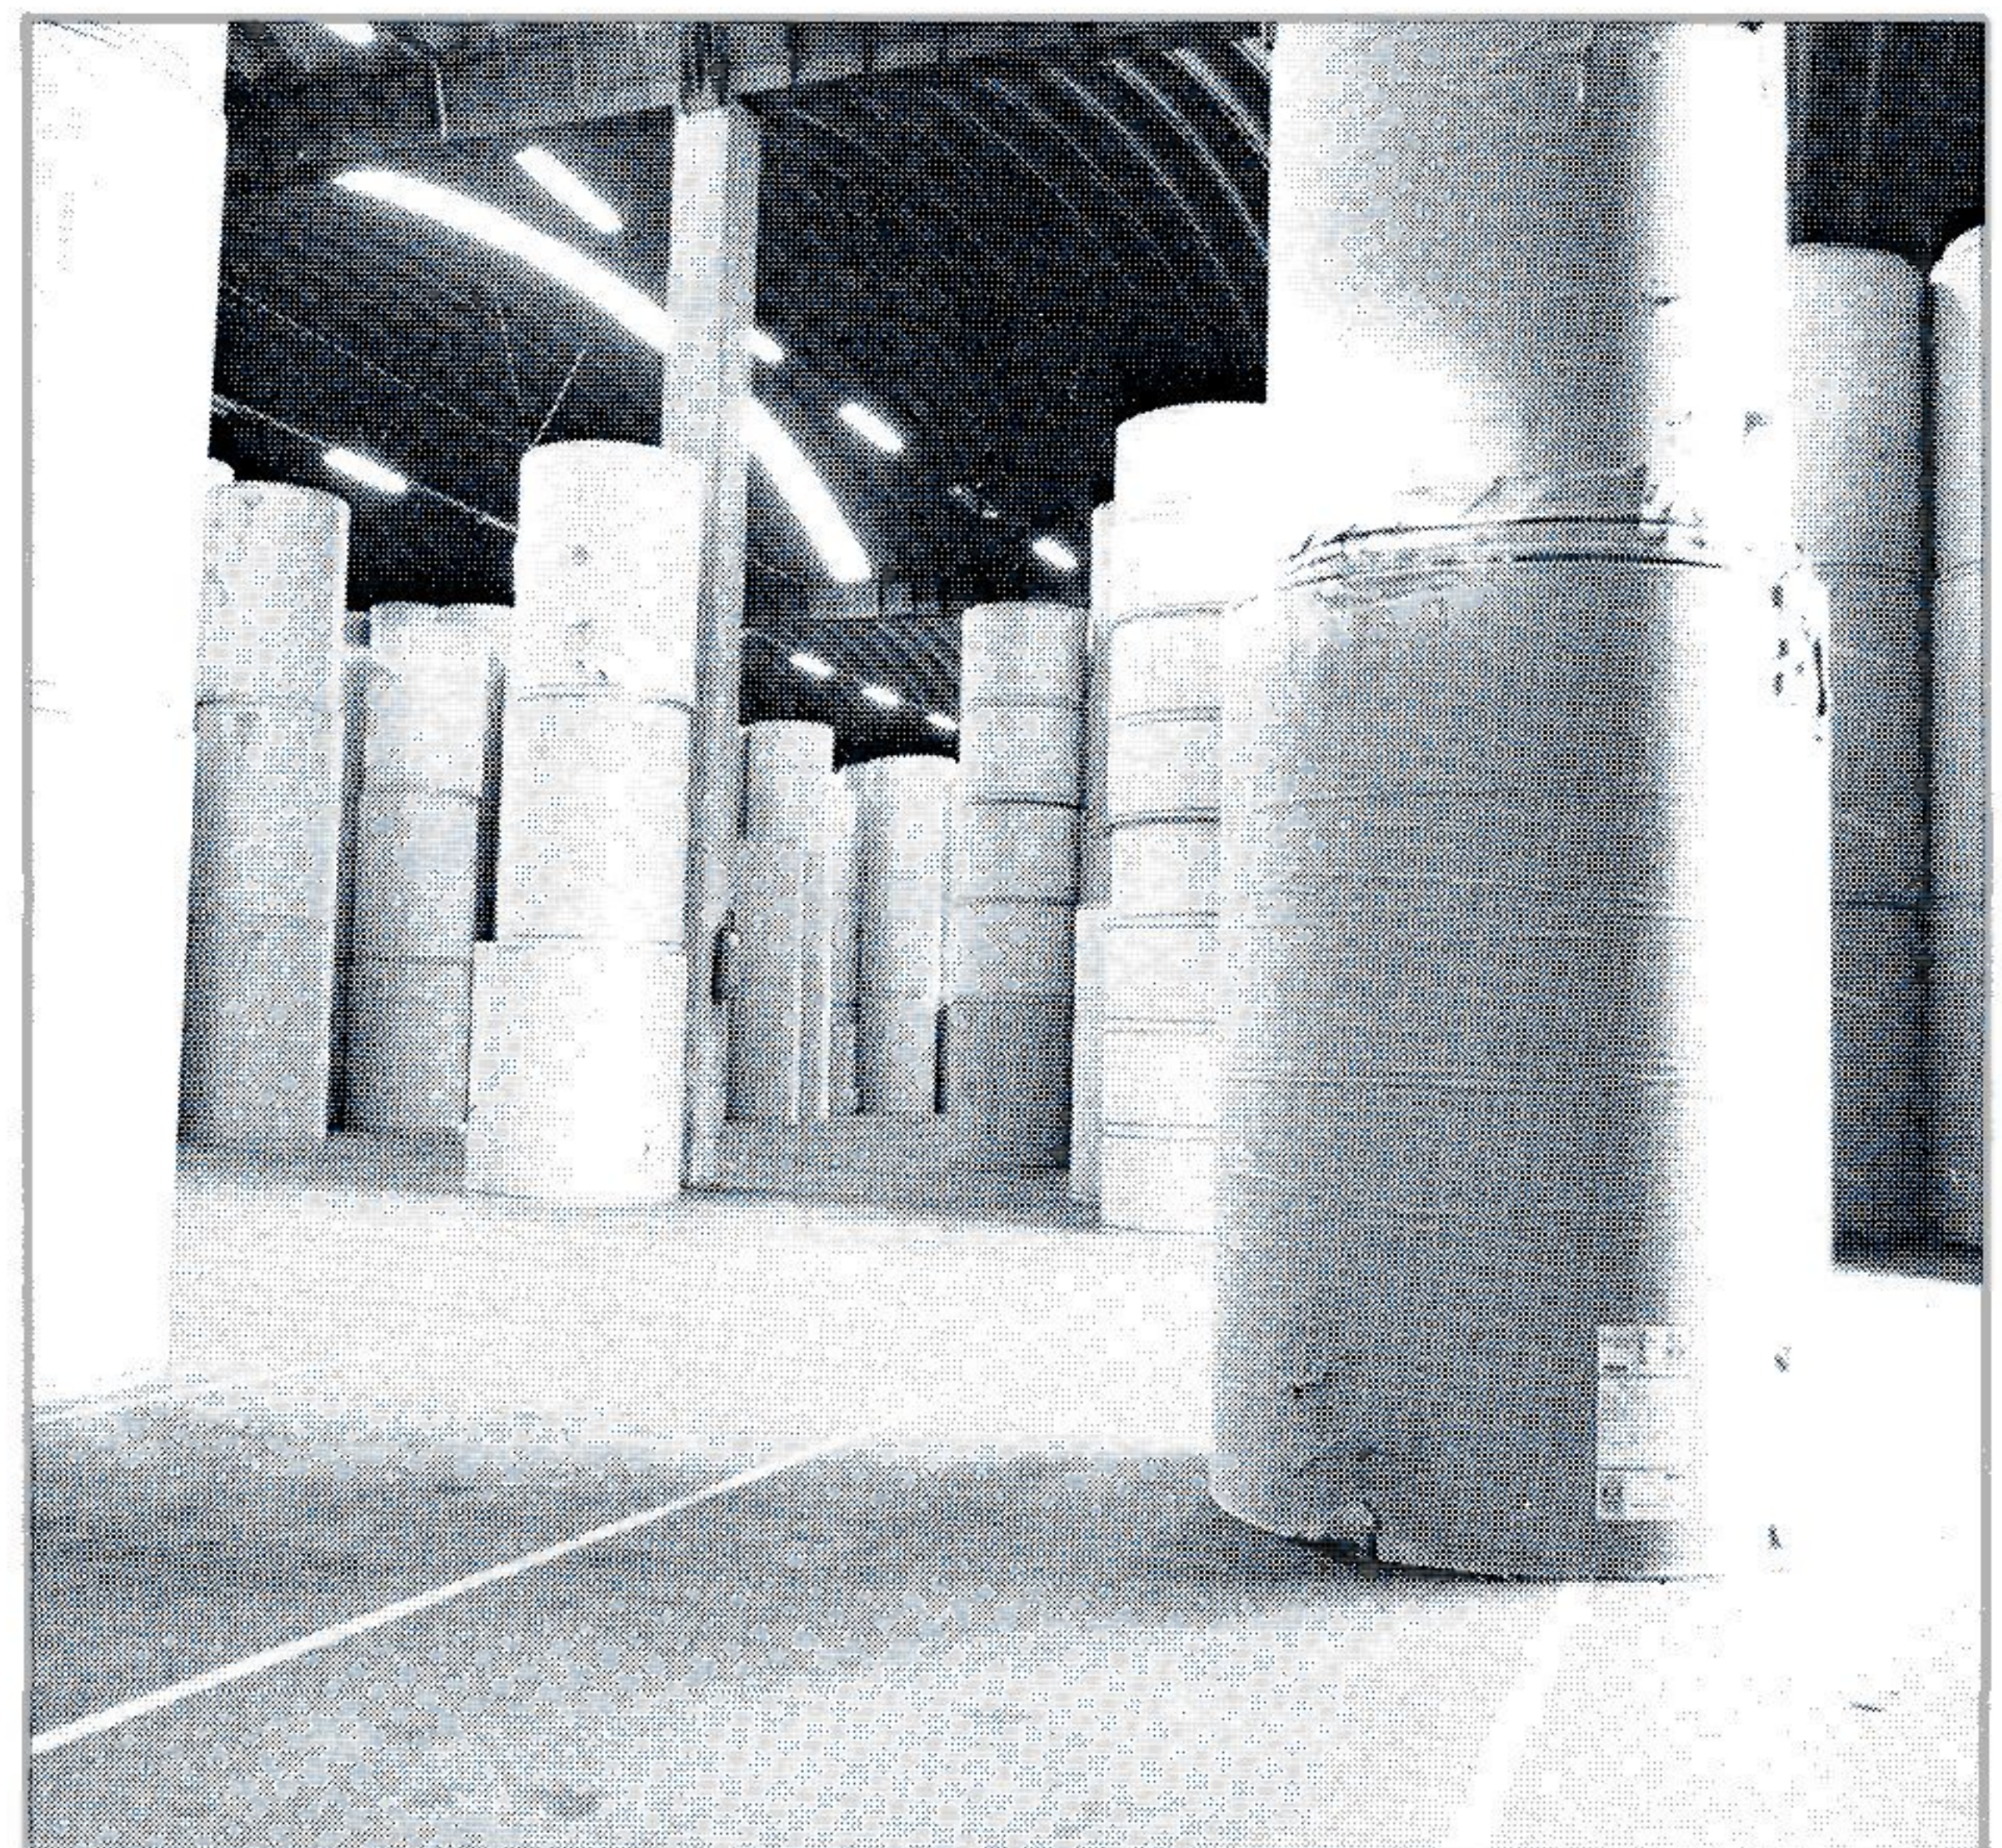
Fig. 1. A schematic layout of the Voith paper-machine used by Hamburger AG. The monitored bearings are in the dryer-section (both PRE-DRYER and AFTER DRYER) at the bottom of the figure

Hamburger AG, situated in Pitten, Austria, was founded in the year 1853 by Wilhelm Hamburger. The company is one of the constituent parts of a larger group comprising Mosburger AG, Brigl und Bergmeister AG and Hamburger AG. The company recycles waste paper, producing corrugated packing paper. They run 1 Voith and 1 Erwepa paper-machine, manufacturing 24 hours a day at full capacity. They employ 250 people and produce 150 000 tonnes of corrugated packing per year. Fig. 1 shows a schematic layout of the monitored paper-machine at Hamburger AG.

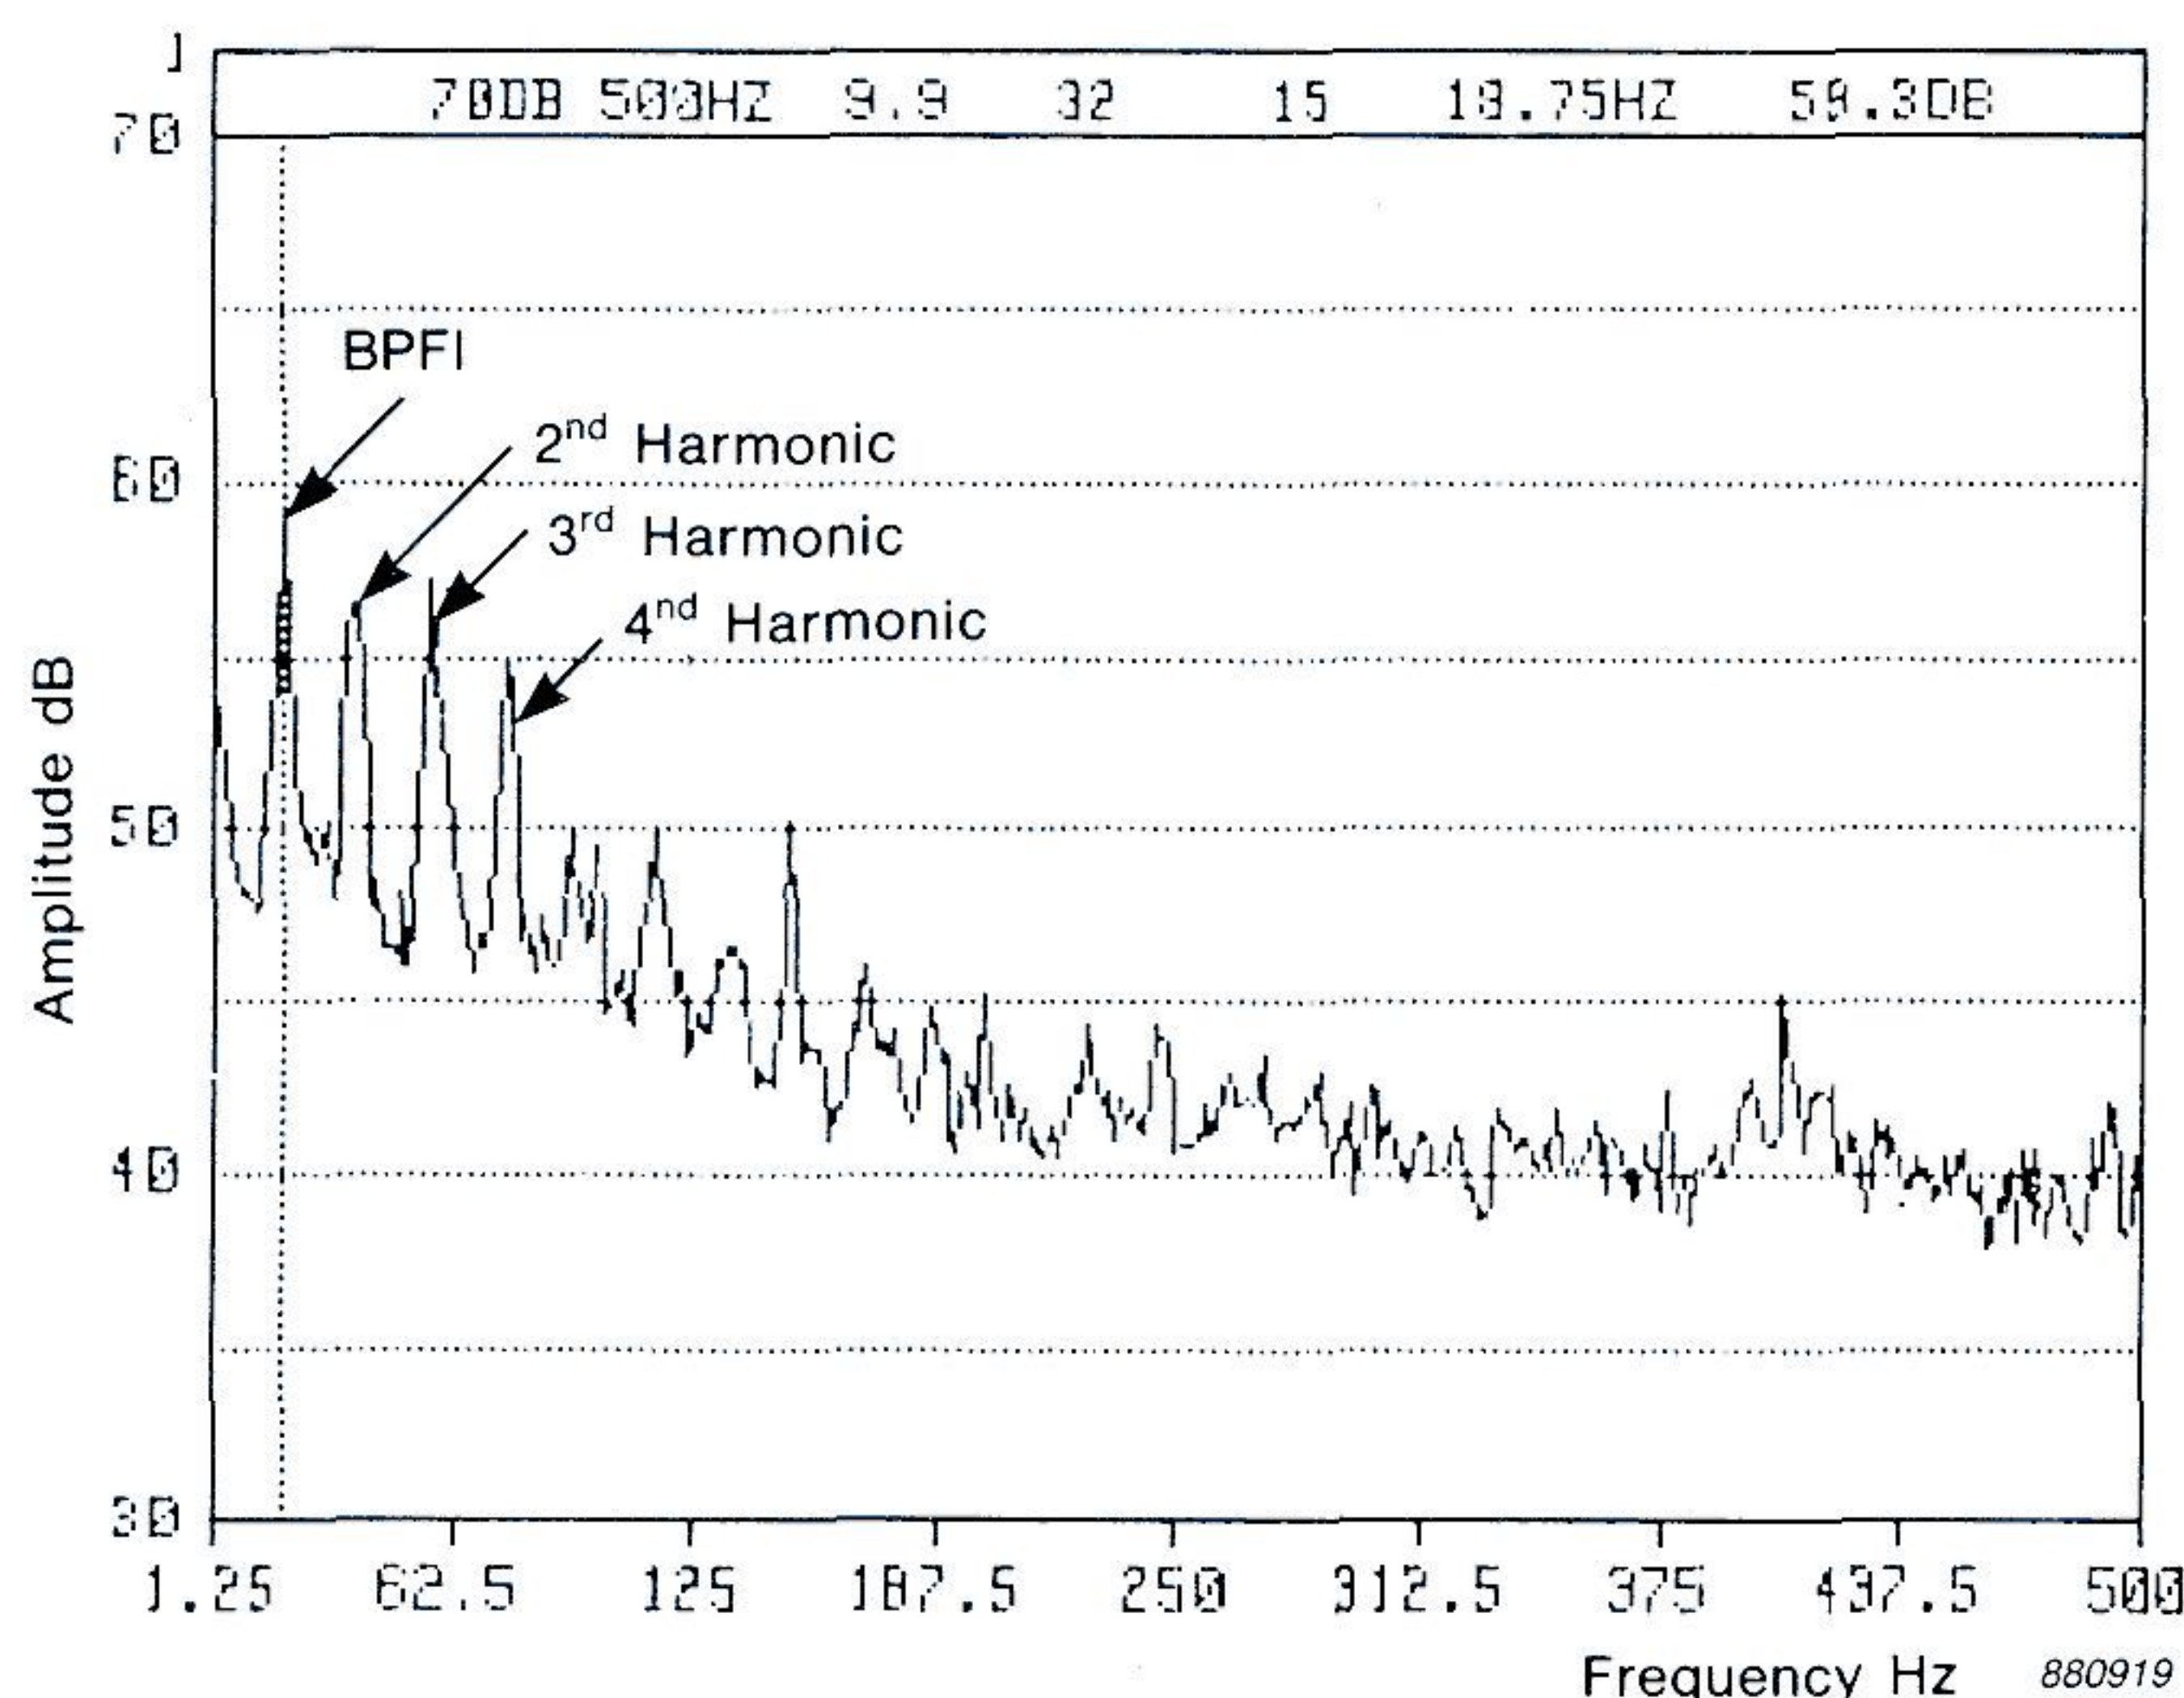
Fig. 8. The envelope spectrum for bearing TS 20. The cursor (dotted line) is positioned at the peak (18,75 Hz), where the inner-race fault is readily identifiable

As can be seen from the plot of the envelope spectrum in Fig. 8, the fault was identified as a flaw in the bearing's inner-race. A trend-analysis was then performed to give an estimate of the remaining life of the bearing, it is shown in Fig. 9. With this information at their disposal, Hamburger AG scheduled the bearing for replacement in December 1986 at one of their regular maintenance shutdowns. When the bearing was dismantled, the maintenance team verified that it did have an inner-race fault.
