# Application Notes

## Diagnosis of Vibration Problems in Holland

### Case Studies from the Groenpol Vibration Consultancy

Matt o'Sullivan  
Mechanical Engineer  
Brüel and Kjær, Denmark

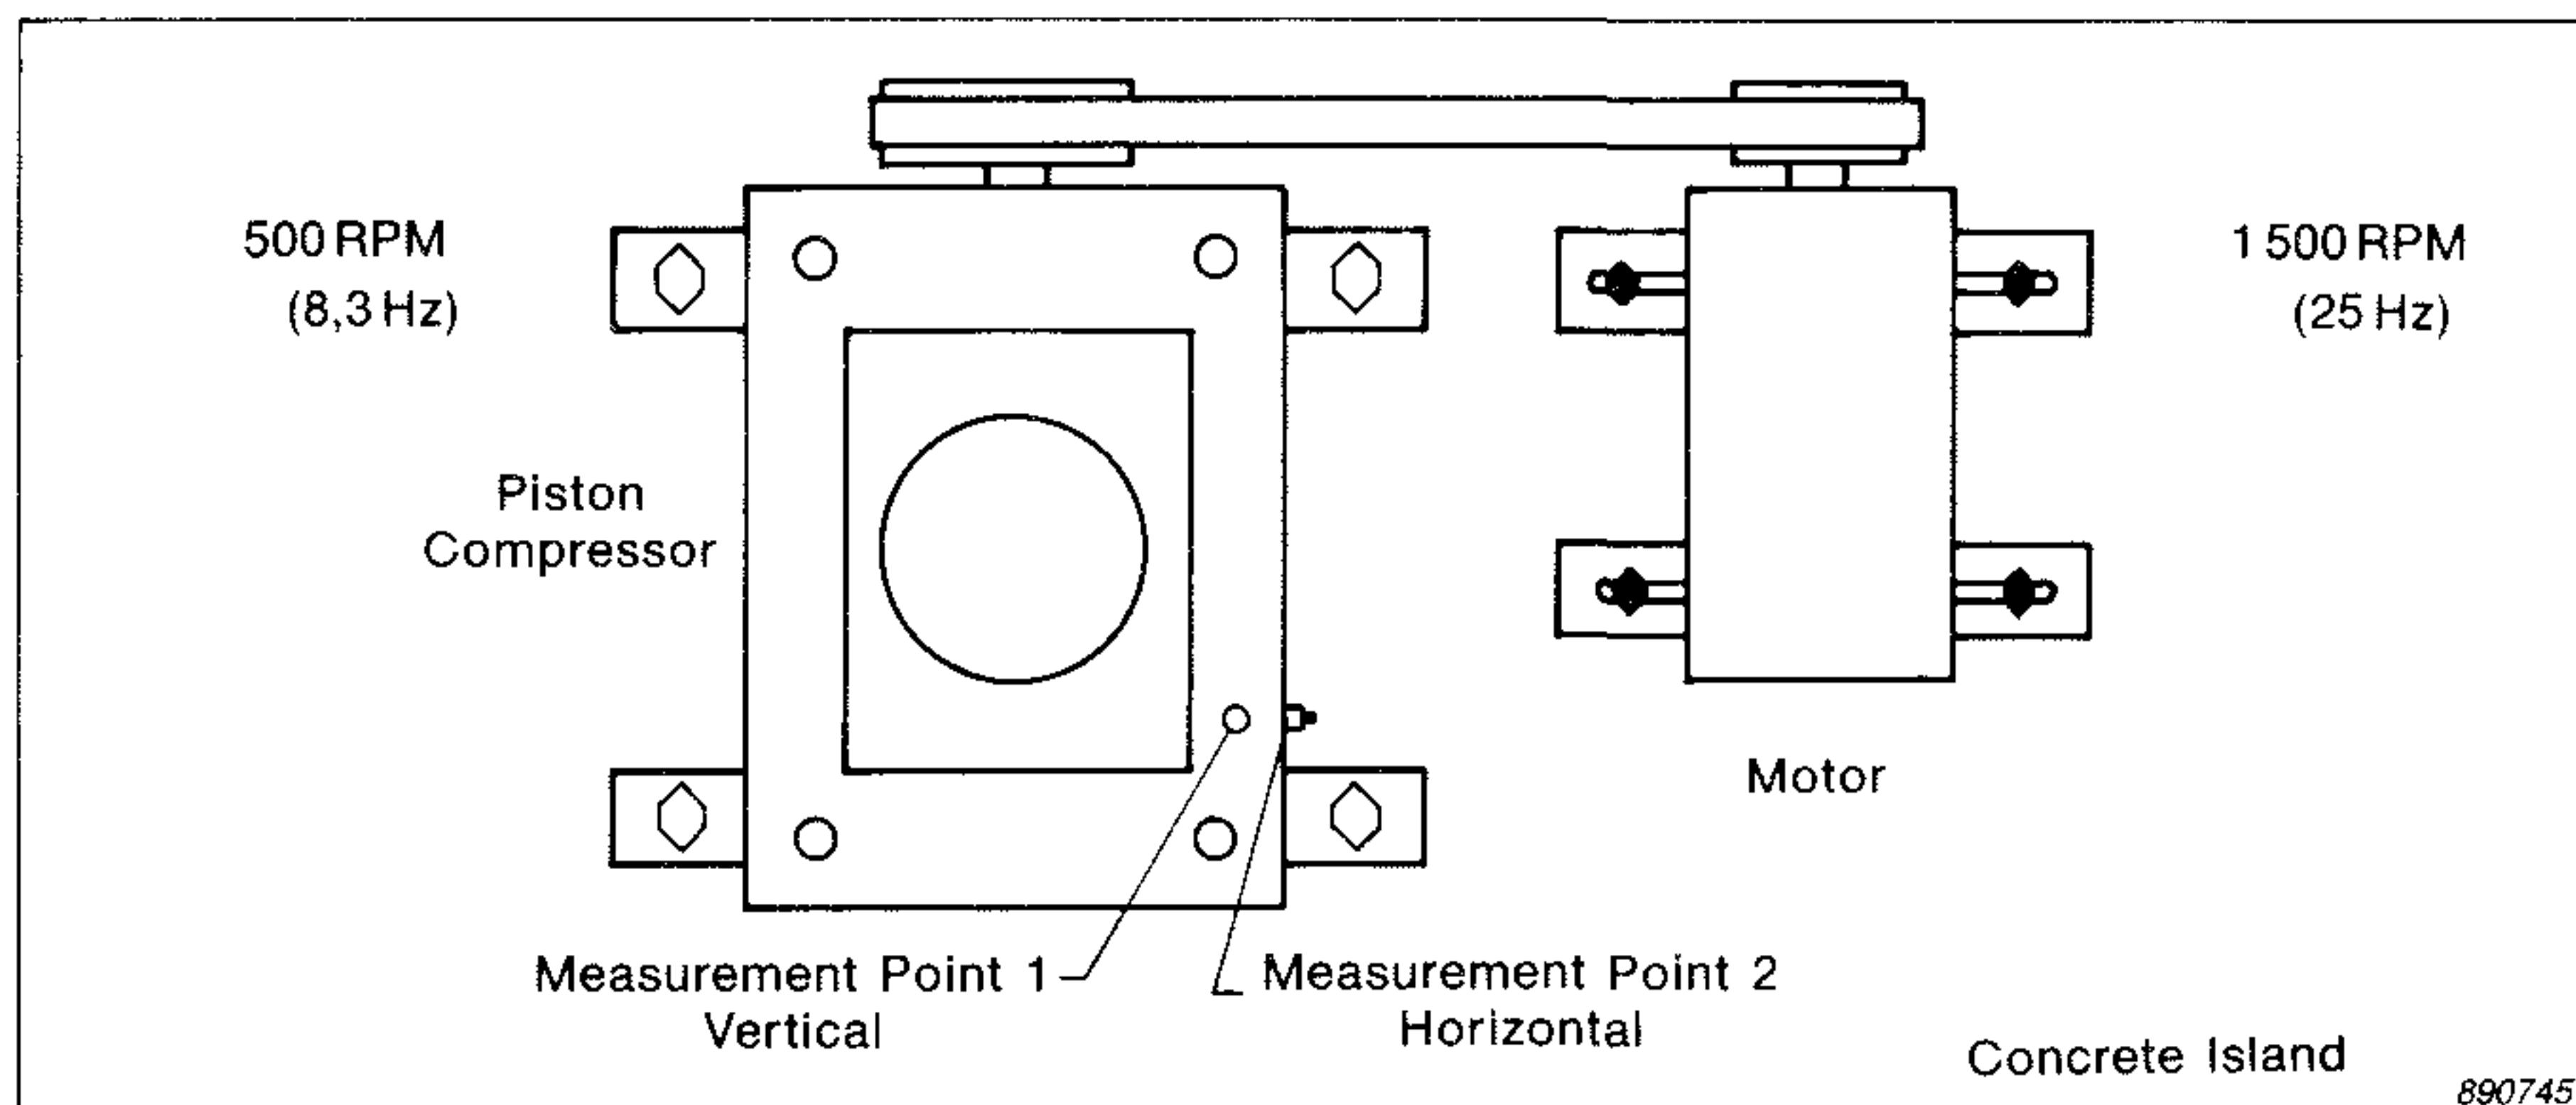
They measured the overall vibration levels, on all three compressors, at the points shown in Fig.1. For one machine the vertical ( $12,8 \text{ mm s}^{-1}$ ) was much higher than the horizontal ( $4,4 \text{ mm s}^{-1}$ ). This result suggested a foundation problem.

Fig. 1. A top view of the motor and compressor on the concrete island. The locations of the vertical and horizontal measurement points are indicated

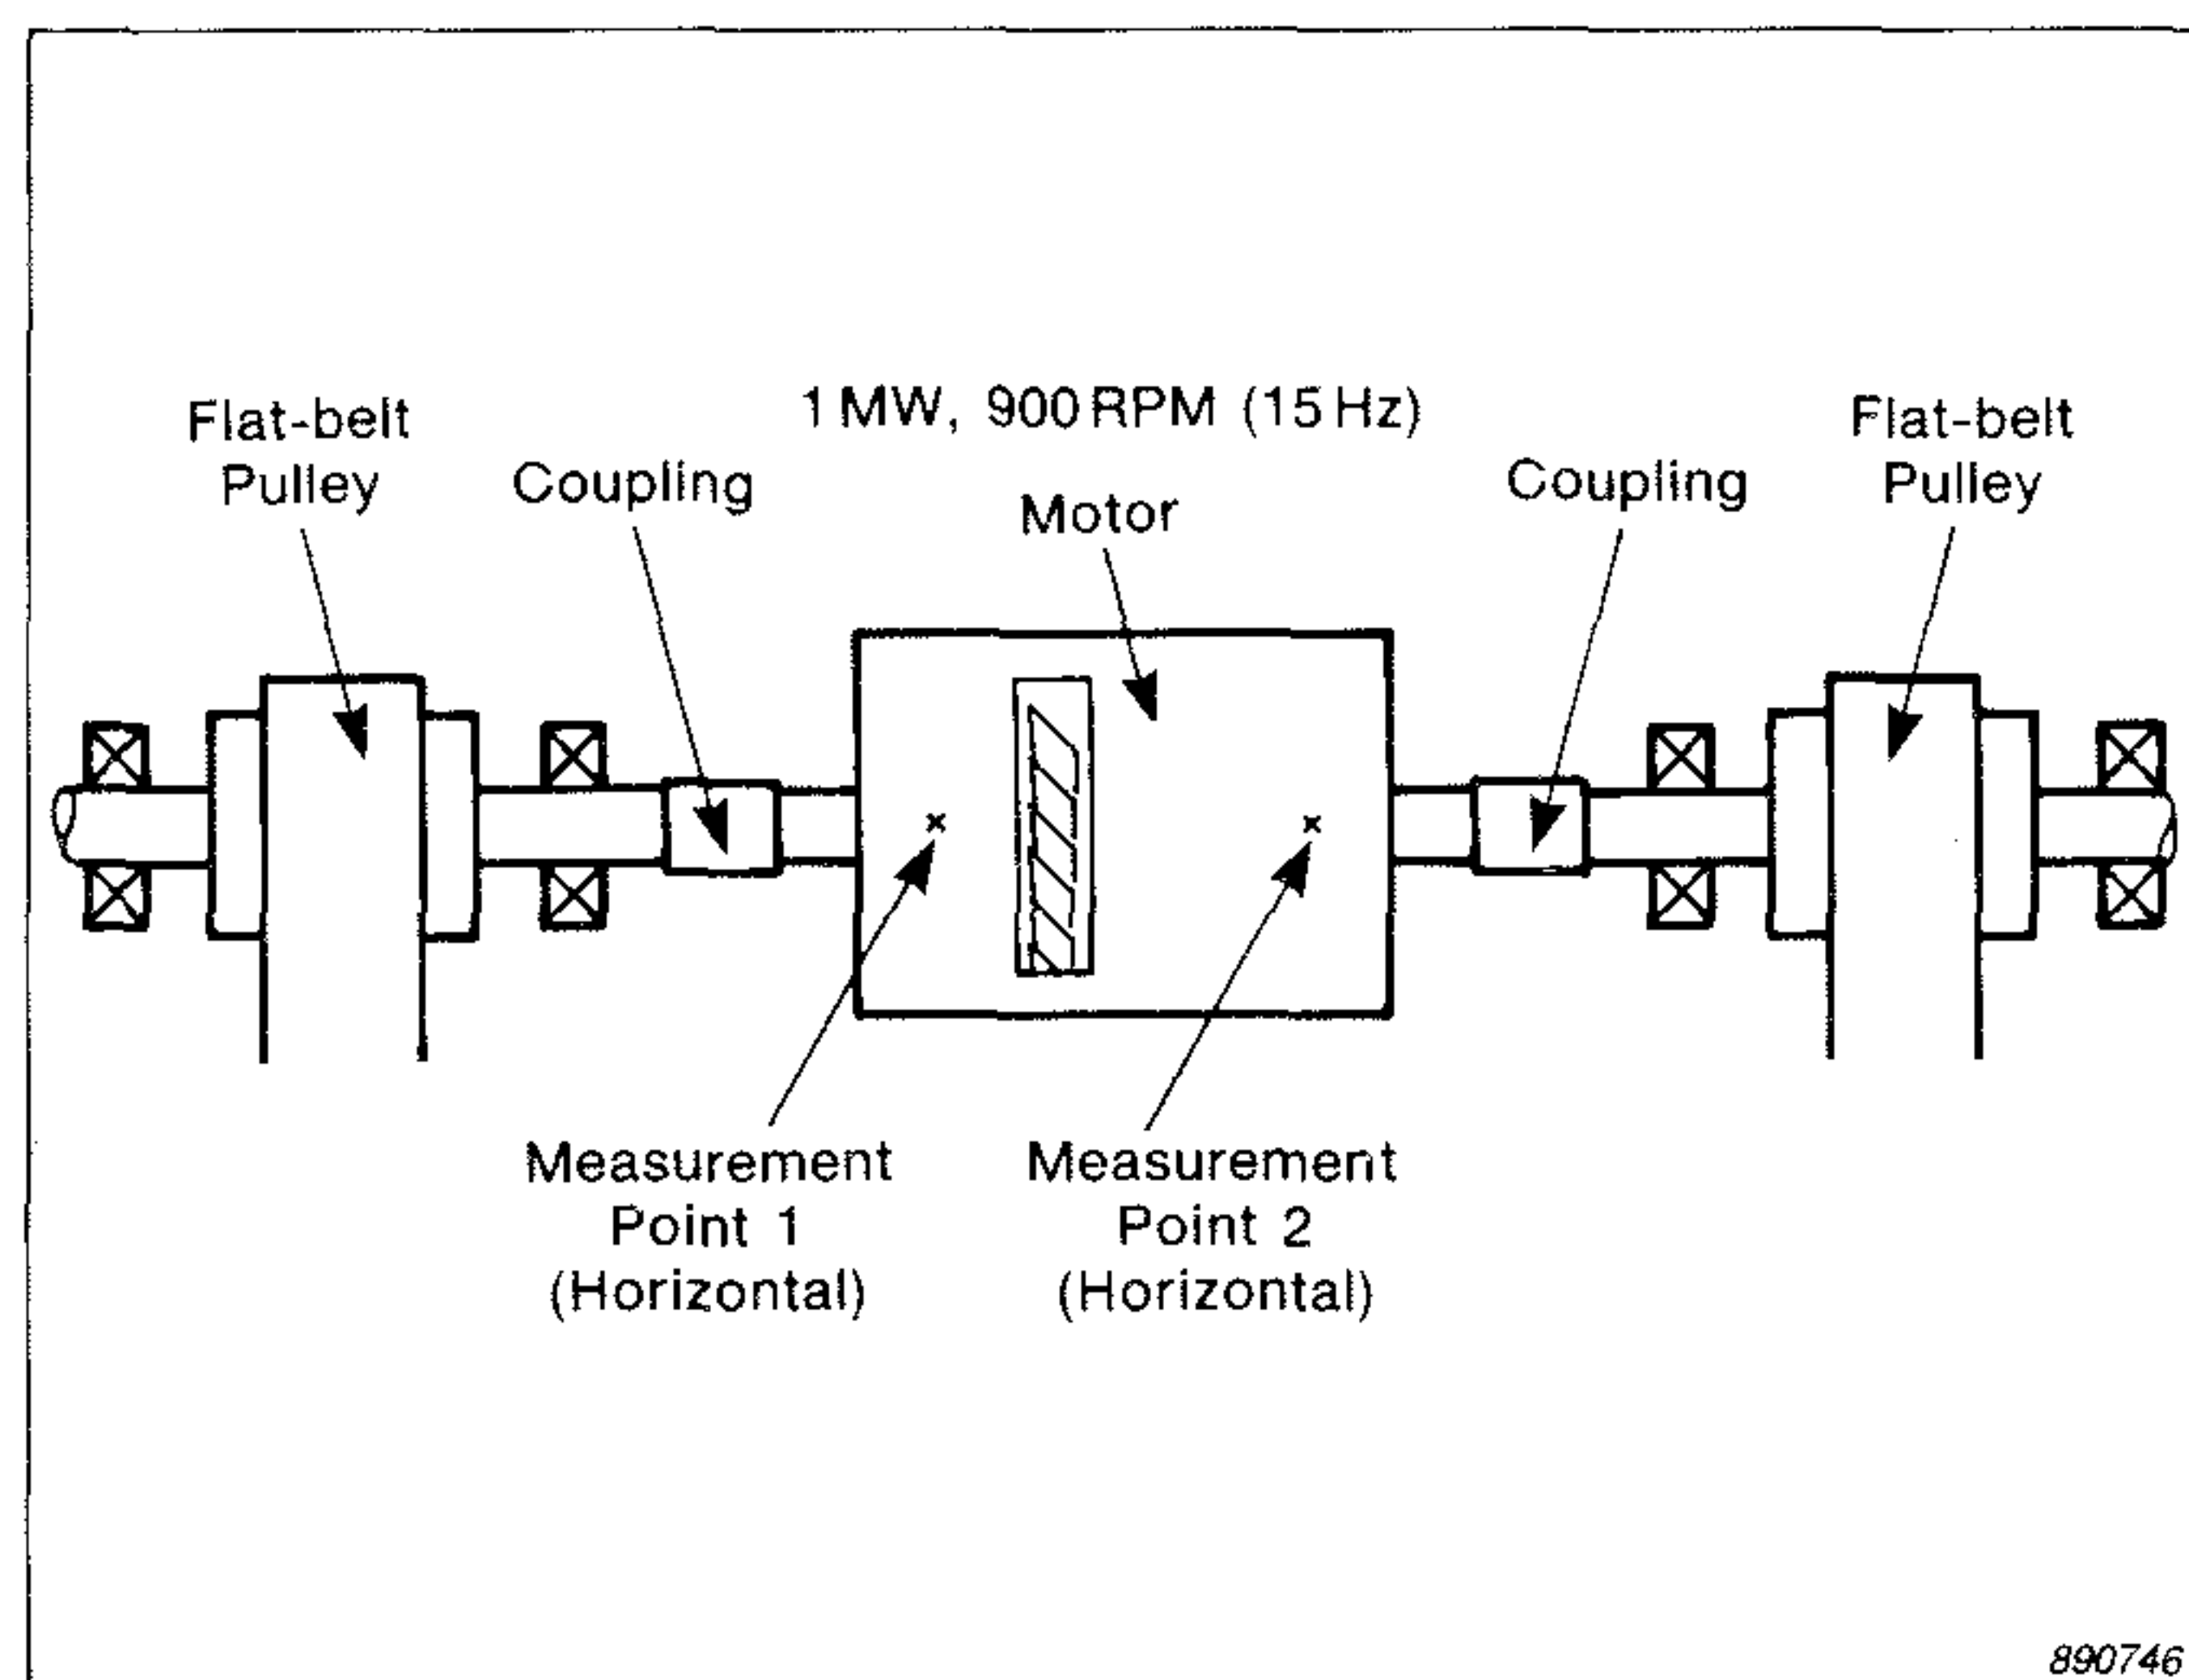
The motor concerned is a 1MW, 900 RPM (15 Hz) unit, located high up in an awkward position. It drives flat-belt pulleys at both ends, see Fig.7. When the maintenance staff noticed that the vibration level was relatively high compared to vibration severity criteria VDI 2056, they called Groenpol and asked them to do the repairs in-situ.

To diagnose the fault, Groenpol measured with the vibration analyzer at the two horizontal measurement points shown in Fig.7. At measurement point 1 they noticed a high vi-

Fig. 7. The 1 MW motor drives two flat-belt pulleys as shown. Since it is very large and located high up in an awkward place, the maintenance staff wanted the repairs done in-situ

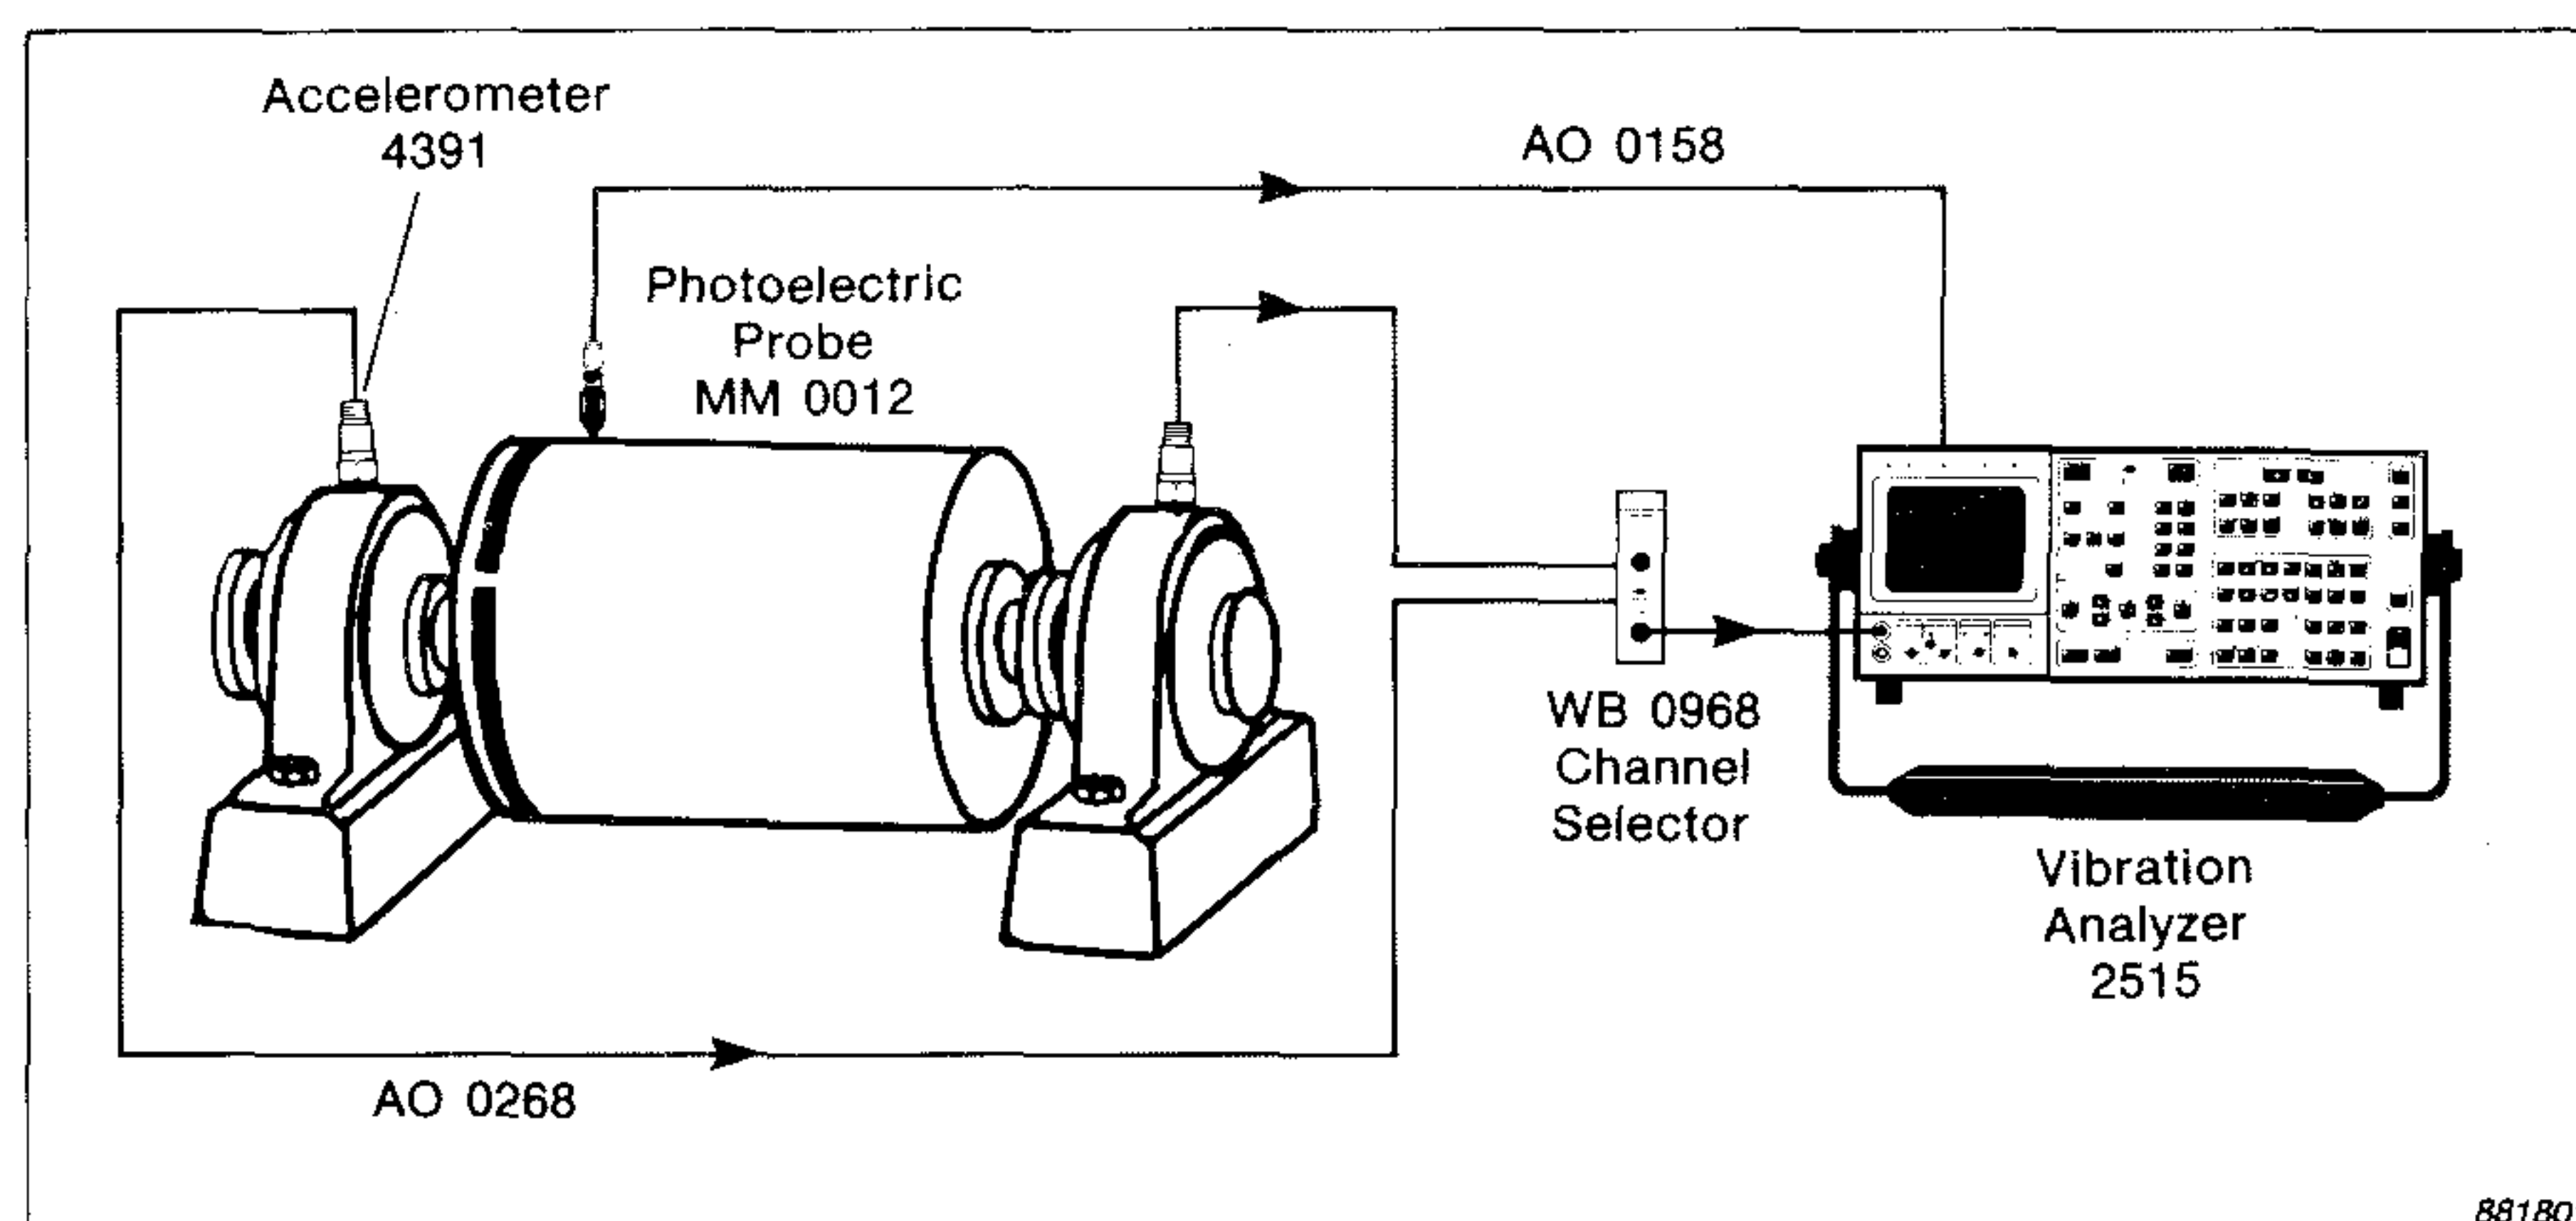
When the vibration level became excessive, the company asked Groenpol to balance the fan. A typical instrumentation set-up for 2-plane, in-situ dynamic balancing is shown in Fig. 10.

Fig. 10. A typical instrumentation set-up for in-situ balancing with a portable vibration analyzer

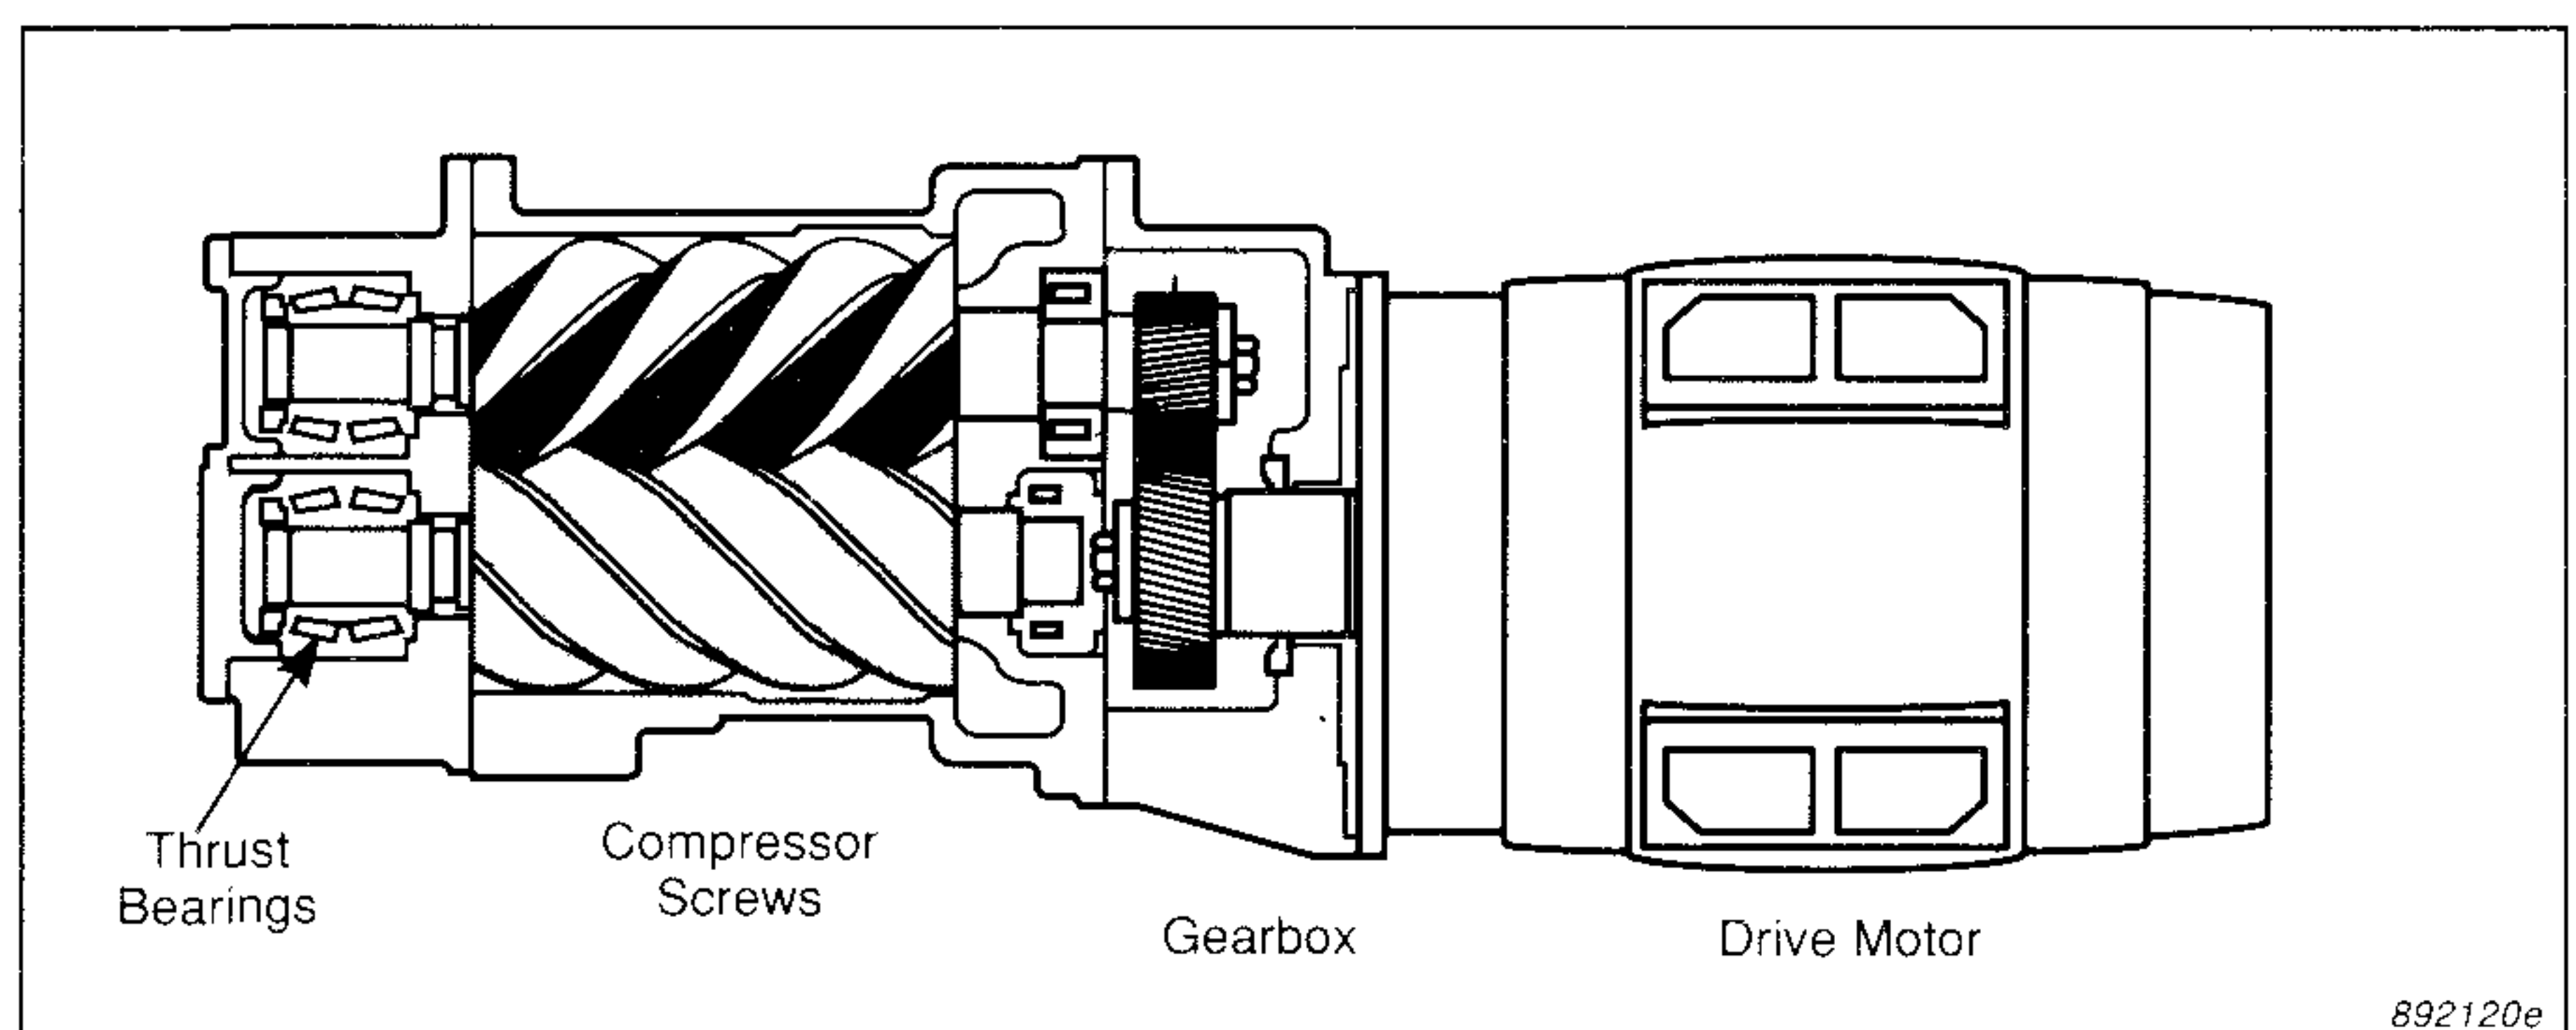
Screw compressors are used for high-pressure compression. Two adjacent, rotating spiral screws trap the gas at one end and force it out the other, see Fig. 13. In small compressors, as in this case, an electric motor drives one screw, which in turn drives the other screw. The speed ratio of the screws depends on the numbers of lobes. These are normally 4 and 6, which means a speed ratio of 6:4.

Fig. 13. A typical, small screw compressor, in which the top screw drives the bottom screw. The spiral profiles on the screws are called lobes; normally one screw has 4 lobes and the other has 6 lobes. The lobemeshing frequency is the product of the number of lobes and the screw rotation-frequency

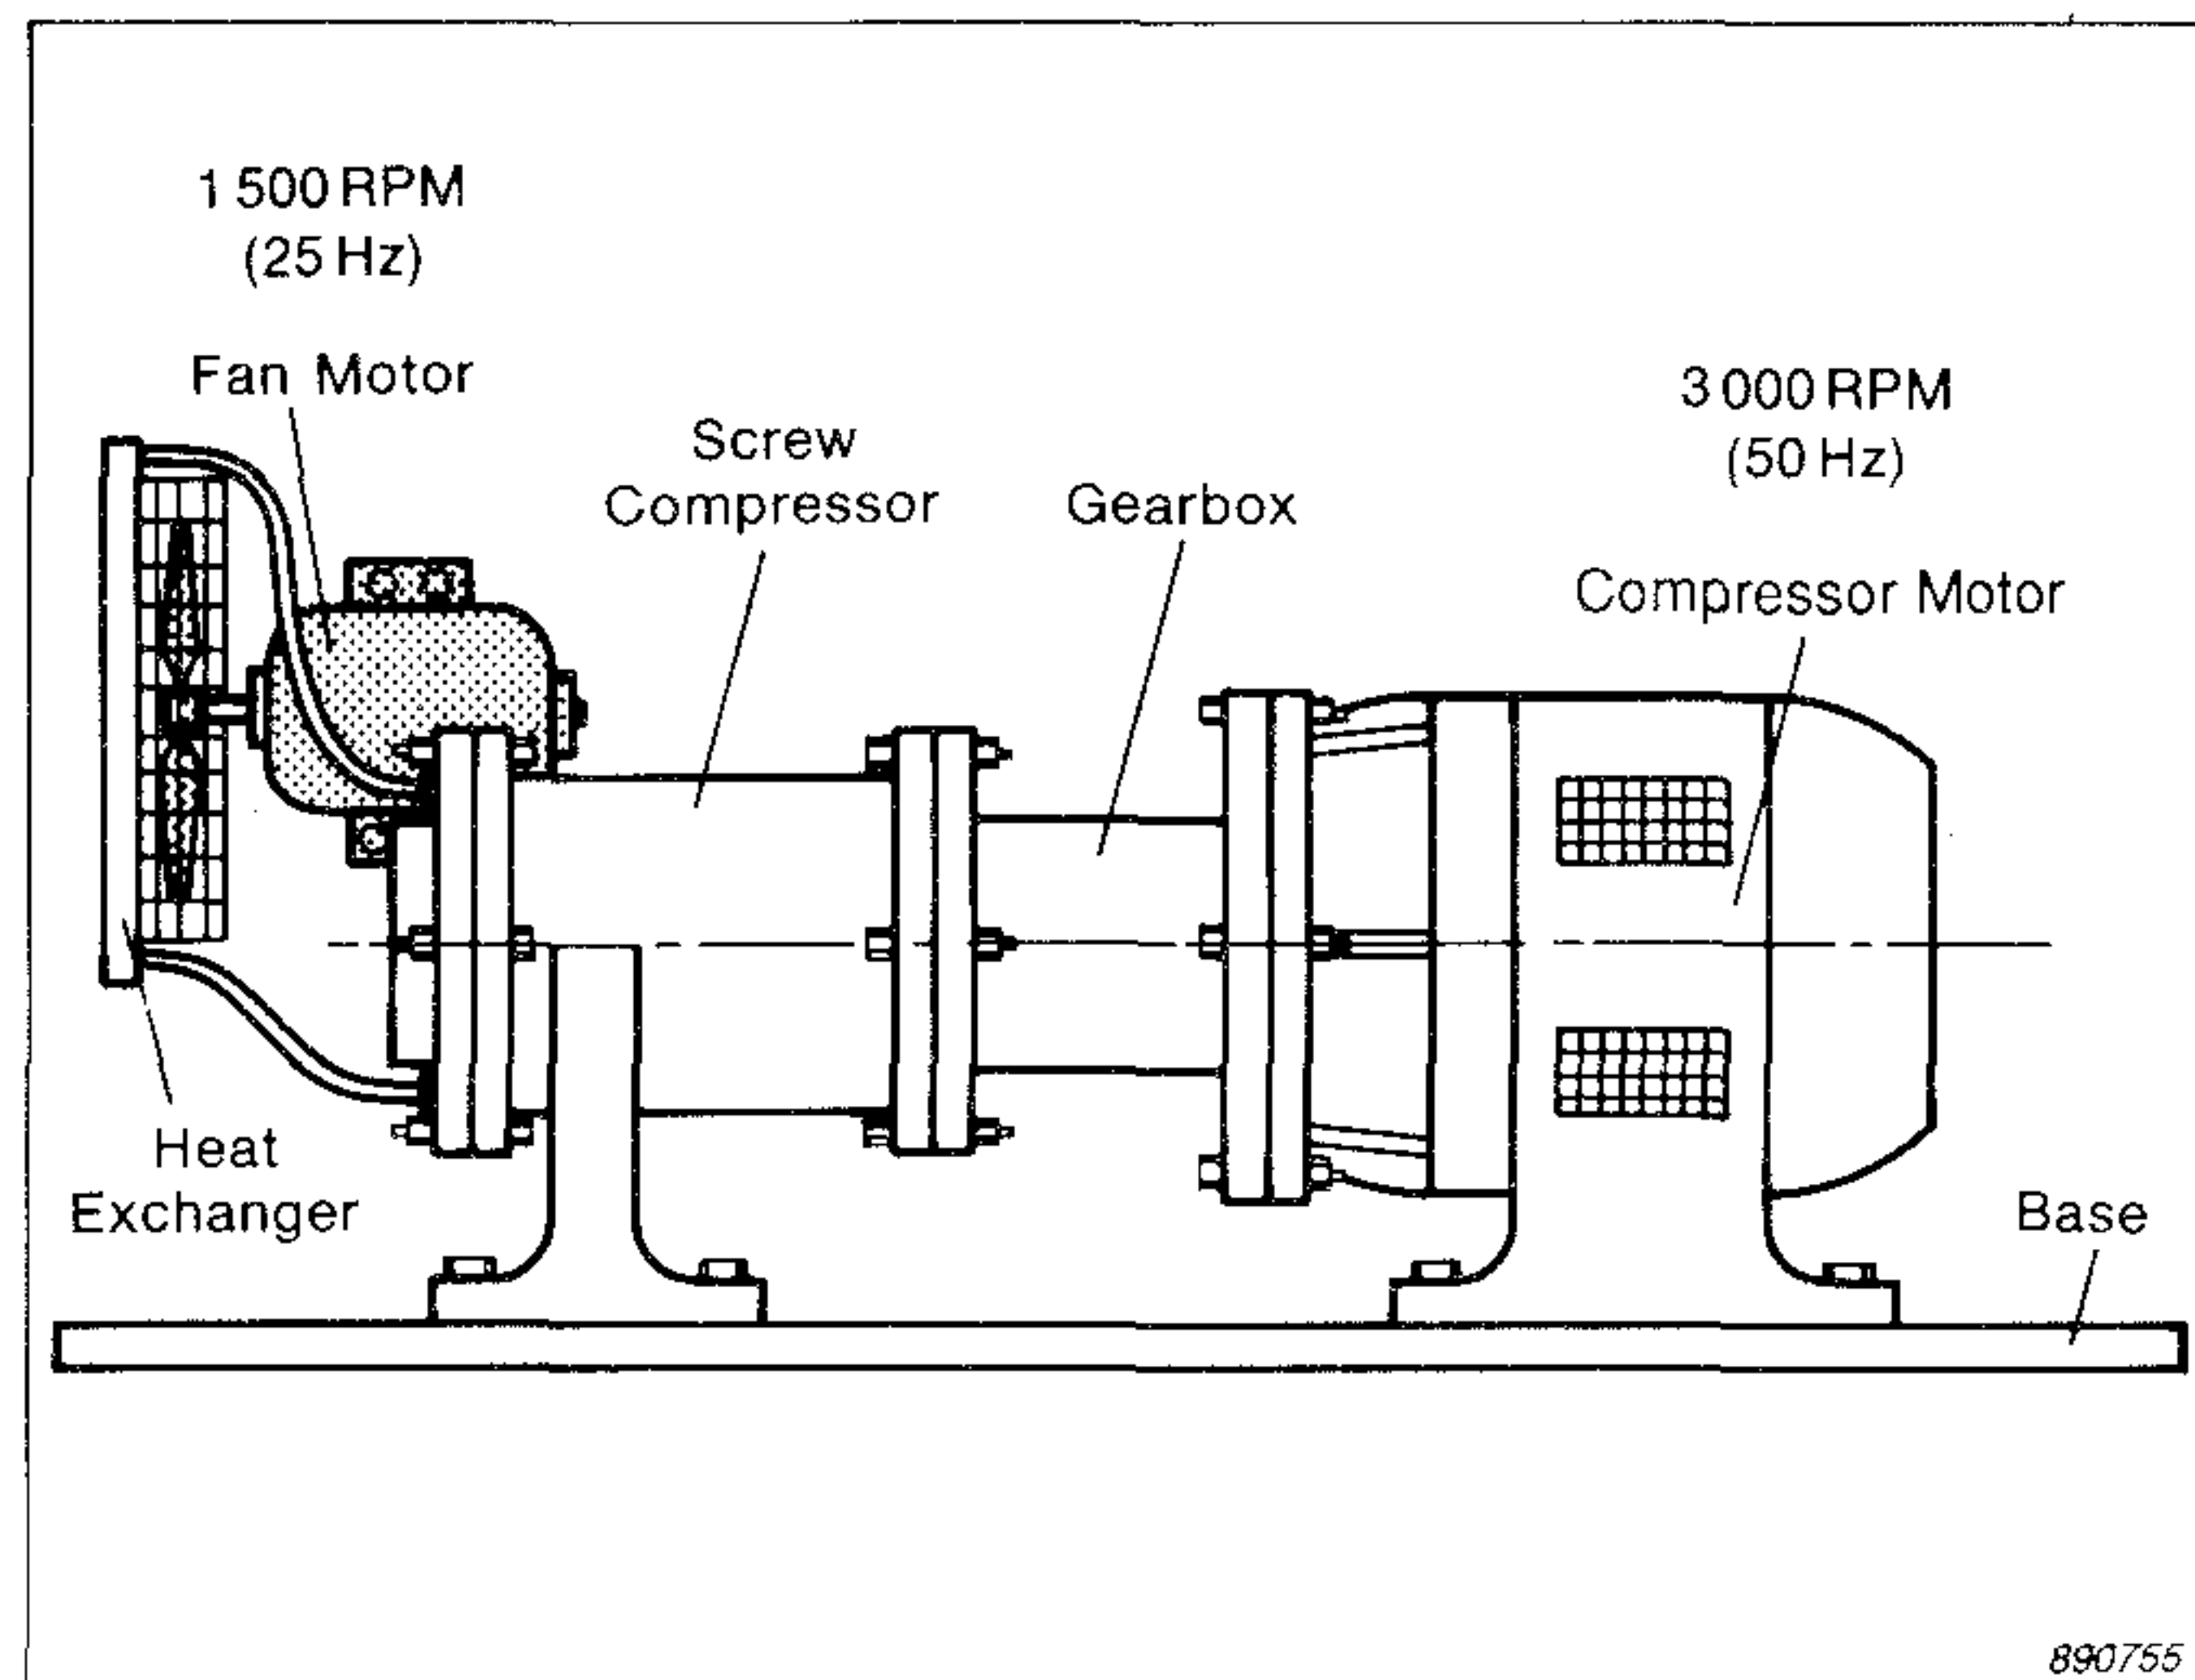
The compressor in question is mounted as shown in Fig. 14. When the company noticed high noise and vibration levels, they asked Groenpol to correct the problem. Groenpol found the spectrum shown in Fig. 15 when they mea-

When the bearing failed again soon afterwards, Groenpol began to suspect a structural problem. They measured on the frame and found excessive vibration at 25 Hz i.e. at the rotation speed of the cooling fan. They concluded that the fan was exciting a resonance frequency of the frame and they advised the company to modify the frame. The company ignored this advice and subsequently they paid the price when a seal failed in the compressor and oil entered the air system. All operations had to be stopped until the system was cleaned out.

Fig. 14. The compressor unit which consists of the compressor motor, gearbox and screw compressor, and a smaller motor which drives a cooling fan
