Machine-Condition Monitoring Using Vibration Analysis

A Case Study from an Iron-Ore Mine

by D.N.Brown & J.C.Jørgensen
Brüel & Kjær

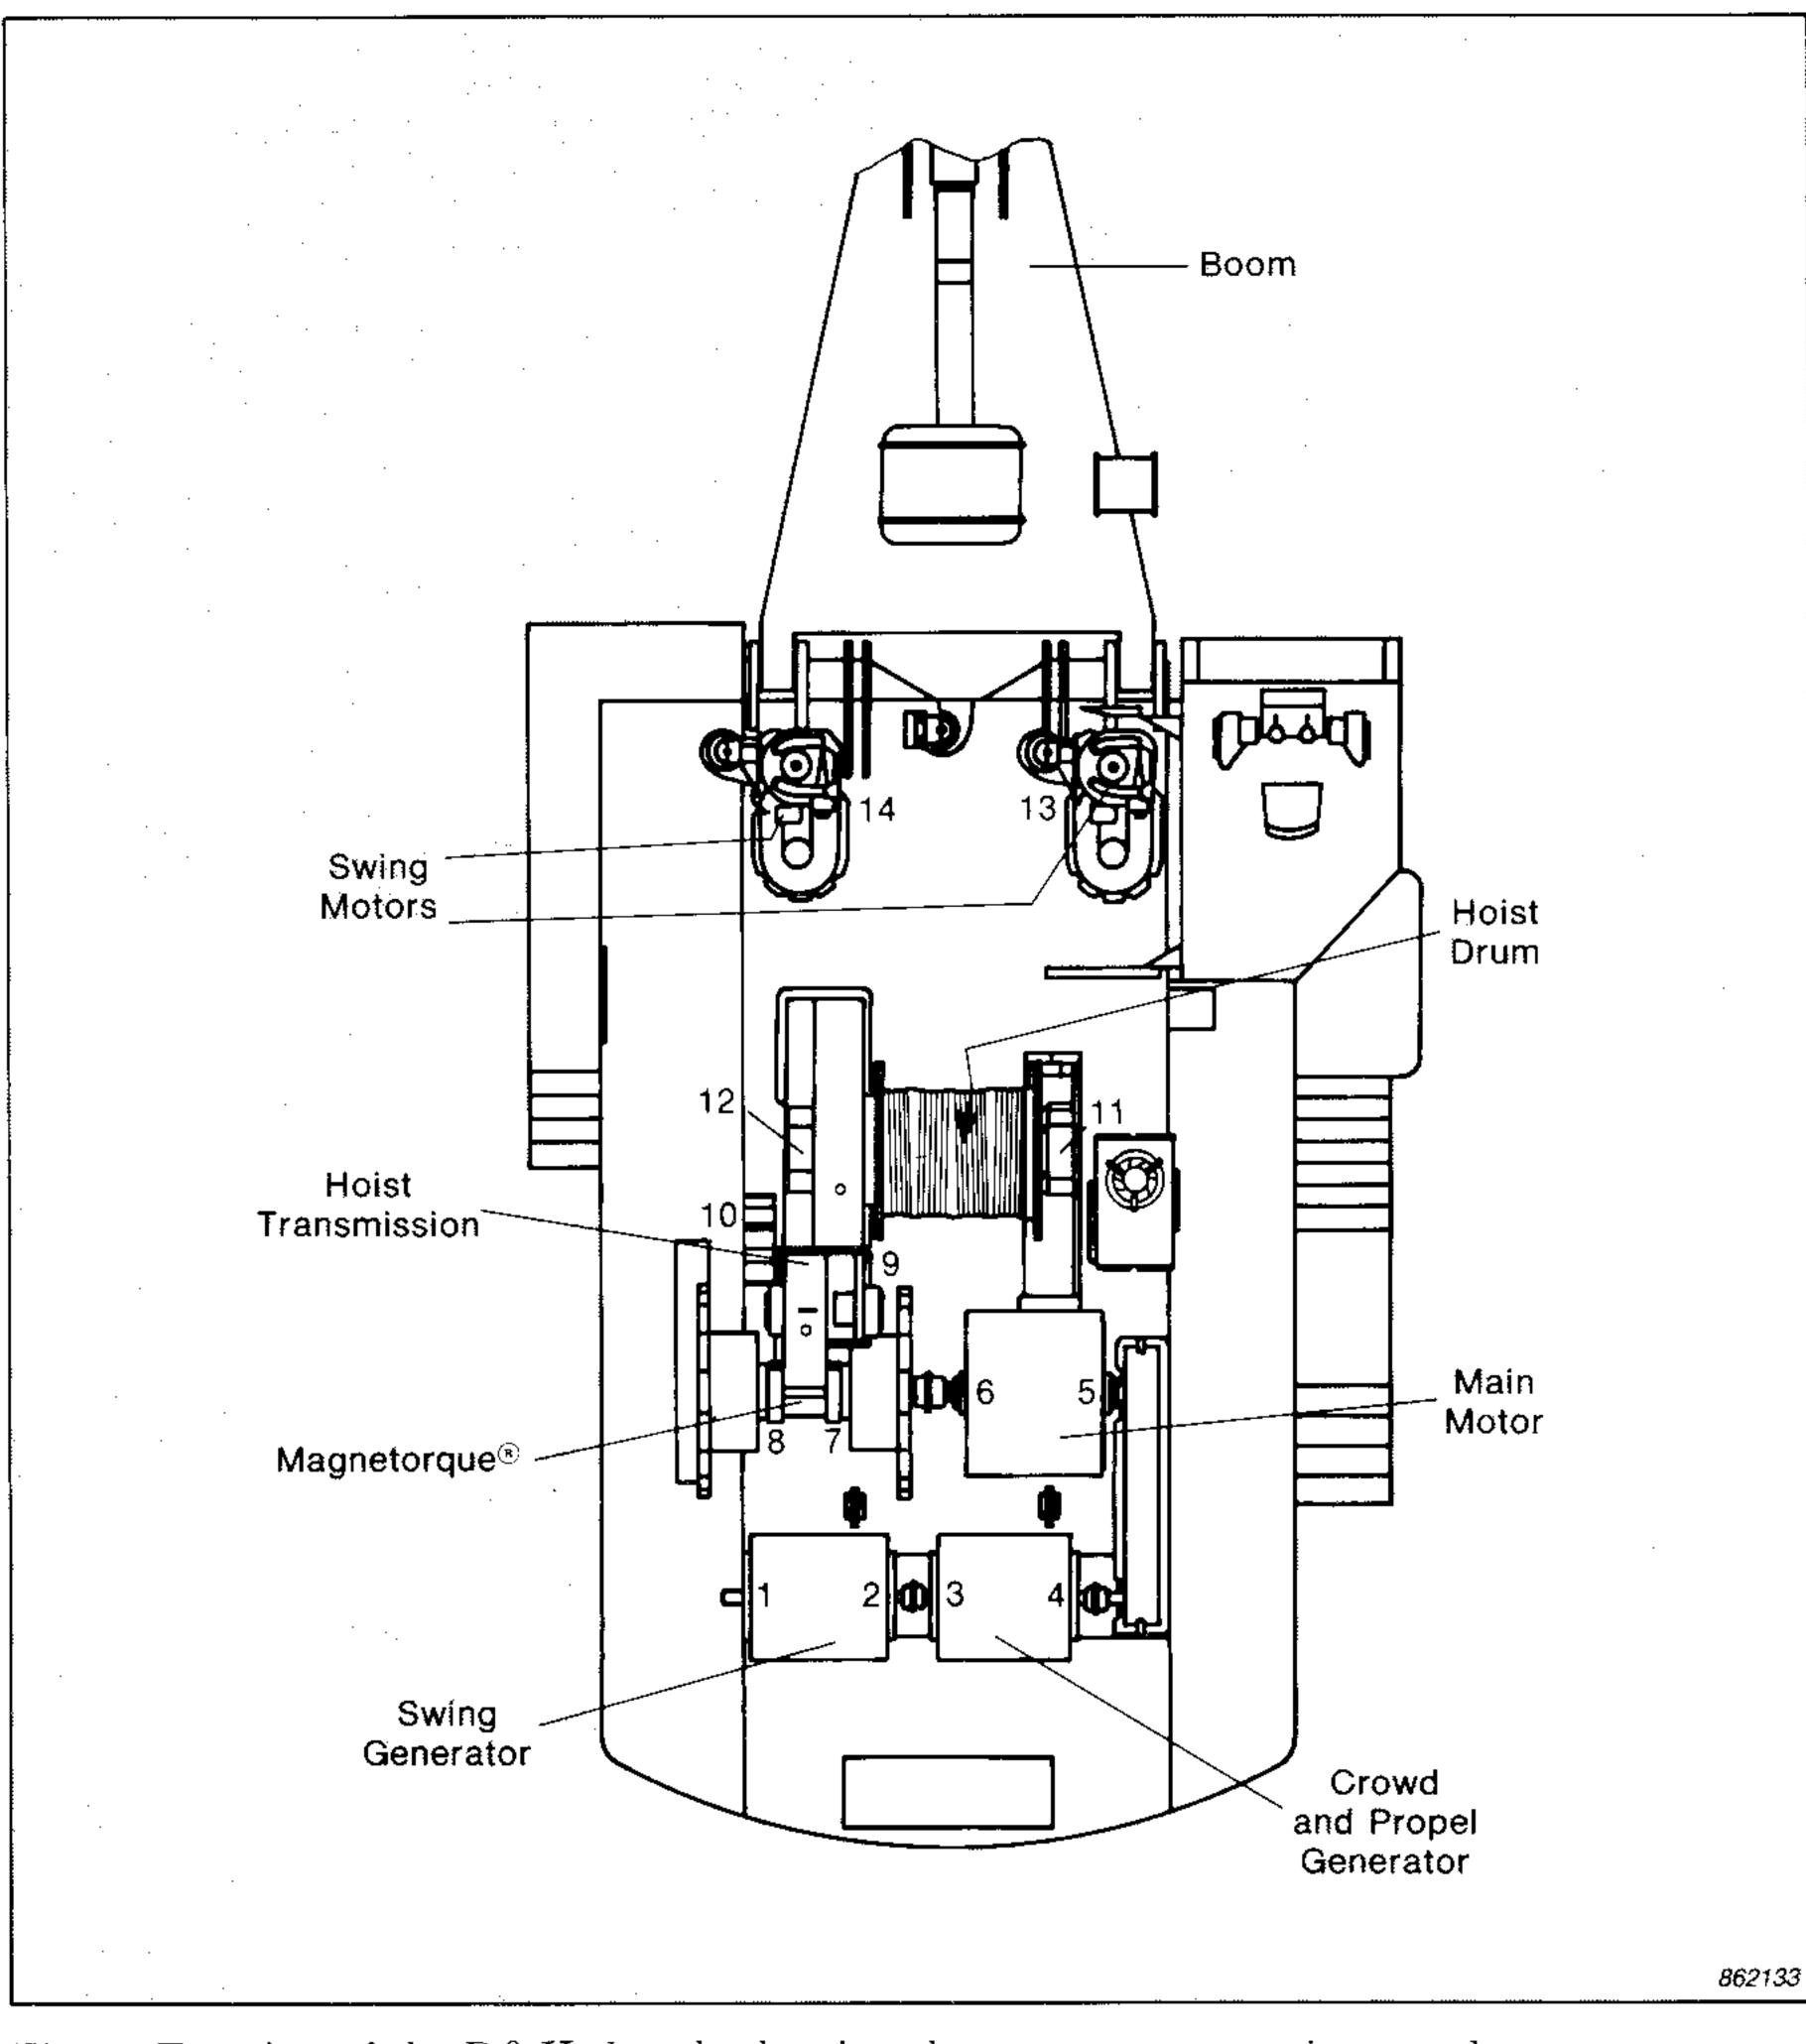
Fig. 4. Top view of the P&H shovels showing the measurement points used

Figs. 4 and 5 show the measurement points on the two types of MG-Sets found in the shovels. Vibration measurements are first made on a new or reconditioned MG-set when it is in the maintenance shop, prior to fitting in the shovel. A reference spectrum for comparison is then recorded. Immediately after installation in the shovel another reference spectrum is recorded (this is to check for installation problems, usually misalignment, and sometimes transportation problems). Measurements are then made on the MG-Set every 1000 to 1200 hours, and spectrum comparisons made with both the reference spectra (although the measurement interval is now being decreased to every 600 hours to obtain more results for better trend analysis).

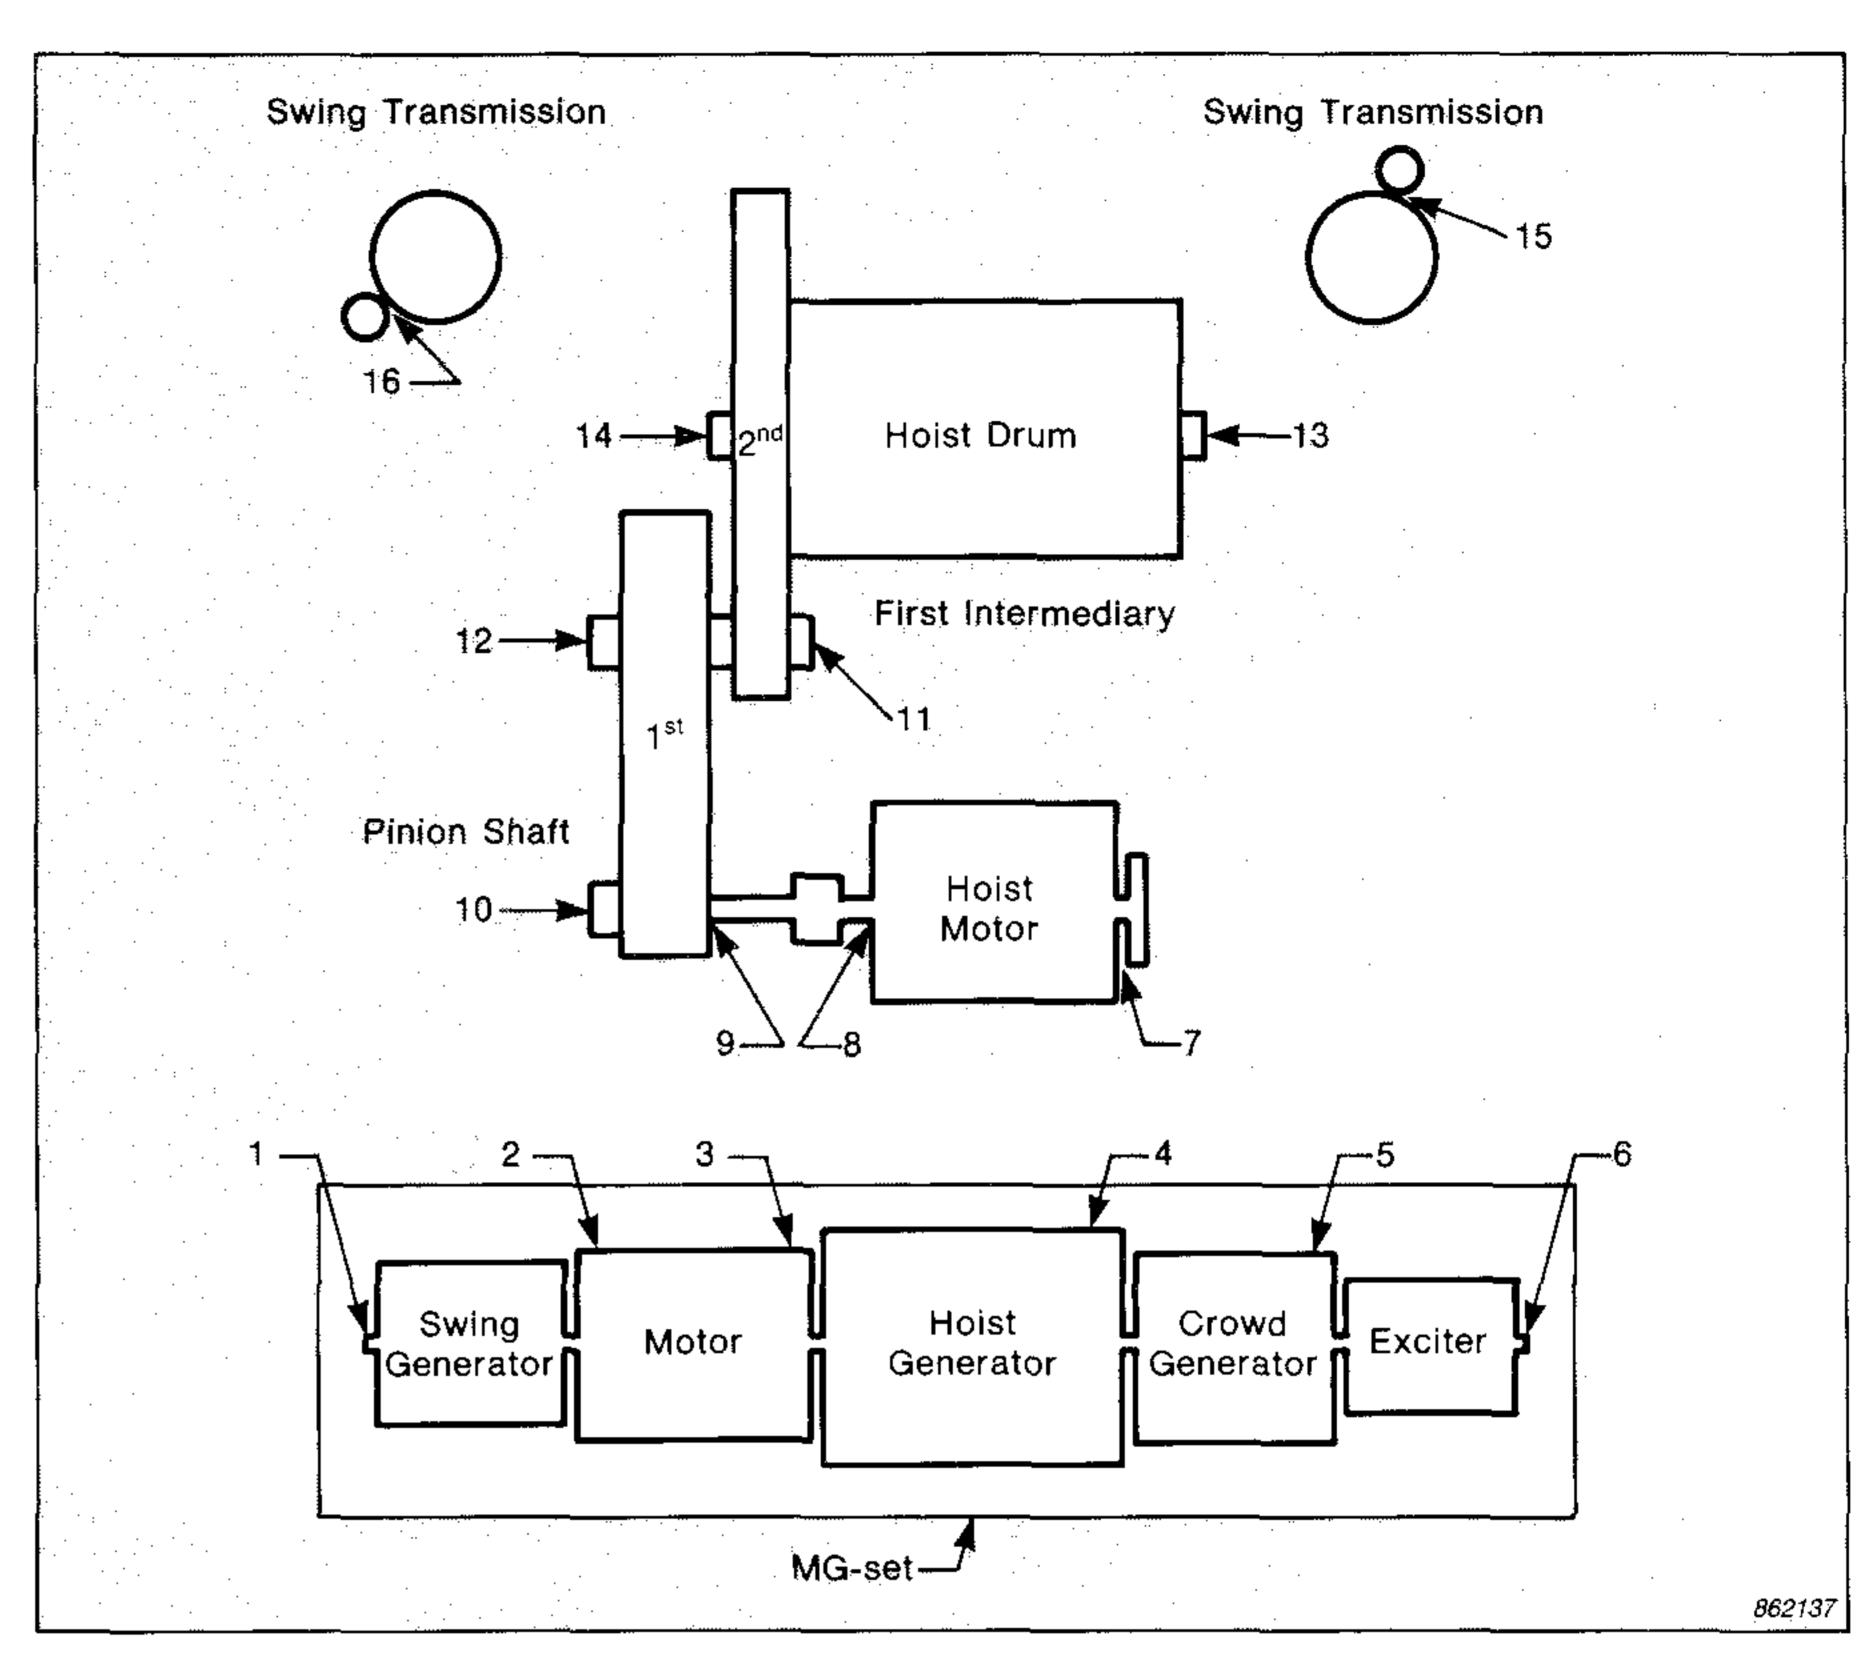
Fig. 5. Schematic (top) view of the Bucyrus-Erie and Marion shovels showing the measurement points used

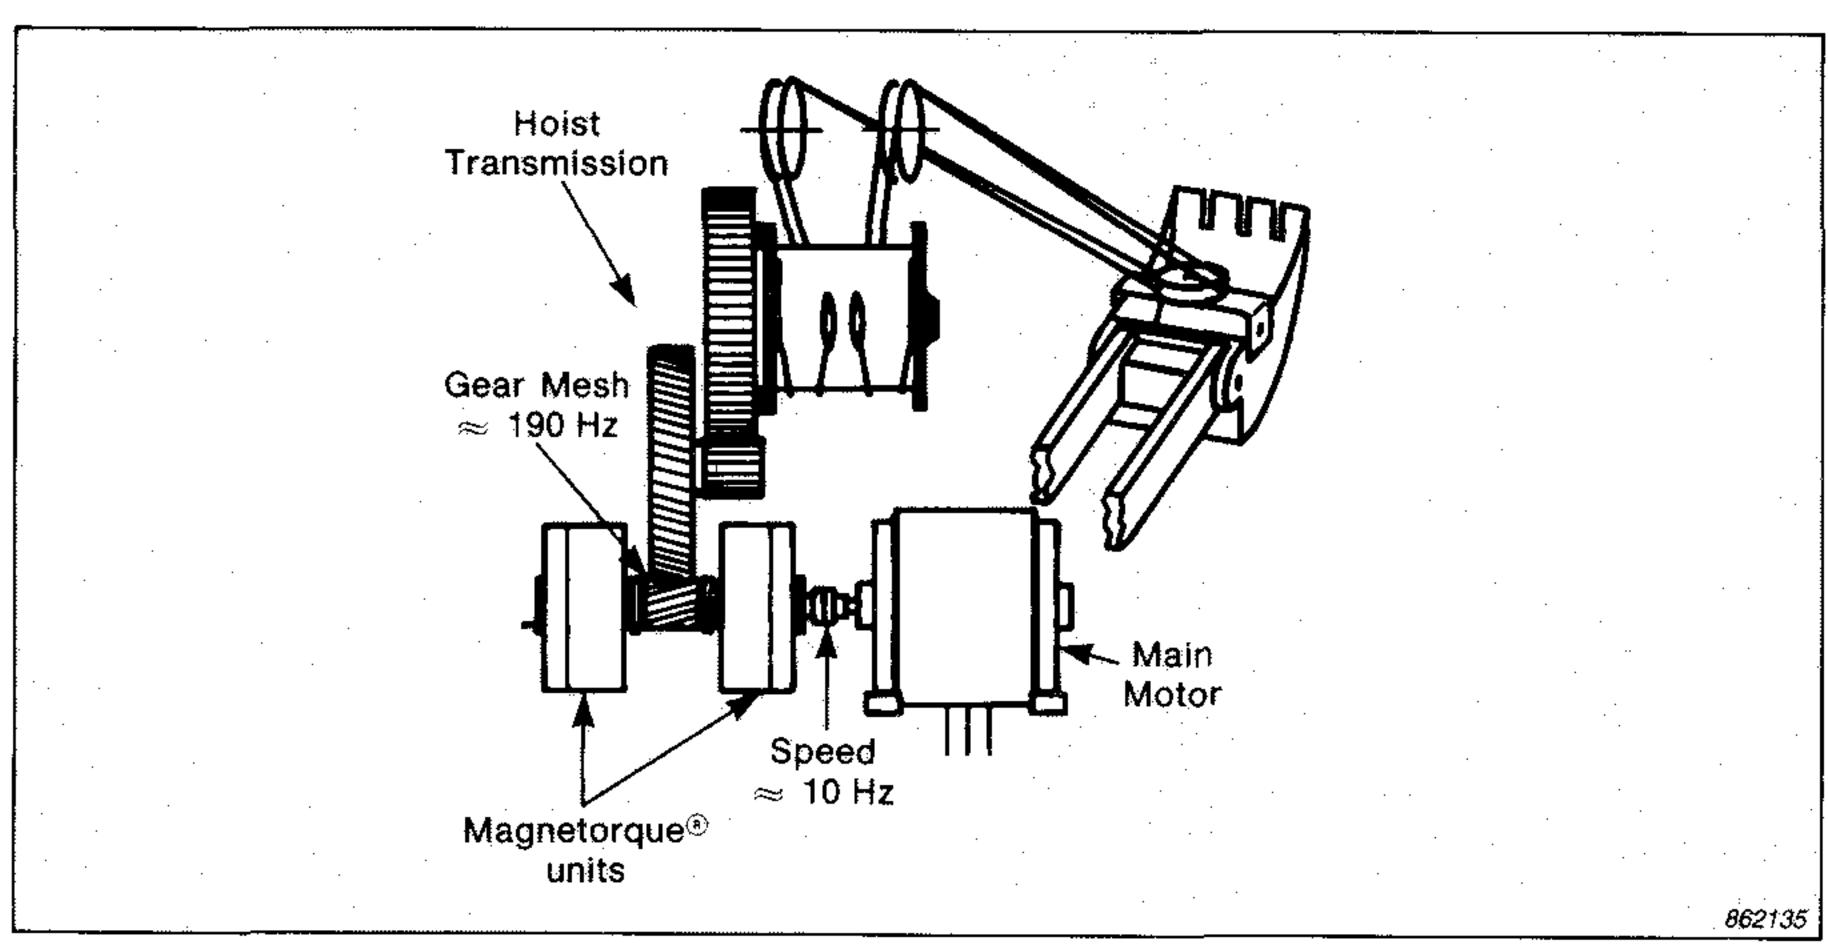
The Magnetorque® provides the drive for the hoist in the P&H shovels. This is a fairly complex piece of equipment which works on the principle of the eddy-current clutch. Fig. 10 shows the layout of the hoist's drive and transmission, and Fig. 11 the measurement positions.

Fig. 10. Layout of the hoist's drive and transmission

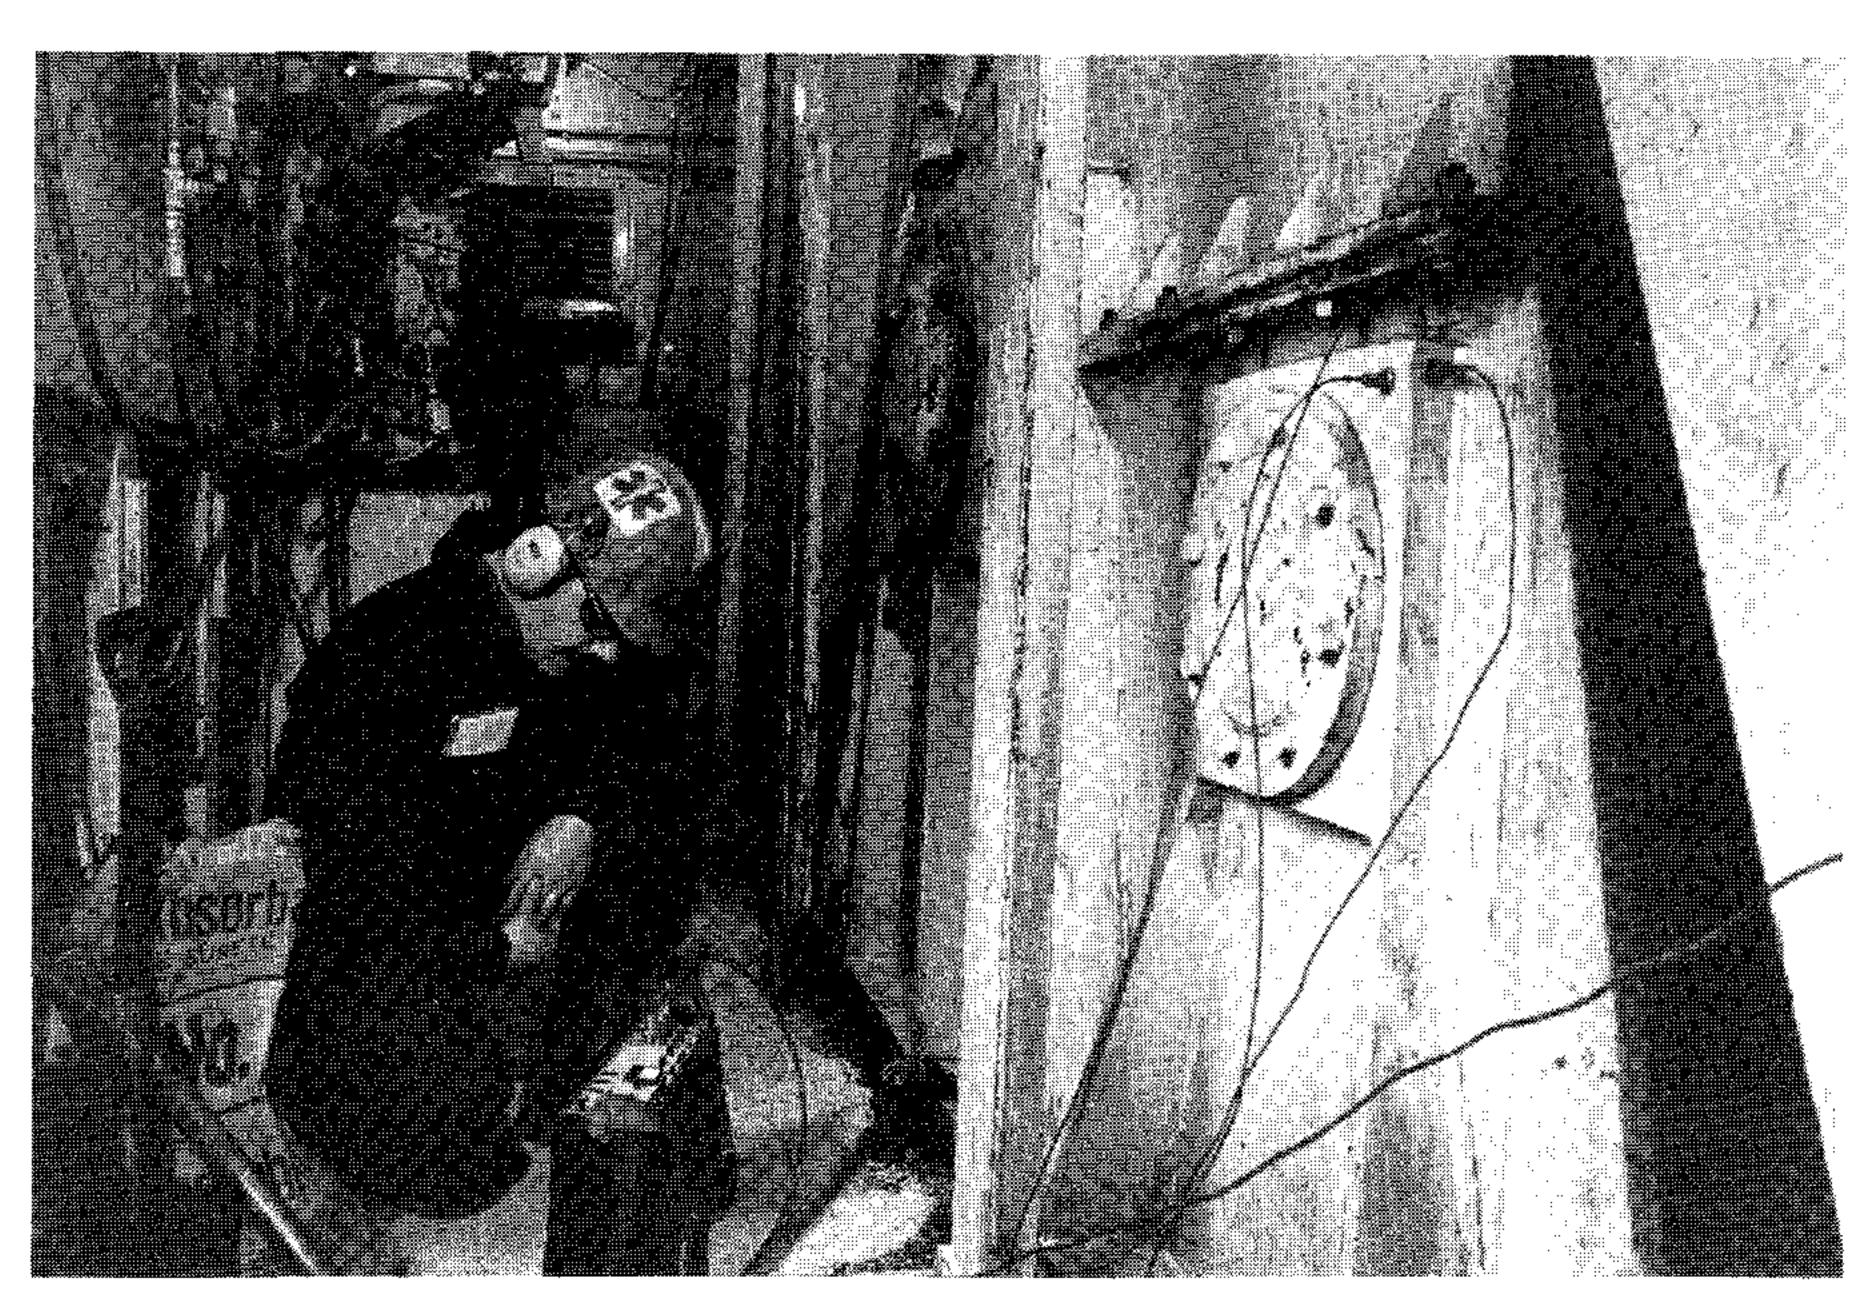
Fig. 11. Recording the vibration levels from the hoist-drive transmission. Measurements are made in the X, Y and Z directions

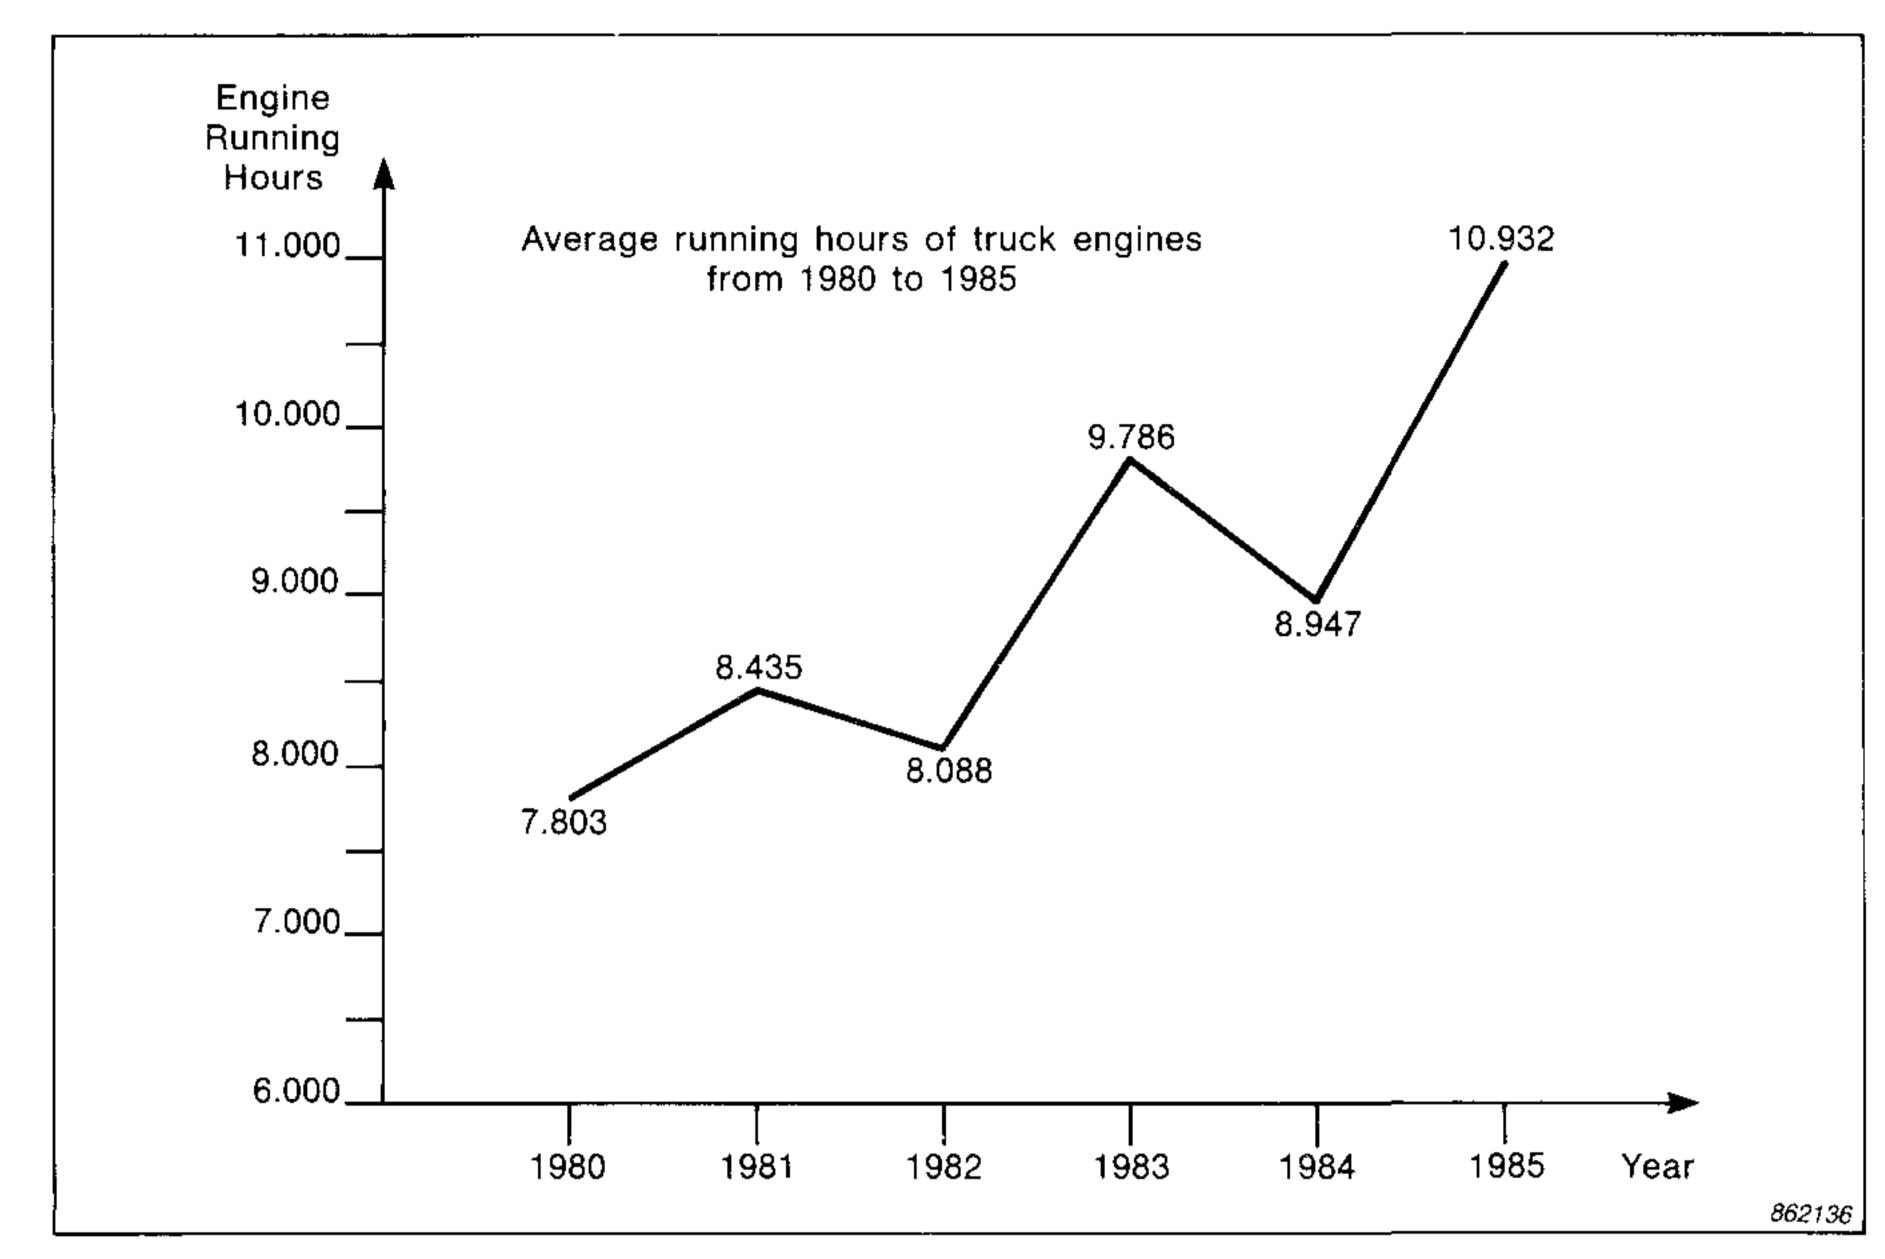
Up to 1980, the diesel engines were always changed at 10000 hours. Now, with the aid of condition monitoring, the running time has been considerably increased and at present two engines have been running for over 18000 hours. Fig. 13 shows the average life of a truck engine before being removed for reconditioning.

Fig. 13. Average life of truck engines

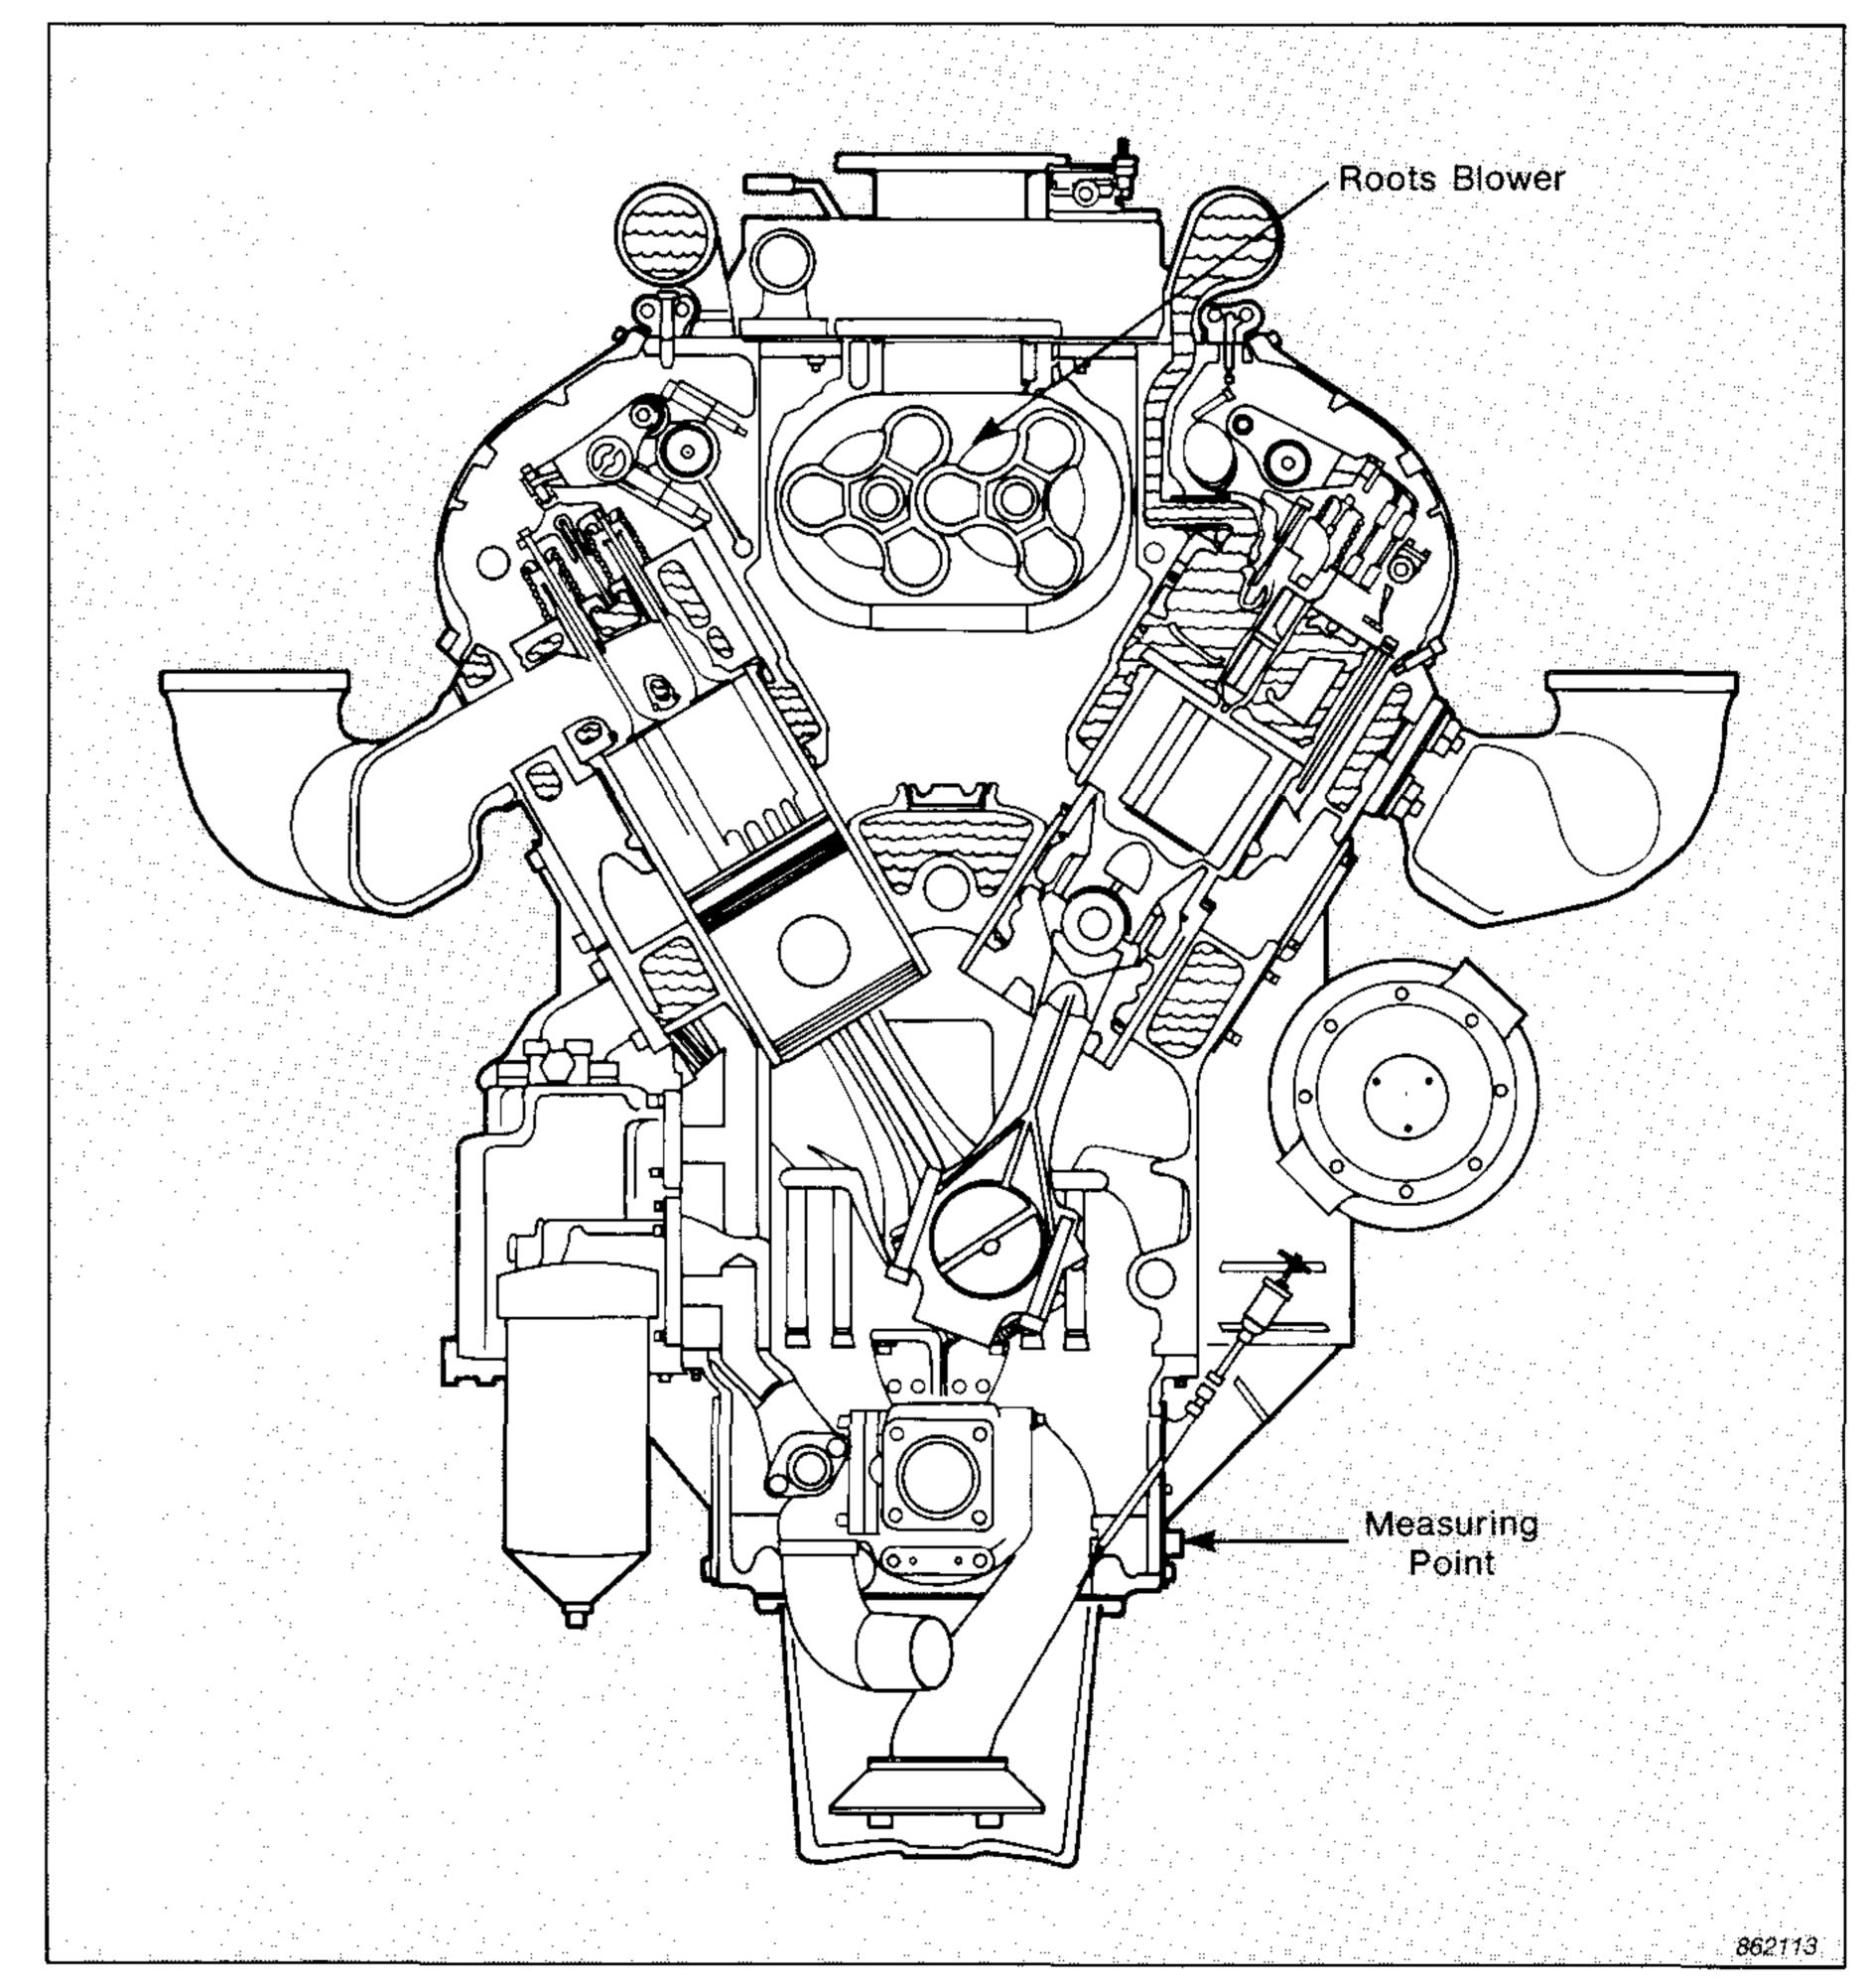
The problem first arose after a modification to the engine. This had an unfortunate side-effect which resulted in the blower-drive being constantly loaded and unloaded, and eventually wearing the splines at the end of the drive shaft. At this point, due to the seriousness of the problem, the life of a blower was restricted to 5000 hours. A decision was therefore made to monitor this problem with the aid of the vibration monitoring system. This proved successful and the blower life was raised to 15000 hours. The engine manufacturer was duly informed of the problem, and the design subsequently changed.

The problem was monitored using the spectrum comparison and trending facilities of the system. The problem could be characterised by an increasing vibration component at the rotation frequency of the blower drive-shaft. Fig. 14 shows trend curves made at this rotation frequency. The blower drive-shaft rotation frequency

Fig. 15. The measurement point used on the truck engines to detect the Roots Blower drive problem

was 73,6 Hz or 70,8 Hz depending on the engine-test speed. The upper danger level shown is the maximum vibration level tolerated before repair. Fig. 15 shows a schematic layout of the engine, indicating the position of the Roots Blower and the measuring point used to detect the fault. Fig. 16 shows the blower drive-shaft.

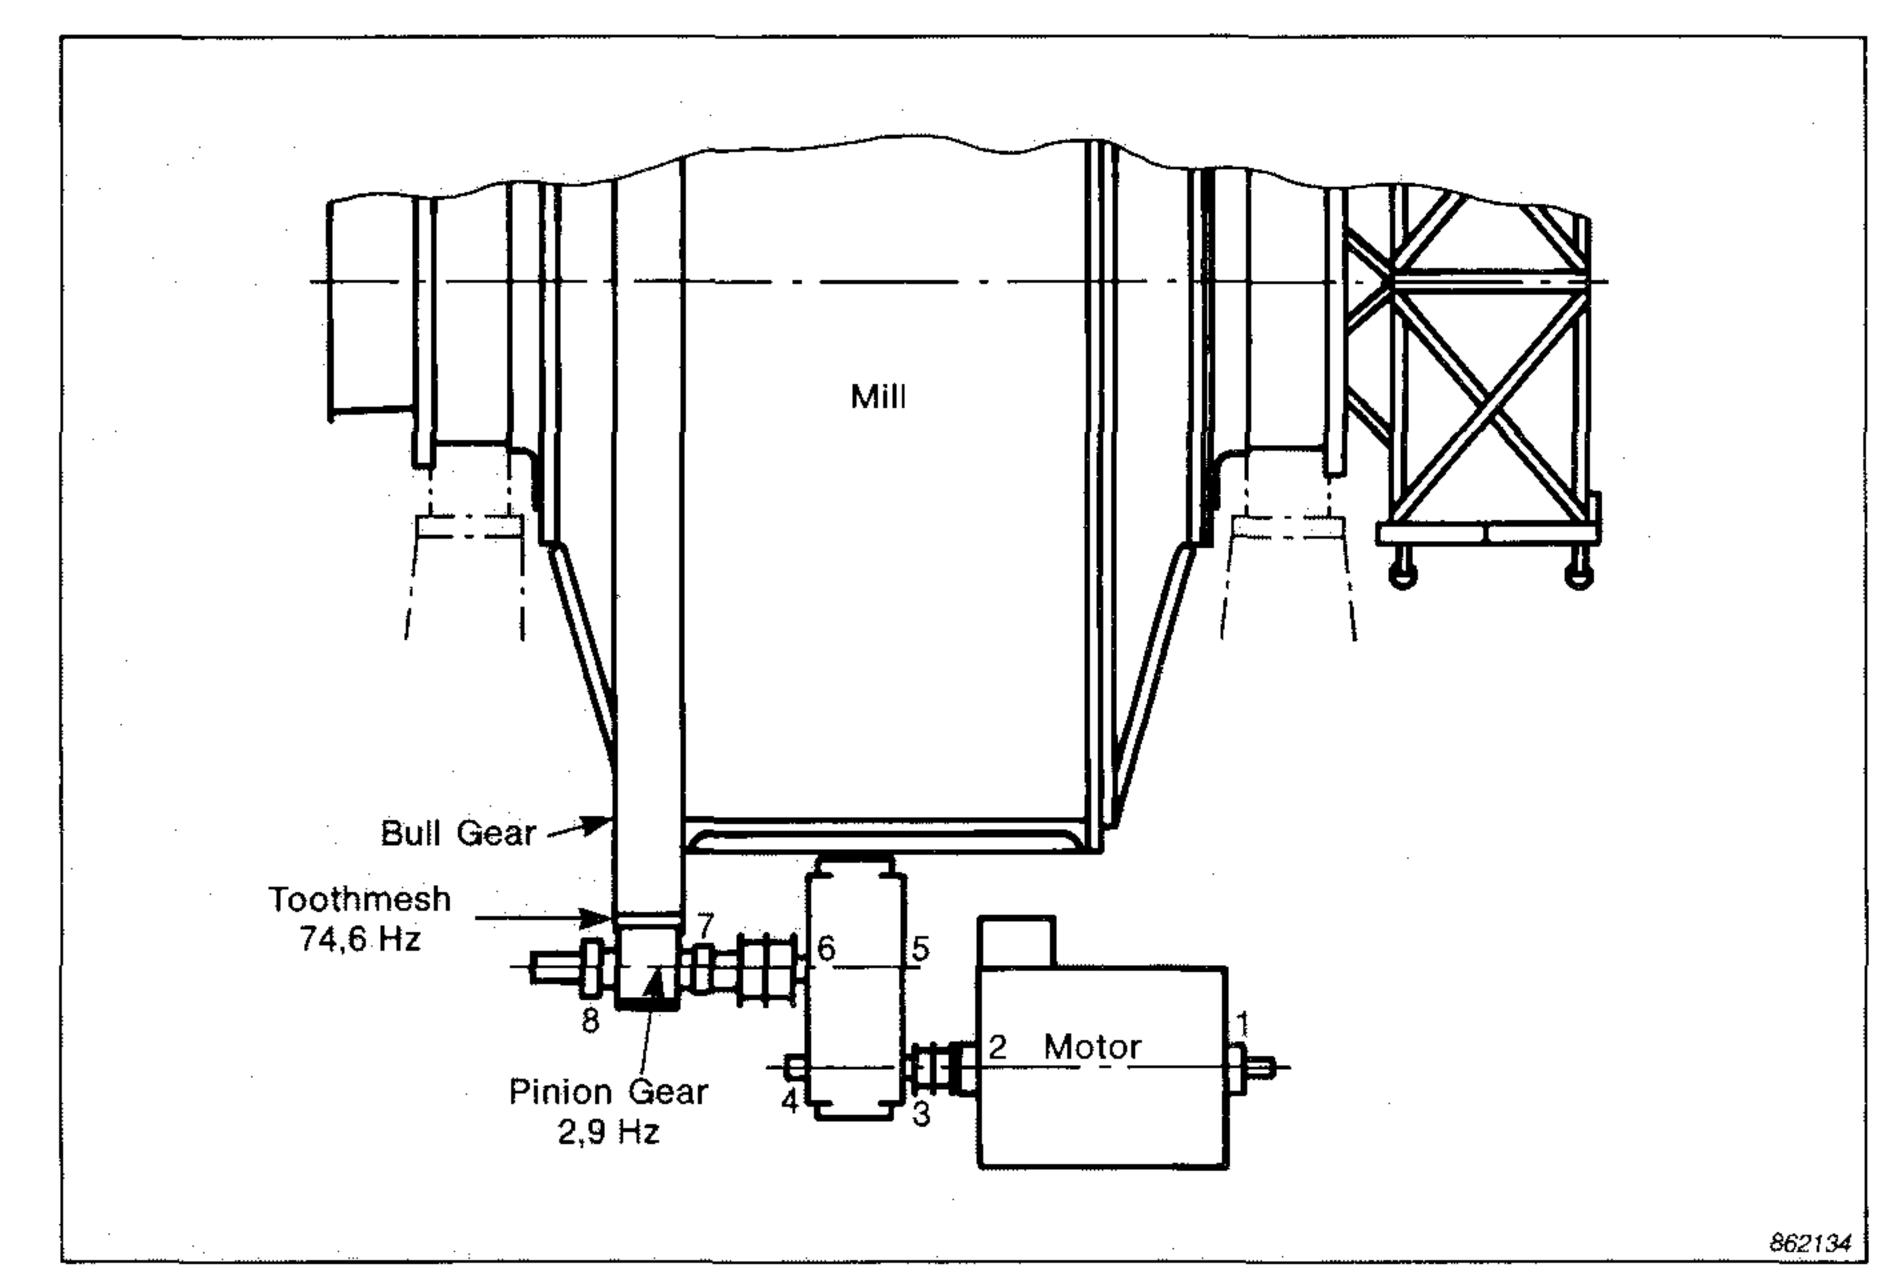
The autogeneous mills are 32 ft diameter cascade type grinding-mills, powered by two 3000 HP motors coupled by gearboxes, see Fig. 21. Because of their importance to the concentrator operation, they have number one priority in the plant. Vibration measurements at 16 measuring points are taken from the drive section of one mill at weekly intervals.

The most common types of problem encountered are due to installation misalignment, bearing failures and gearing problems. Another problem which occasionally occurs is that the dowel-pins locating the bearing pillar-block for the drive often break, thus causing misalignment between pinion and bull gear.

Fig. 21. Measuring points on the autogeneous mill drive
