Envelope analysis – the key to rolling-element bearing diagnosis

by Joëlle Courrech and Mark Gaudet
Brüel & Kjær

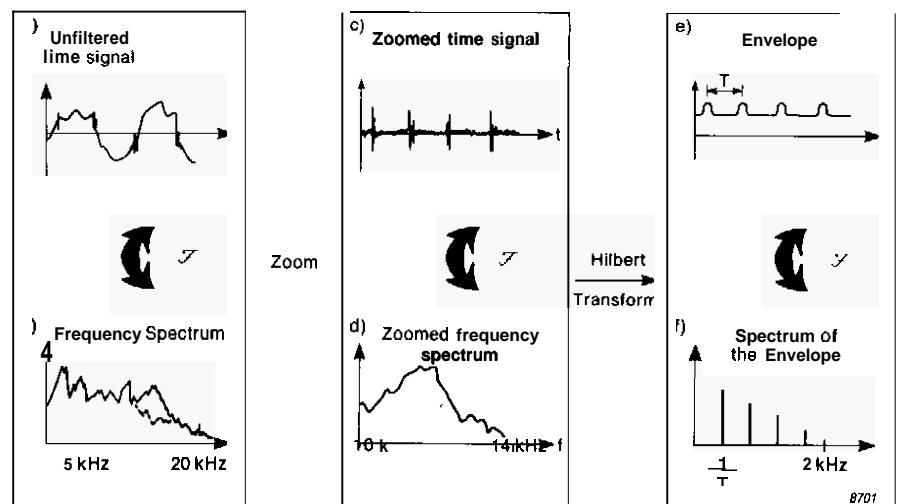
The 2032/34 uses zoom to extract the region of the resonance excited by the hearing-fault, from the frequency spectrum. Then the Hilbert transform is used to produce the envelope of the filtered time signal.

The envelope-analysis principle of the 2032/34-based system is shown on the previous page:

(a) is the time signal of the vibration measurement, from the bearing housing.
(h) is the corresponding frequency spectrum, which is related to the time signal by the Fourier transform. An increase in level in a particular frequency range (as indicated by the dotted line) is detected when a structural resonance has been excited by a fault.
(d) is the frequency spectrum extracted by zooming around this particular frequency range. It contains the structural resonances which have been excited by the impacts produced by the fault(s).

(c) is the corresponding time signal, which contains only the resonance frequency which is modulated by the impact frequency.

(e) In the analogue process, the time signal is then rectified and smoothed by a detector to produce the envelope of the time signal. Consequently, the envelope contains only the low modulation-frequency component relating to the impact rate(s). The 2032/34 produces a very accurate representation of the time signal, which is free from the limitations of a smoothing circuit, by using the Hilbert transform to calculate the magnitude of the time signal.

(f) The time envelope is then frequency analyzed to establish the impact

frequencies. This reveals the presence of a bearing fault. The Dual-Channel Analyzer Type 2032/34 computes the frequency spectrum of the envelope of the zoomed time signal, when controlled either by a computer with the Envelope Analysis Program for the 2032/34 or by Graphics Recorder Type 2313 with Application Package BZ7006.

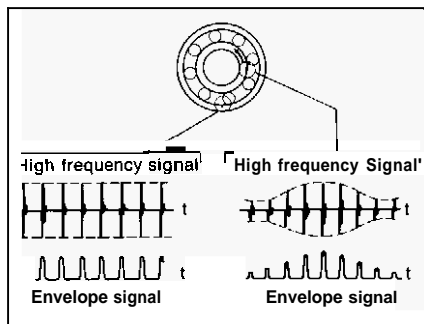
Fig. 2. The modulation effect caused by a fault on the stationary and on the rotating race.

Figure 2 illustrates the difference between the signal produced by a fault on the stationary race and a fault on the rotating race. In the first case, the fault will always be subject to the same load and the resulting impacts will have equal amplitudes. In the second case, the fault will rotate in and out of the loaded region, causing modulation of the impact amplitudes by the rotation speed of the shaft.

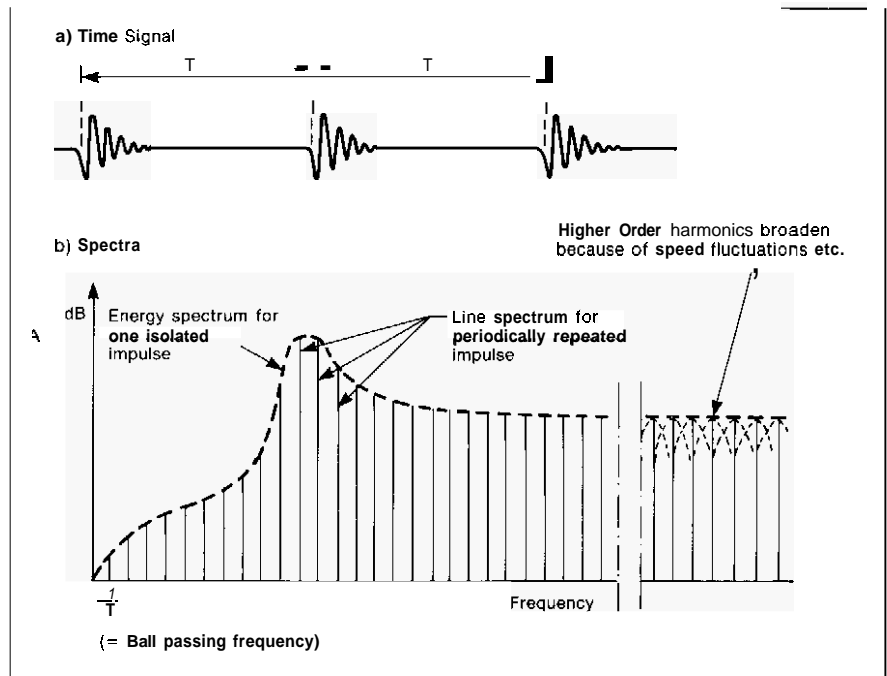
Fig. 1. Frequency spectrum for an idealized impact fault.

Figure 1 illustrates the result of analyzing an impactive fault exciting only one resonance. The dotted line represents the energy spectrum of one pulse, that is the frequency response of a single-degree-of-freedom system. If the pulses are identical and are uniformly spaced by T , the spectrum of the impact series would be a line spectrum comprising all harmonics of the repetition frequency $1/T$, with the largest amplitudes in the vicinity of the resonance frequency. The repeti-

tion frequency could be determined by zooming in this region and establishing the harmonic separation. In practice, there are small differences between the pulses and in their spacing; as a consequence the higher order harmonics broaden and eventually merge. As an example, a speed fluctuation of 0,1% would cause merging around the thousandth harmonic. At low frequencies the influence of speed fluctuations is very small. However, the harmonic pattern of the hearing fault(s)

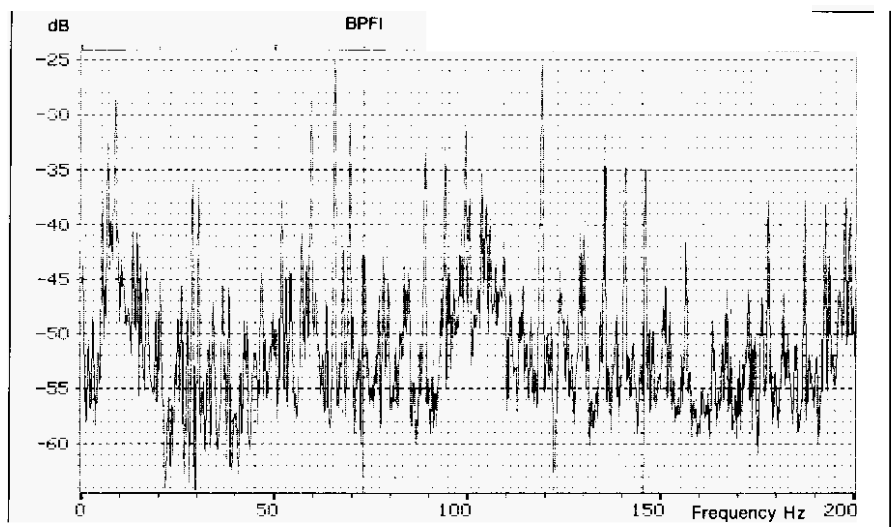
Fig. 3. Baseband vibration spectrum up to 200 Hz for a faulty ball-bearing. It is very difficult to detect any of the bearing characteristic frequencies.

The frequency spectrum of the acceleration signal for the ball bearing is shown in Fig. 3. This is the region in which we would expect to detect the bearing characteristic frequencies for a faulty bearing. It's very difficult to detect any of the bearing frequencies in the baseband measurement because other vibration sources have produced more dominant frequency components.

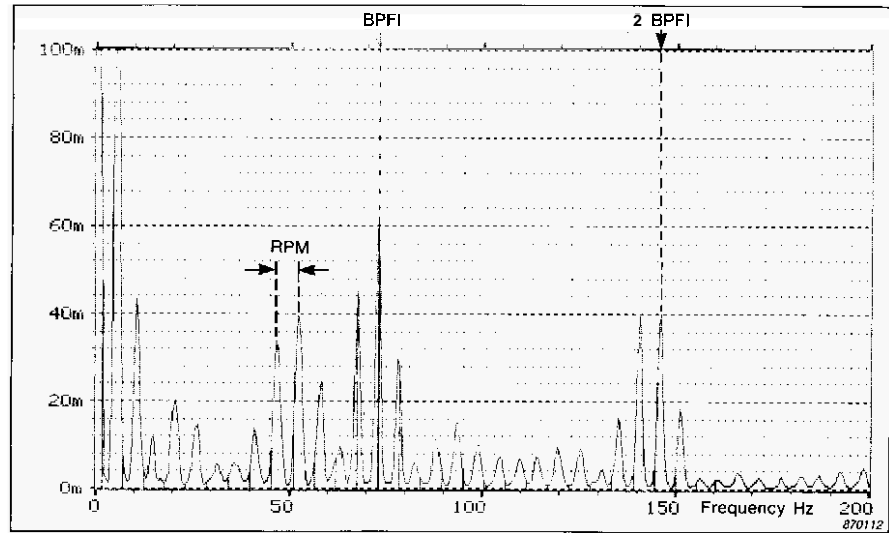
Fig. 4. Envelope of the frequency analysis (zoomed around 9kHz) of the faulty ball-bearing. The BPFI and sidebands modulated by the RPM are clearly evident.

Consequently, 2032/34-based envelope analysis was used to produce the envelope of the zoomed time signal. The corresponding frequency spectrum was calculated using the Graphics Recorder Type 2313 together with the BZ7006 Application Package, and this is shown in Fig. 4. This clearly shows the BPFI at 73Hz and the second harmonic at 146Hz; the sidebands are caused by modulation due to the rotation speed which is 5.3Hz. This modulation occurs as the fault moves through the loaded area of the bearing.

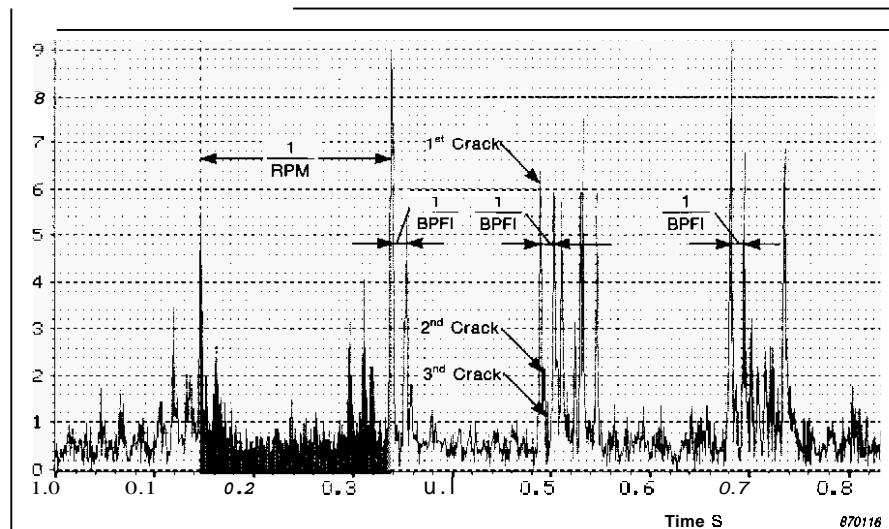
Fig. 5. The envelope's time-signal showing a series of impacts repeating at the rotation frequency. Close inspection reveals three closely-spaced peaks, relating to three transverse cracks on the inner race.

The envelope of the zoomed time-signal is shown in Fig. 5. This reveals a series of peaks repeating with a period equal to $1/\text{BPFI}$. Each time a ball passes a crack, an impulse is produced, which results in a peak. On examining Fig. 5 more closely, three more-narrowly spaced peaks are evident. These peaks originate from three transverse cracks on the inner race. The three-peak pattern is repeated as balls pass over the three cracks. These impacts are clearly amplitude modulated with a period equal to $1/\text{roller-rotation frequency}$.

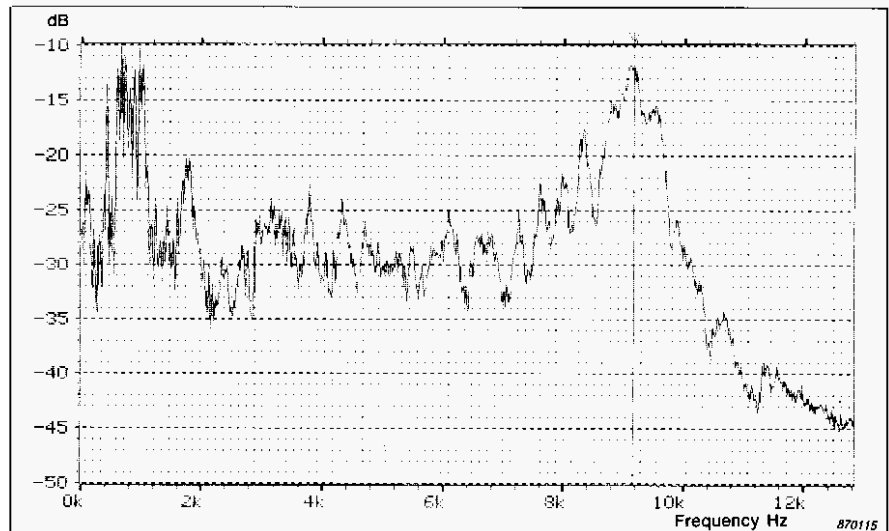
Fig. 6. Response function (0-12.5kHz) produced by a hammer test, showing the structural resonances for the bearing housing. The resonance at 9kHz was used for the zoom analysis.

As no reference spectra were available for the paper-drier, a hammer test was used to produce the frequency response to an impact. This reveals the structural resonances of the bearing, which are shown in Fig. 6. The structural resonances are concentrated in the 8kHz to 10kHz region, which is the region most suitable for zoom analysis as it offers the greatest signal-to-noise ratio.
