Application Notes

Quality-control of Bearings Using Vibration Monitoring

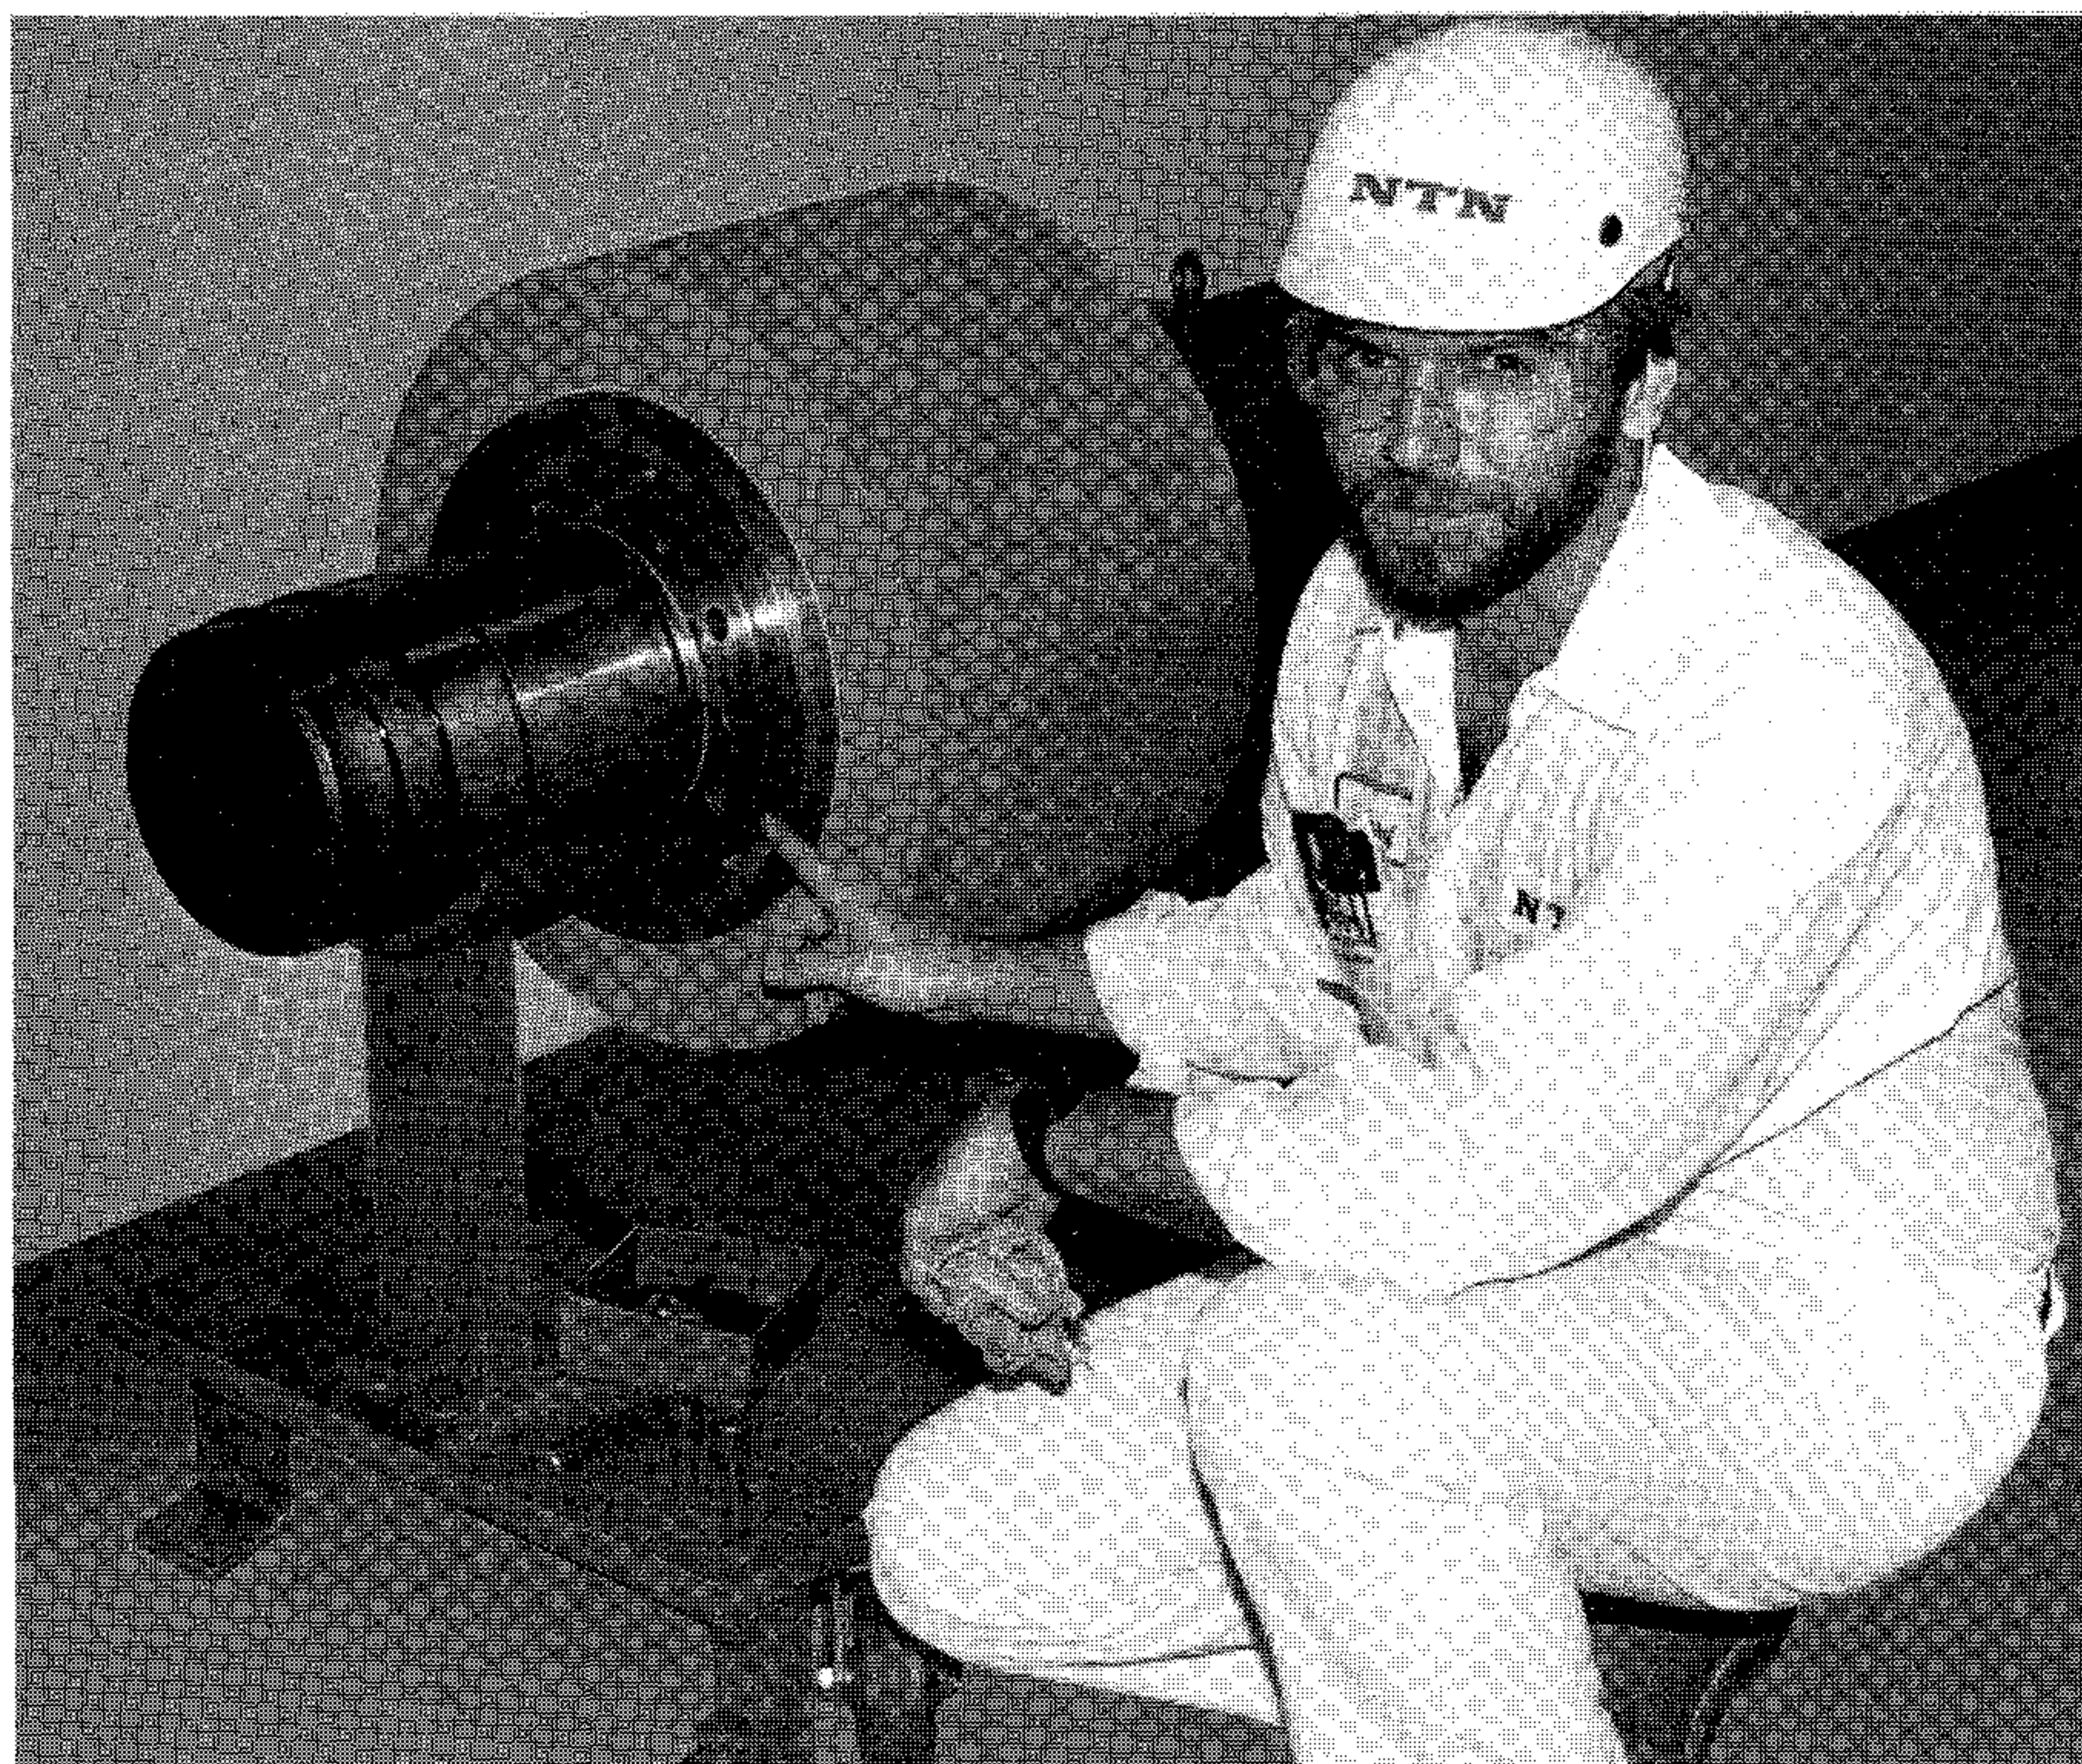
Bearing quality greatly depends upon the quality of the grinding wheel. By permanently monitoring vibrations from the grinding wheel, a tight check can be kept on its condition
