Vibration Analysis at a Ski Resort

The Portable Vibration Analyzer Type 2515 is a rugged, sophisticated analysis tool for identifying and diagnosing vibration problems. This Application Note outlines how the Type 2515 was used at a Rocky Mountain ski resort to monitor the condition of chairlift bearings, to test lift chairs for structural flaws, and to record and examine vibration spectra from final gear drives and from snow-making equipment.

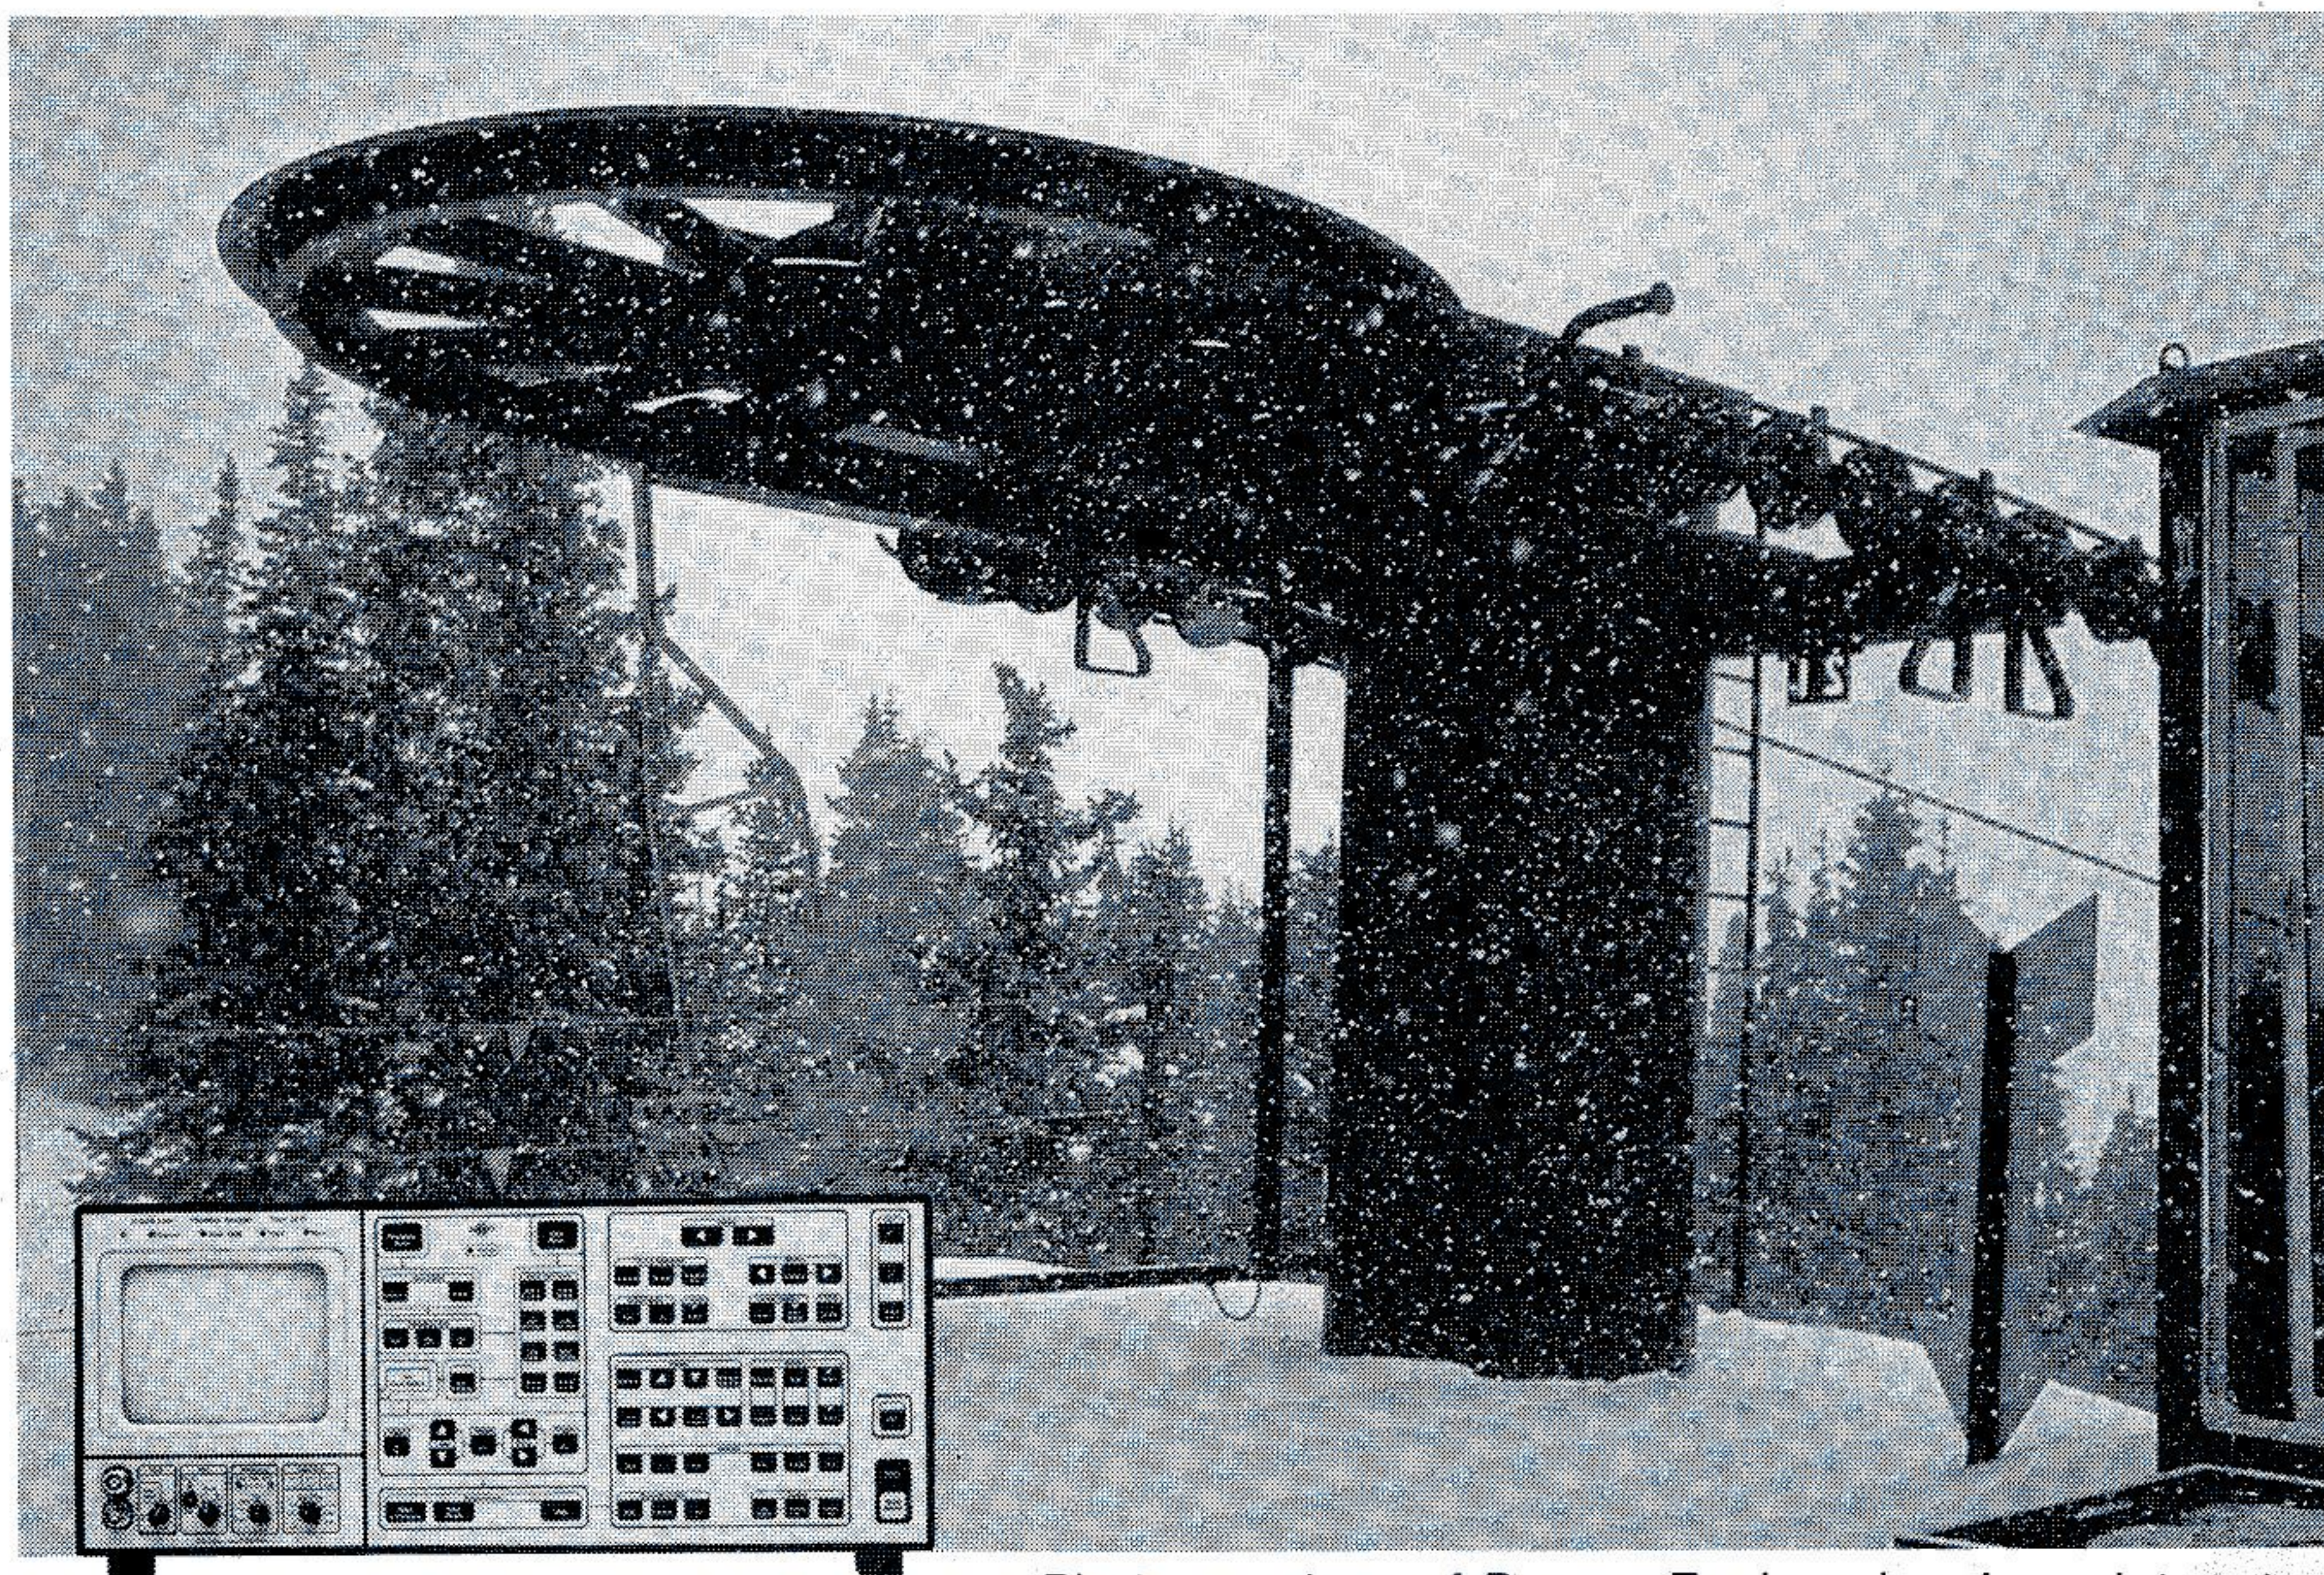
A typical bullwheel at a ski resort. Monitoring the bullwheel bearing-vibration with the Type 2515 Vibration Analyzer can give early warning of bearing faults

One of the critical spots on a chairlift is the bullwheel bearing. A typical bullwheel is shown in the photo above. Denver Engineering Associates used

the Type 2515 to measure the vibration spectrum of this bearing. This spectrum can give an accurate picture of the condition of the bearing. A monitoring programme can easily be set up to check the condition of the bearing on a permanent basis.

Since the tower that the bullwheel is mounted on experiences many types of vibration, including the loading and unloading of the chairs, measurements should be taken at the same point in the rotation cycle of the bullwheel. Synchronous sampling reduces such extraneous noise while retaining important bearing information. This can be done using a trigger source such as B&K's Photoelectric Tachometer Probe MM 0024, which is powered directly from the Type 2515.

Powerful memory functions in the Type 2515 can be used to store baseline vibration data for each bearing. This data can be compared with new measurements on a regular basis. Using an accelerometer, the Type 2515 can easily detect the small changes in high frequency vibration typically as-

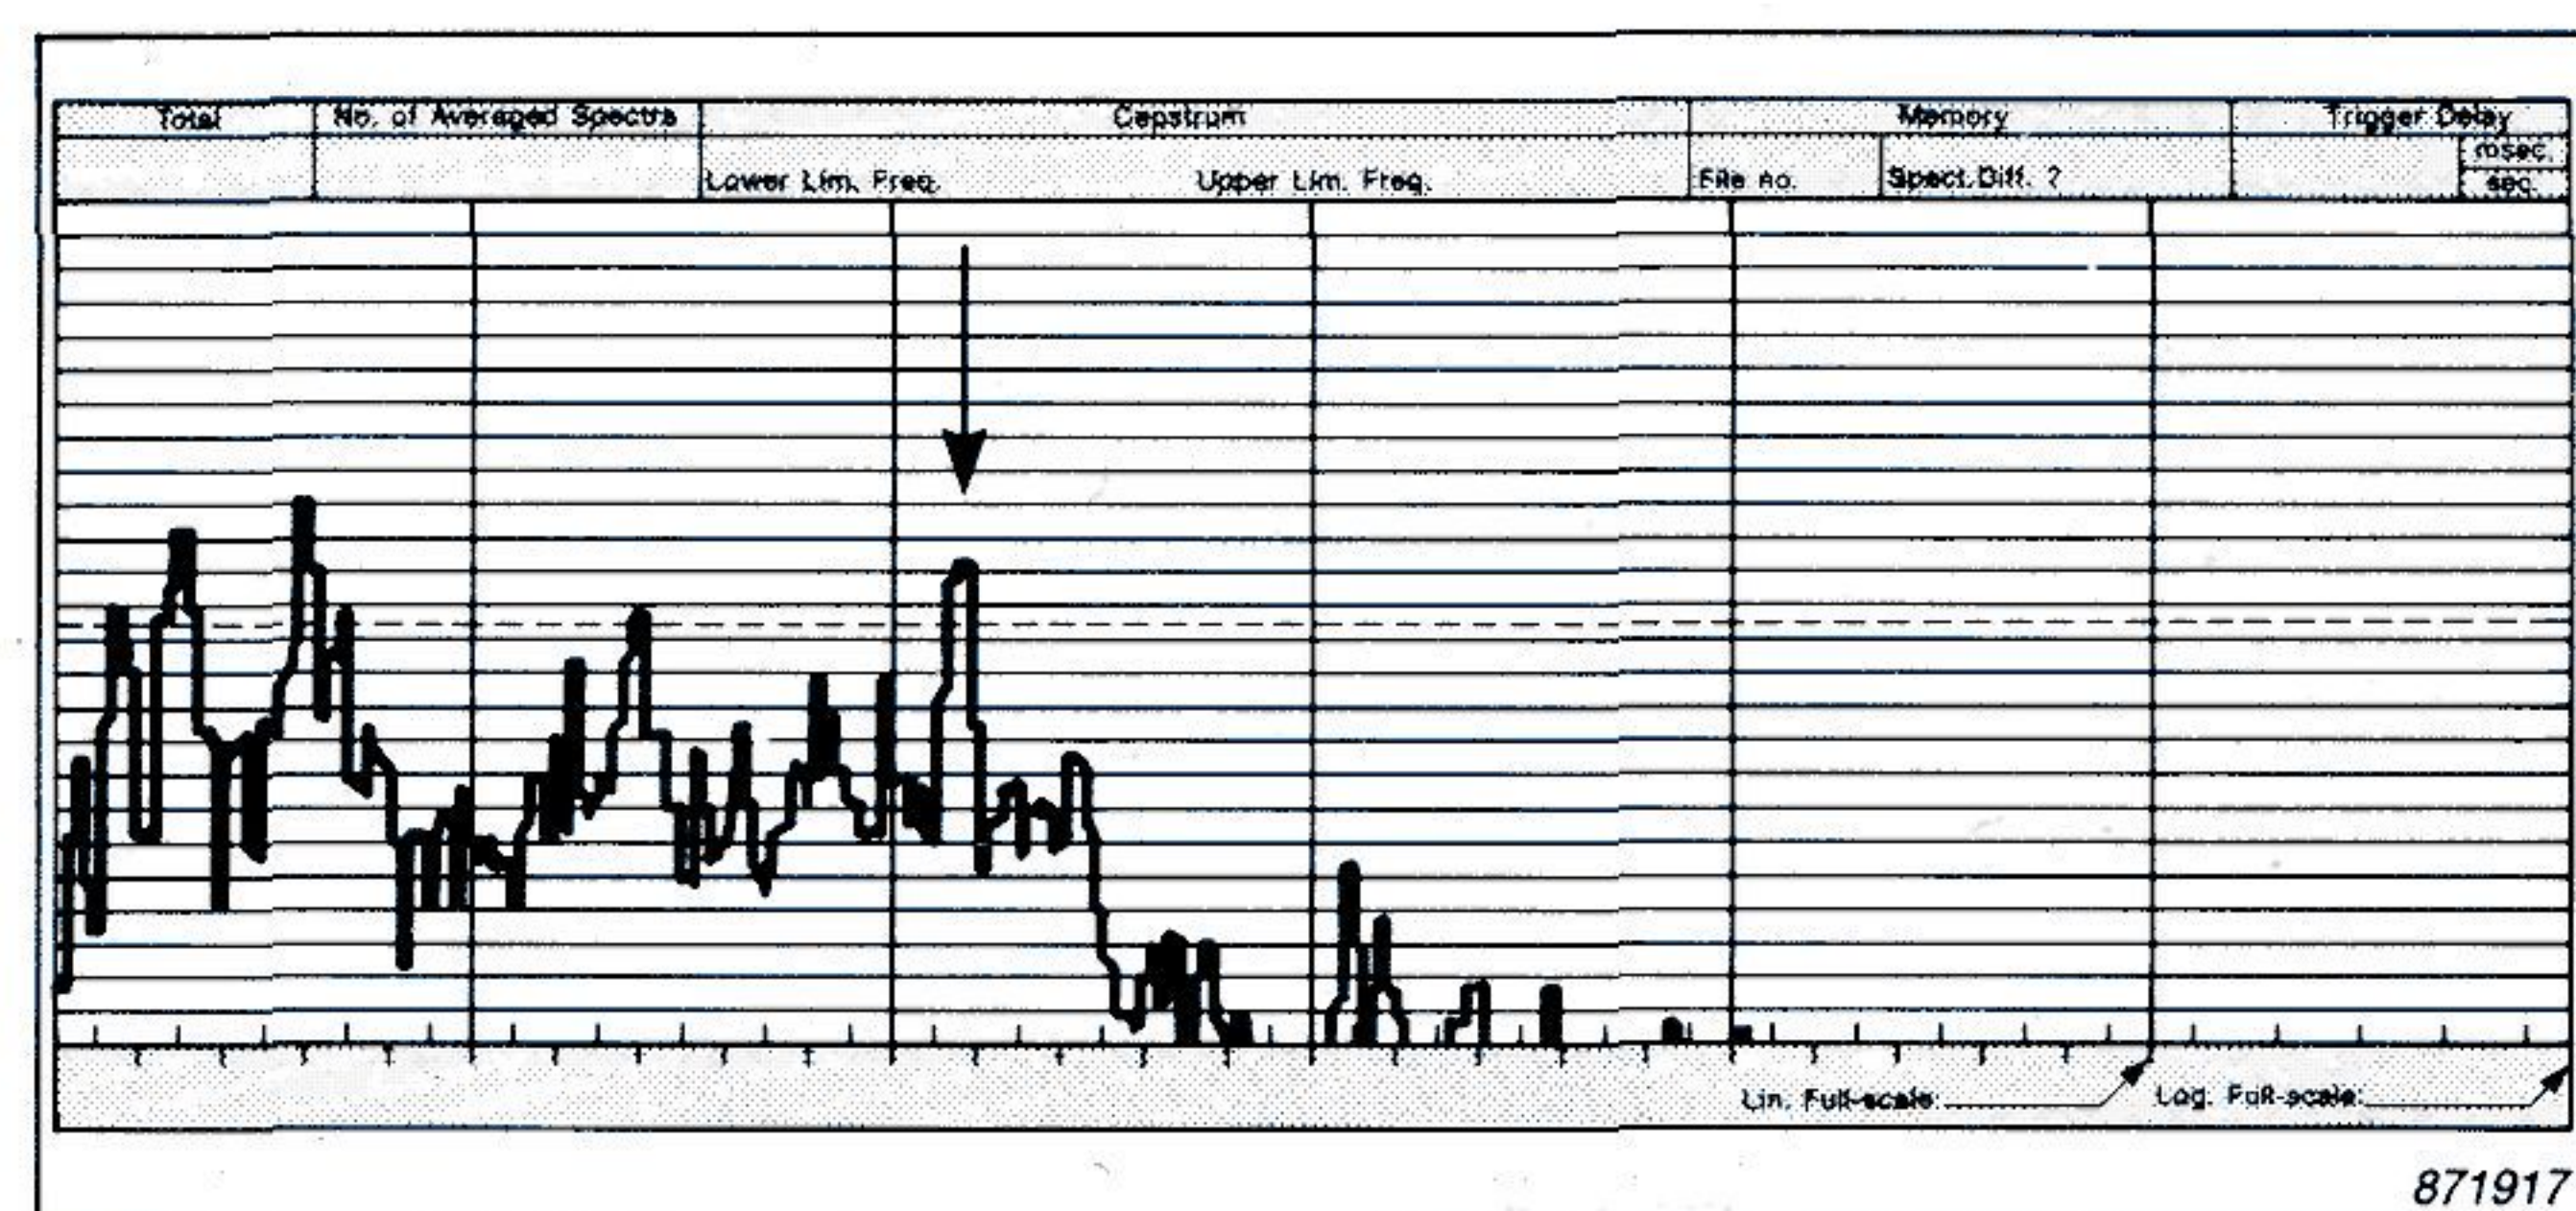
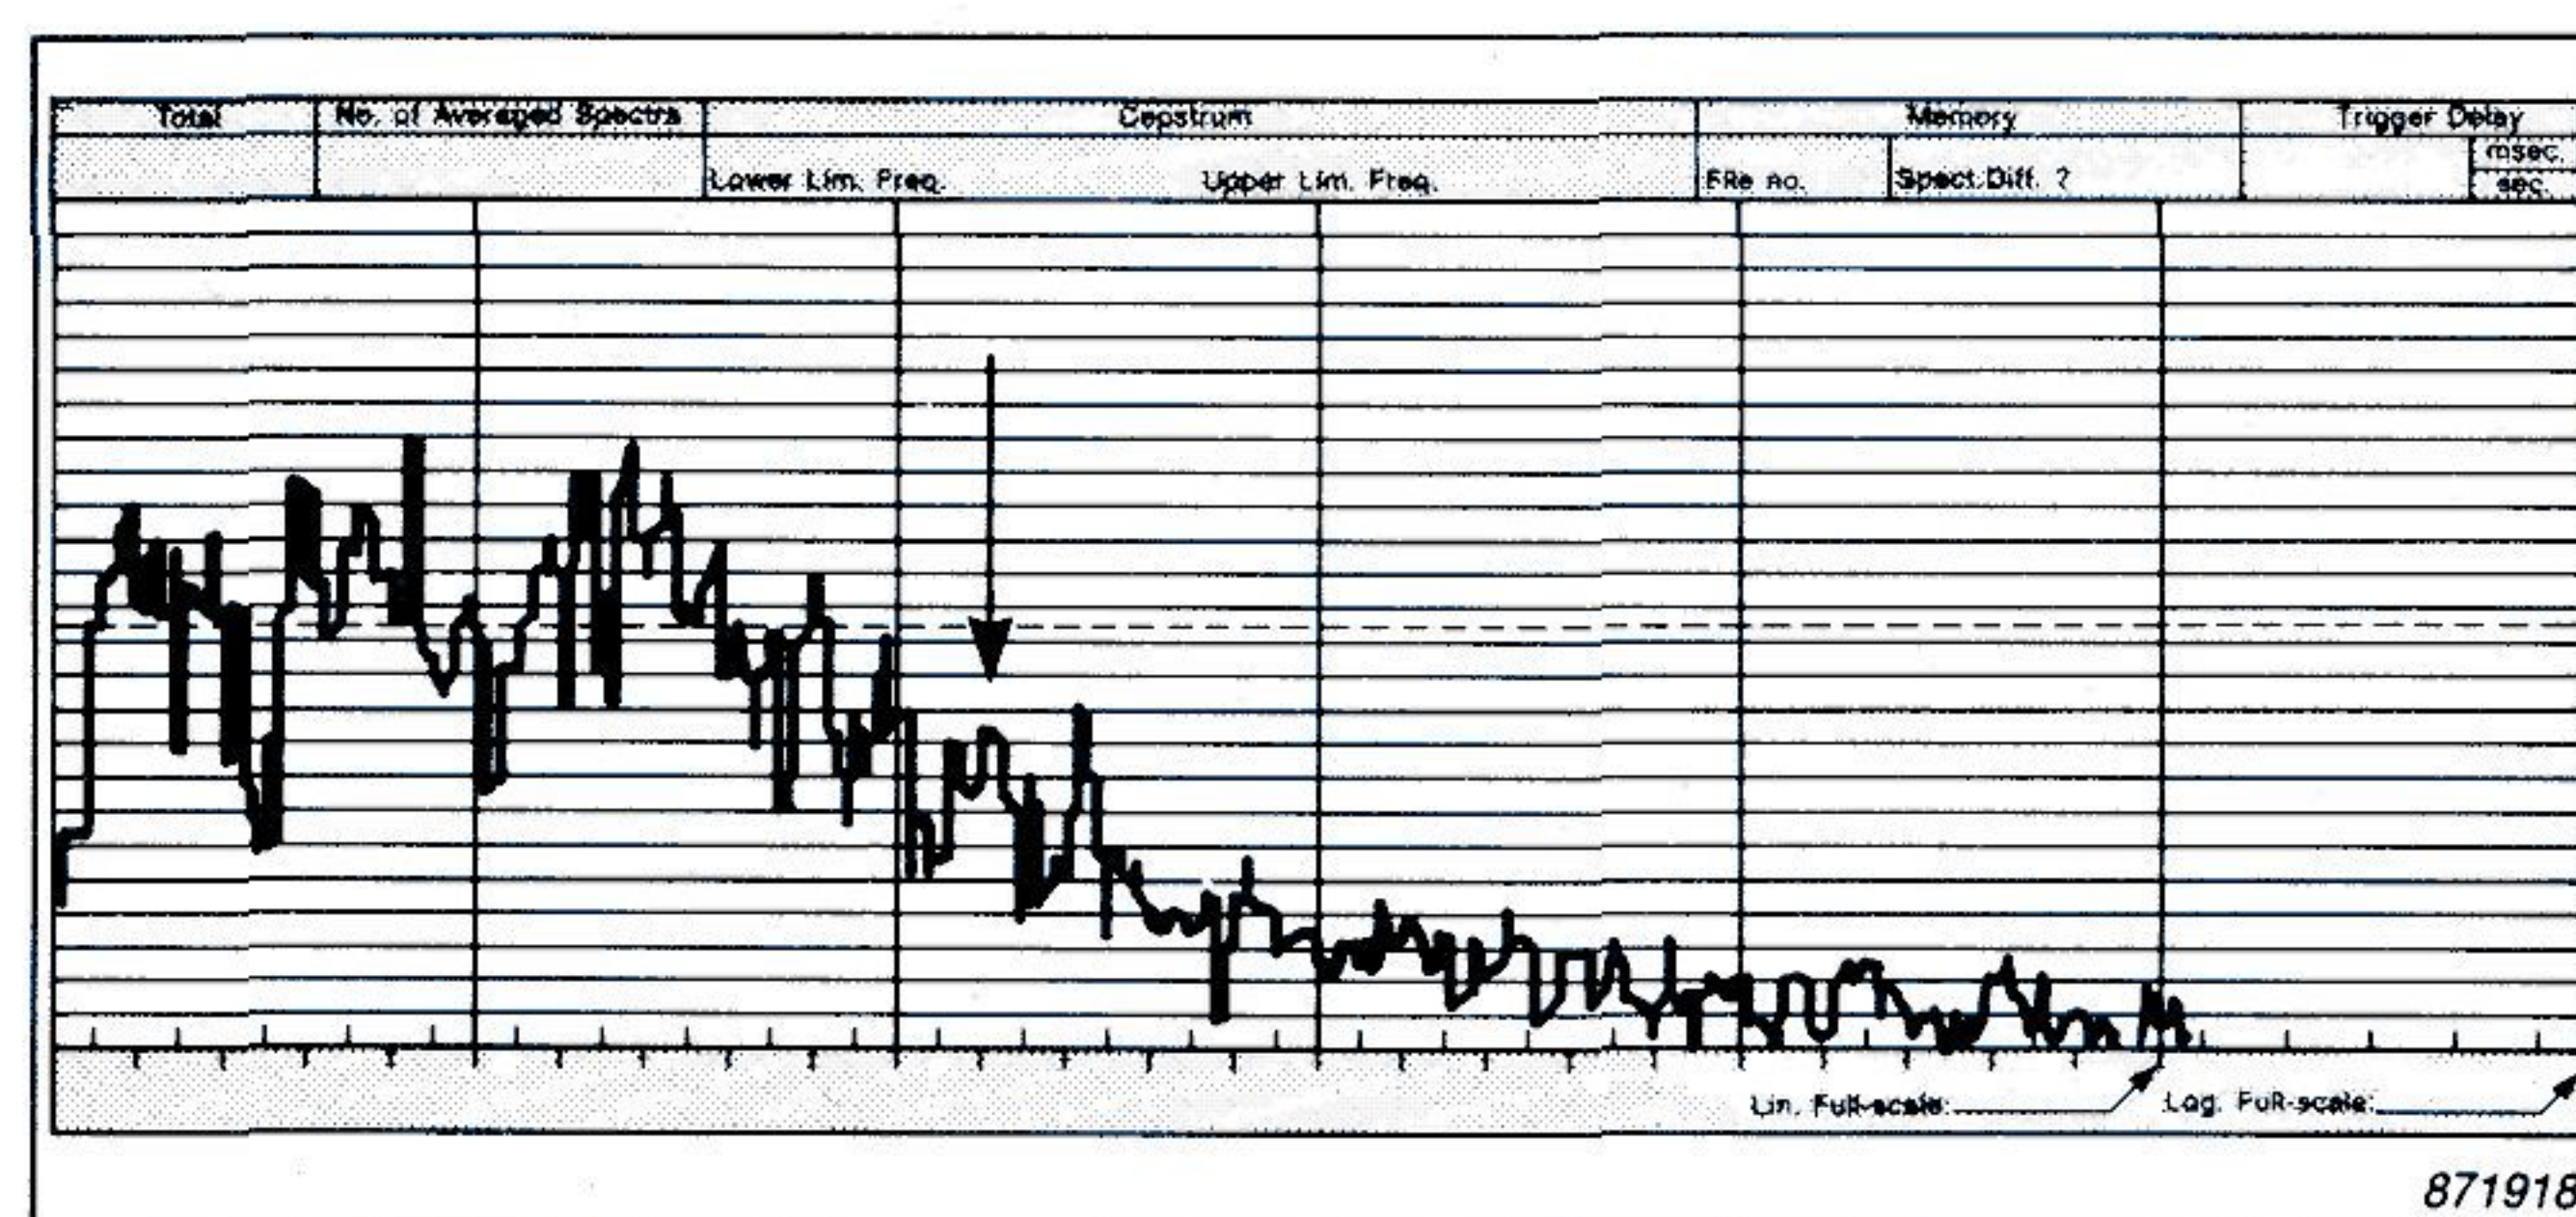
Fig. 1. Spectrum of a good lift chair (left) versus a cracked chair (right). Note the large peak in the good chair (arrowed), indicating a clear, bell-like tone

A simplified one-channel form of modal analysis was used to check the condition of each chair on a lift. The chair was struck by a small object and the frequency response of the chair was recorded on the Type 2515. The process is very similar to ringing a bell; the higher-frequency components present in an intact bell are shifted in a cracked bell to lower frequencies and the ringing dies away rapidly. This gives a cracked bell a hollow, "dead" sound. The same principles apply to testing the lift chairs.

To test this process, a measurement was made on a chair with no known defects (Fig. 1 left) and on a chair with a known defect (Fig. 1 right). The spectrum from the "good" chair shows a large peak at 4200 Hz, while in the spectrum from the cracked chair the peak is absent.

This form of testing was used to detect faults and defect welds in areas of chairs which are covered with rubber boots or are otherwise hidden from other inspection procedures. The test procedure is relatively fast: several hundred chairs could be tested in only a few hours.
